## IMPORTANT SAFETY RECALL

**NHTSA Recall Number:** 22V-349  
**Altec Identifier:** CSN 858

## HOP System Connections Inspection

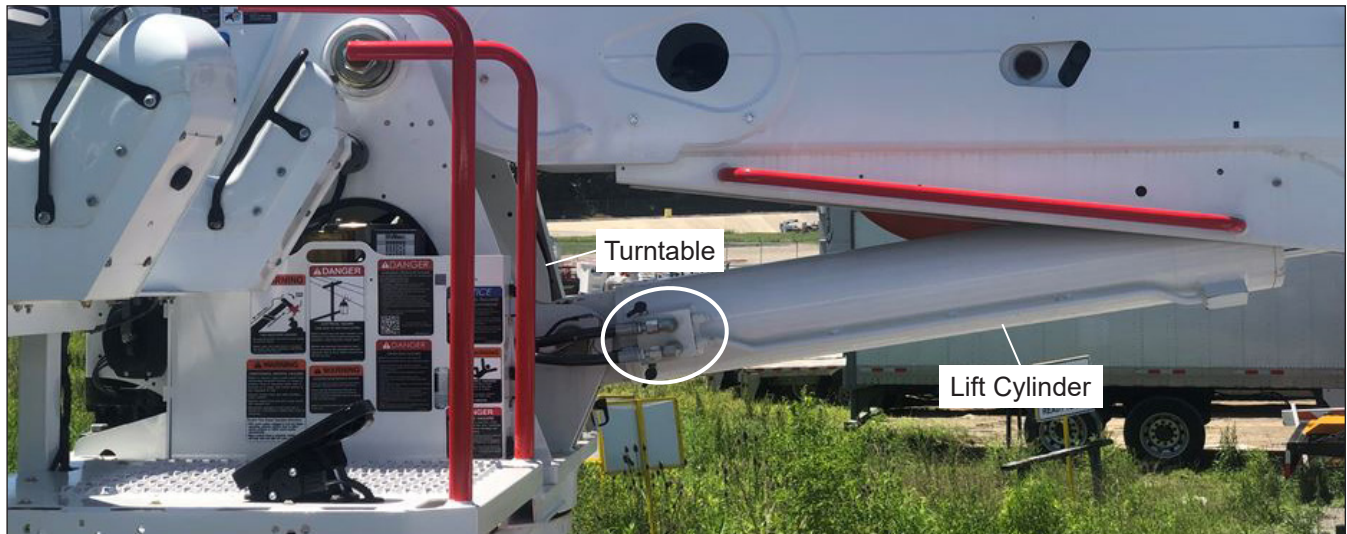
**Figure 1 — Load Holding Valve Block Location**

1. Position the unit on a level surface, apply the parking brake, and turn off the engine. Remove the key from the ignition, and secure it following your employer's vehicle lockout/tagout procedure. Chock the wheels.
2. Find the load holding valve block on the lift cylinder, located on one side near the turntable (refer to Figure 1).

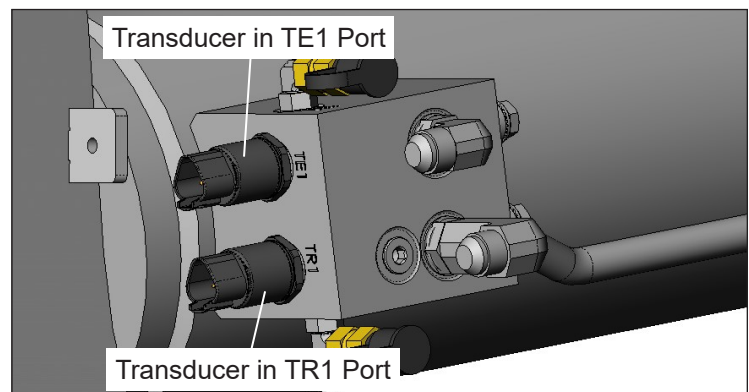
**Figure 2 — Pressure Transducers  
(DH Series Shown, Other Models May Vary)**

3. Locate the two pressure transducers installed in the ports stamped "TE1" and "TR1" on the valve block (refer to Figure 2).

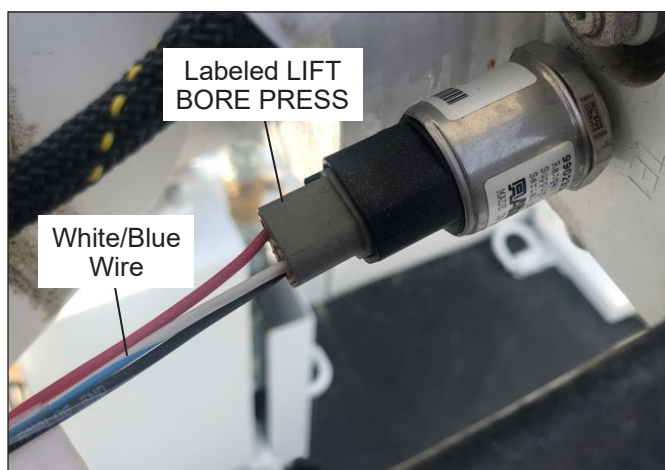
**Figure 3 — Proper Connector on Transducer in TE1 Port**

4. Visually inspect the two connectors from the turntable wiring harness attached to the pressure transducers. Both connectors have a red wire and a black wire. The connectors have a different color third wire and different label wording. The connector with a white/blue third wire and the label "LIFT BORE PRESS" should be attached to the transducer in the TE1 port, and the connector with a white/brown third wire and the label "LIFT ROD PRESS" should be attached to the transducer in the TR1 port (refer to Figures 3 and 4).

- If the connections are reversed from the proper transducers, unplug them and attach them to the opposite transducers as shown in Figures 3 and 4. Proceed to step 6.
- If the connectors are attached to the proper transducers, proceed to step 8.
