**Recall Service Bulletin
RSB22-500-001**

DATE: 7/6/2022

APPLIES TO: This service bulletin applies to certain 2021 through 2023 model year, Gladiator, Metro Star and FC-94 model emergency response chassis cabs built between March 2022 and May 2022.

NHTSA/TC Id: **22V373/TC2022-275**

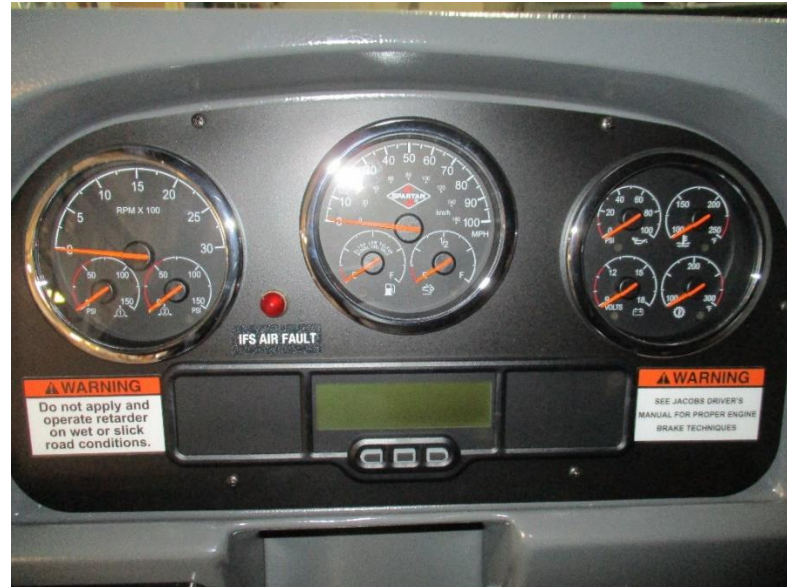
Figure 2.

Remove and Replace Hercules HC Node: Driver's Side Behind Gauges

- 4) Ensure master and ignition switches are turned off
- 5) Remove the 6 screws holding Instrument cluster in place and remove instrument cluster.

Refer to Figure 2.1

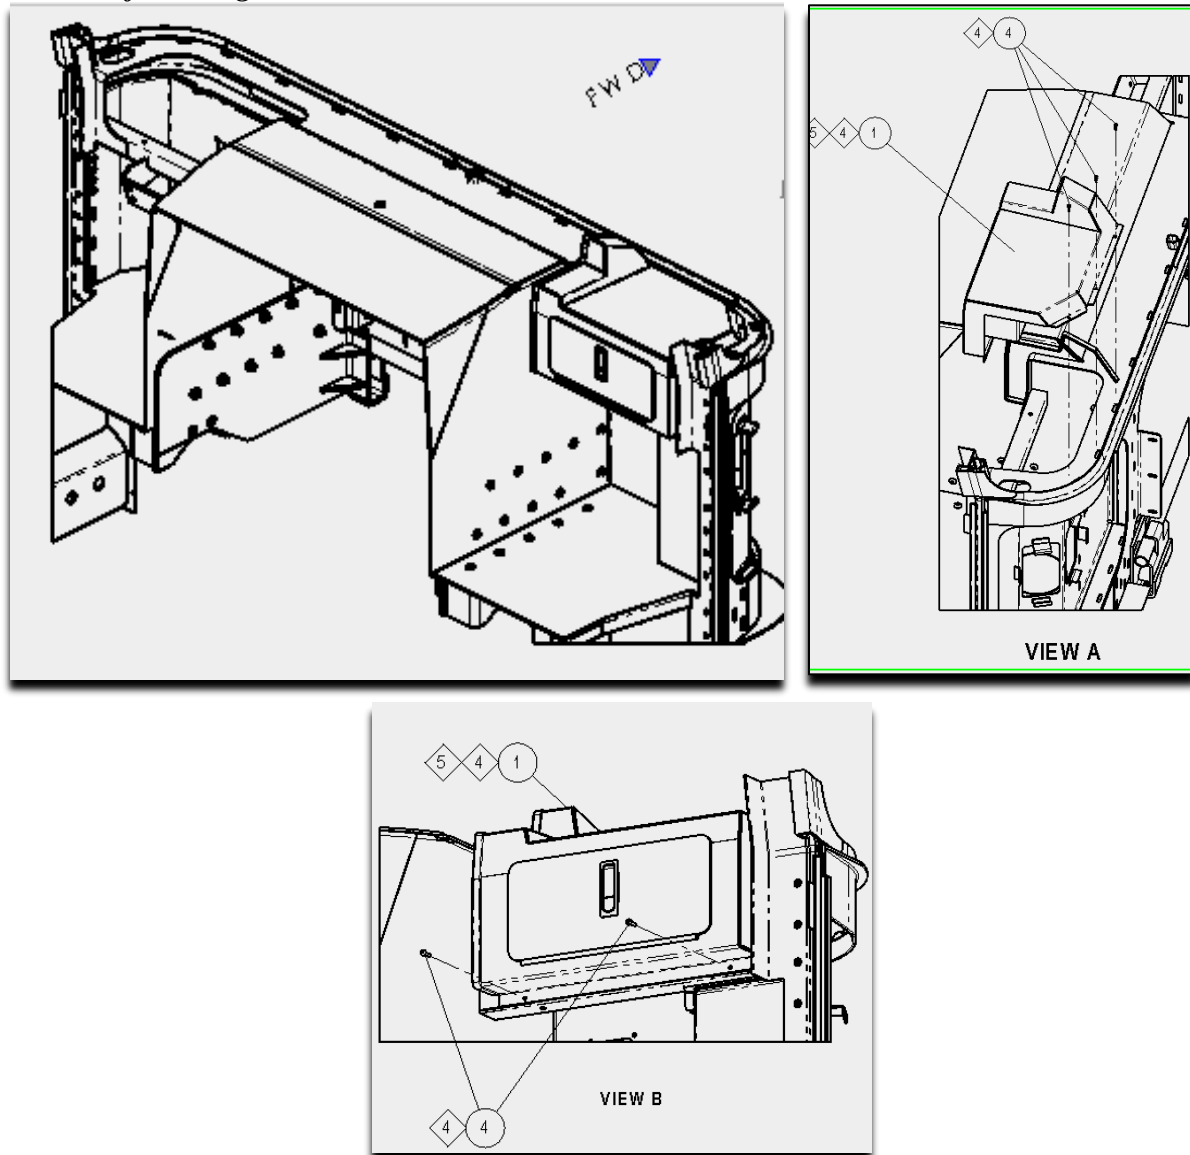
Remove and Replace Hercules HC Node: Officer's Side Behind Glove Box

- 12) Locate glove box on officer's side dash area
- 13) Remove fasteners and lift glove box assembly from dash area.

Refer to Figure 4.1
