VSR-TSB-035

NHTSA Campaign Number: 22V-378

Vehicle Safety Recall - Technical Service Bulletin

Attention: Oshkosh Product Owner
Subject: Alternator and Hood Pump Cable Routing
Models Affected: Oshkosh S-Series 2.0 Front Discharge Mixer
Model Year: 2019-2022 (VIN 788727 - 814106)
Date: June 2022

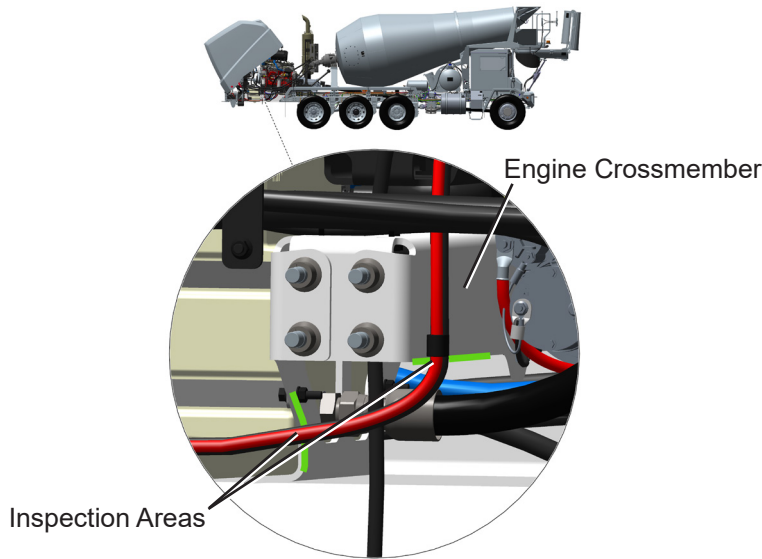
Figure 1

A concern affecting safety exists in some Oshkosh S-Series 2.0 Front Discharge Mixers. Vehicles have been identified that have alternator cables routed that may rub against components and over time wear cable sleeve or insulation exposing cable wires. The defect may cause a thermal event if the positive alternator cable is worn and makes contact with the vehicle's sub frame. This bulletin provides instruction on rerouting the alternator cables.

3. Inspect alternator positive and negative cables for signs of wear to cable sleeve or insulation along front side edges of rear engine crossmember. See Figure 1.
4. If either cable shows signs of sleeve or insulation wear during inspection replace cable. If there are no signs of wear continue to Step 5 for updated cable routing and cushion clip positioning.
