August 2022  
FL937A  
NHTSA #22V-394  
Transport Canada #2022-288

## Subject: Freightliner Steering Assembly U-Joint Pinch Bolts

**Models Affected: Specific model year 2023 Freightliner 108SD, 114SD, and Business Class M2 vehicles manufactured February 1, 2022, through May 13, 2022.**

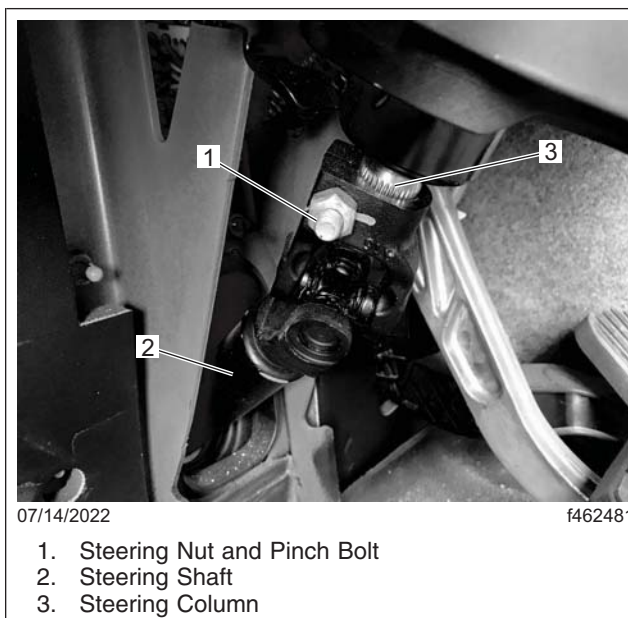
**Fig. 1, Steering Pinch Bolt Location**

1. Park the vehicle on a level surface, shut down the engine, and set the parking brake. Chock the rear tires.
2. Locate the steering shaft inside the cab, as shown in [Fig. 1](#).
3. Check the connections between the steering column and steering shaft, and the nut to pinch bolt connection, as shown in [Fig. 1](#). Remove the steering column cover to see the bolt.
4. Inspect the nut to pinch bolt connection. There must be bolt threads exposed beyond the nut as shown in [Fig. 1](#).

Are the bolt threads visible?

**NO** → **DO NOT** drive the vehicle. Have it immediately towed to the nearest DTNA dealership for repair.

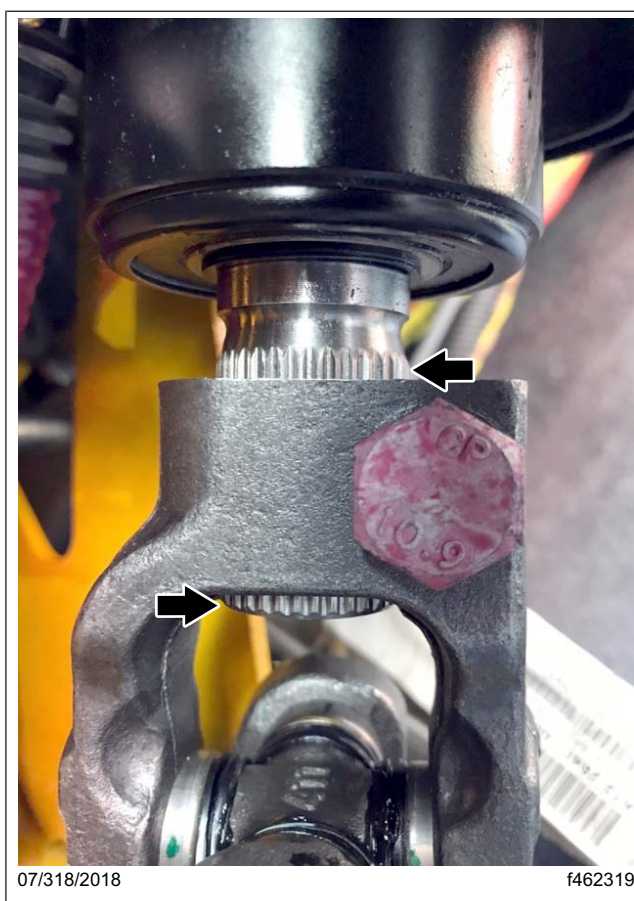
Fig. 2, Steering Shaft Splines

5. Inspect the exposed splines of the steering shaft connection as shown in [Fig. 2](#). It may be necessary to turn the steering wheel to gain adequate visibility of the splines.

If the steering shaft splines are not visible on both sides of the bolted connection, **DO NOT** drive the vehicle. Have it immediately towed to the nearest Freightliner dealership for repair.

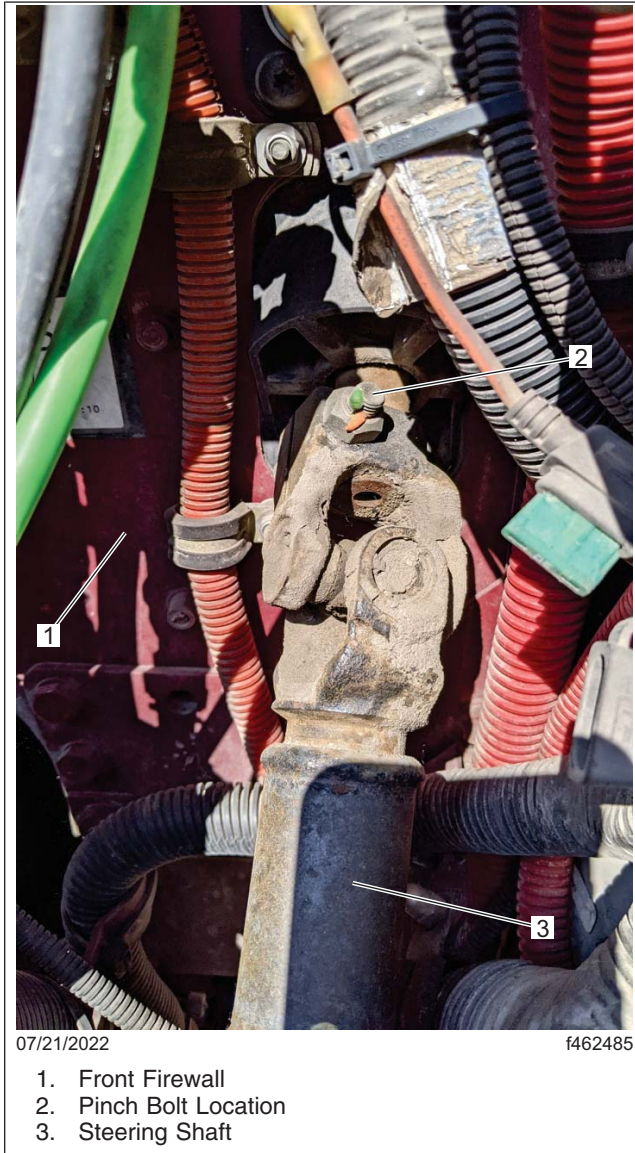
Fig. 4, Pinch Bolt and Front Firewall Location

1. Open the hood.
2. Locate the universal joint of the steering shaft at the front of the firewall. See [Fig. 3](#) and [Fig. 4](#).
3. Check the connections between the steering column and the steering shaft at the front of the firewall, and the nut to pinch bolt connection. See [Fig. 4](#).

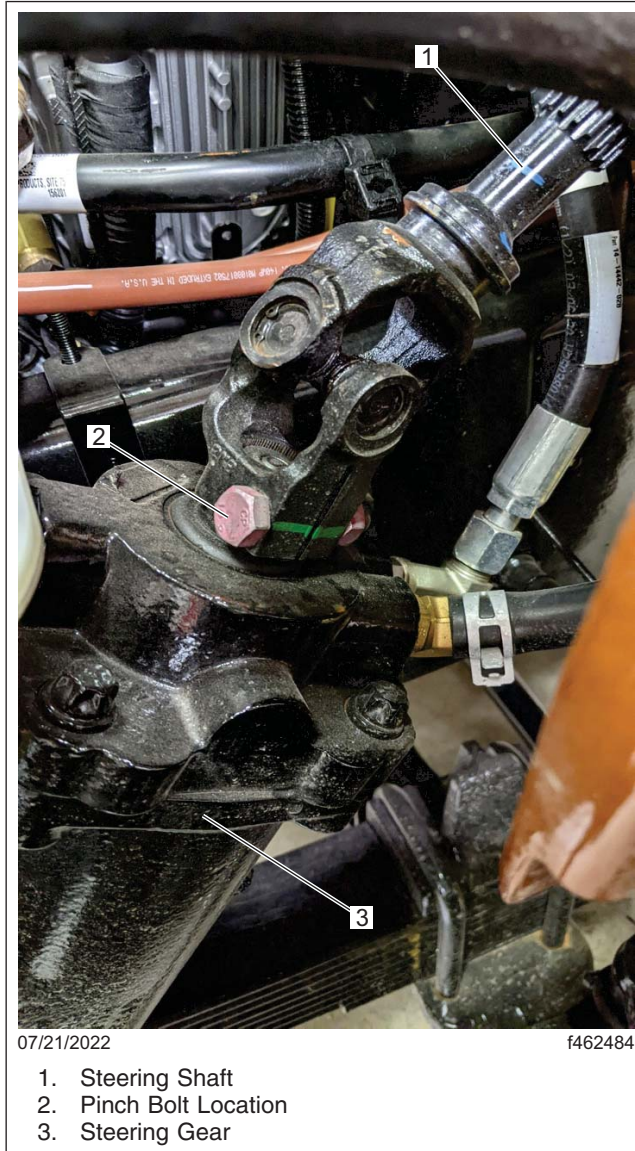
Fig. 5, Pinch Bolt and Steering Gear Location

1. Locate the universal joint at the steering gear. See [Fig. 3](#) and [Fig. 5](#).
2. Check the connections between the steering shaft and the steering gear, and the nut to pinch bolt connection. See [Fig. 5](#).

3. Inspect the nut to pinch bolt connection. There must be bolt threads exposed beyond the nut as shown in [Fig. 1](#).  
Are the bolt threads visible?  
**YES** → Go to the next step.  
**NO** → **DO NOT** drive the vehicle. Have it immediately towed to the nearest DTNA dealership for repair.
4. Inspect the exposed splines of the steering shaft connection as shown in [Fig. 2](#). It may be necessary to turn the steering wheel to gain adequate visibility of the splines.  
If the steering shaft splines are not visible on both sides of the bolted connection, **DO NOT** drive the vehicle. Have it immediately towed to the nearest DTNA dealership for repair.  
If the steering shaft splines are exposed on both sides of the bolted connection, the vehicle may be driven to the nearest DTNA dealer for the formal inspection and to complete the recall.

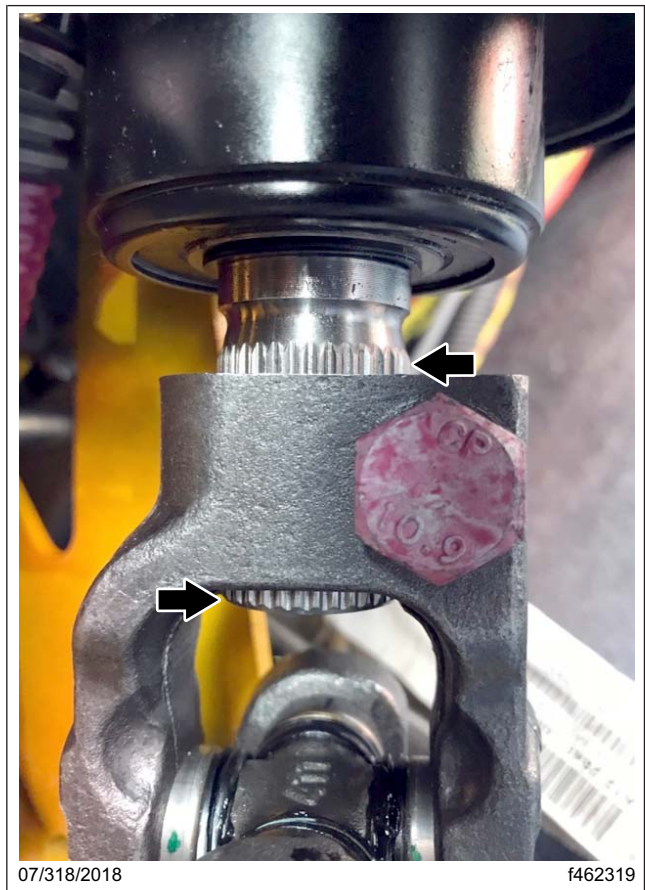
Fig. 6, Steering Shaft Splines

1. Check the base label (Form WAR259) for a completion sticker for FL937 (Form WAR260) indicating this work has been done. The base label is usually located on the passenger door about 12 inches (30 cm) below the door latch. If a sticker is present, no work is needed. If there is no sticker, proceed with the next step.
2. Park the vehicle on a level surface, shut down the engine, and set the parking brake. Chock the tires.
3. Locate the steering shaft inside the cab.
4. Remove the steering column cover.
5. Inspect the splines on the bolted steering shaft connection shown in [Fig. 6](#).

Are the splines exposed on both sides?

6. Position the steering shaft to align the hole with the groove in the shaft, and install a new fastener.
7. Using a torque wrench, tighten the fastener 33 lbf·ft (45 N·m).
8. Apply torque seal on the fastener.
9. Proceed to the next inspection below.

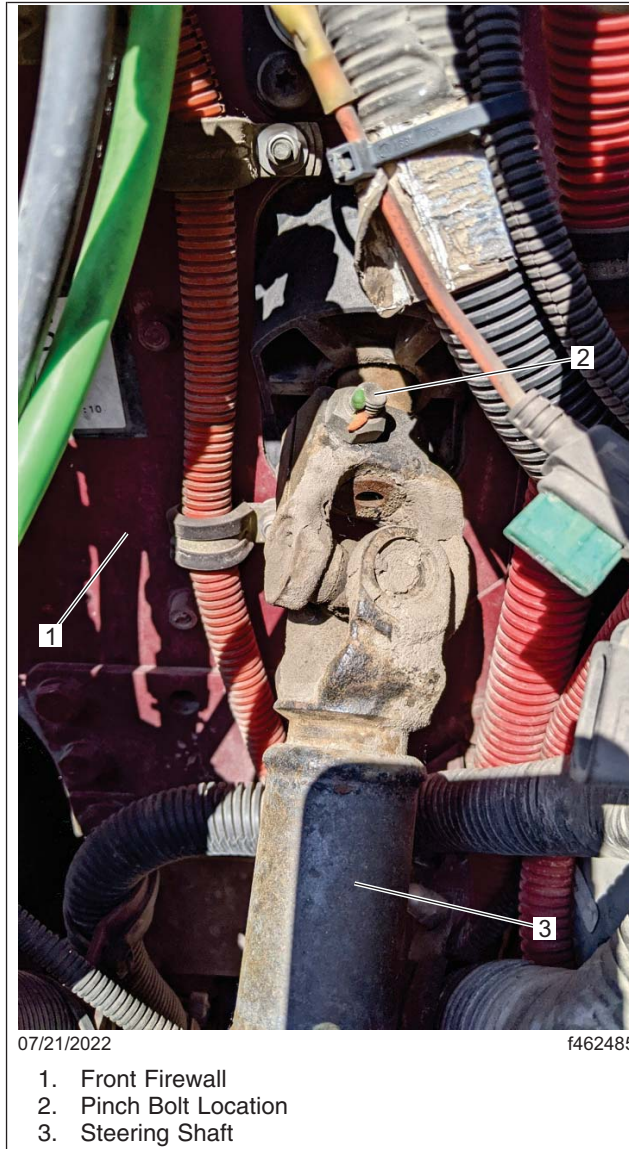
**Fig. 8, Pinch Bolt and Front Firewall Location**

1. Open the hood.
2. Locate the universal joint of the steering shaft at the front of the firewall. See [Fig. 7](#) and [Fig. 8](#).

3. Inspect the splines on the bolted steering shaft connection shown in [Fig. 6](#) on page 12.  
Are the splines exposed on both sides?  
**YES** → Go to step 5.  
**NO** → Go to the next step.
4. Position the steering shaft to align the hole with the groove in the shaft, and install a new fastener.
5. Using a torque wrench, tighten the fastener 33 lbf·ft (45 N·m).
6. Apply torque seal on the fastener.
7. Proceed to the next inspection.

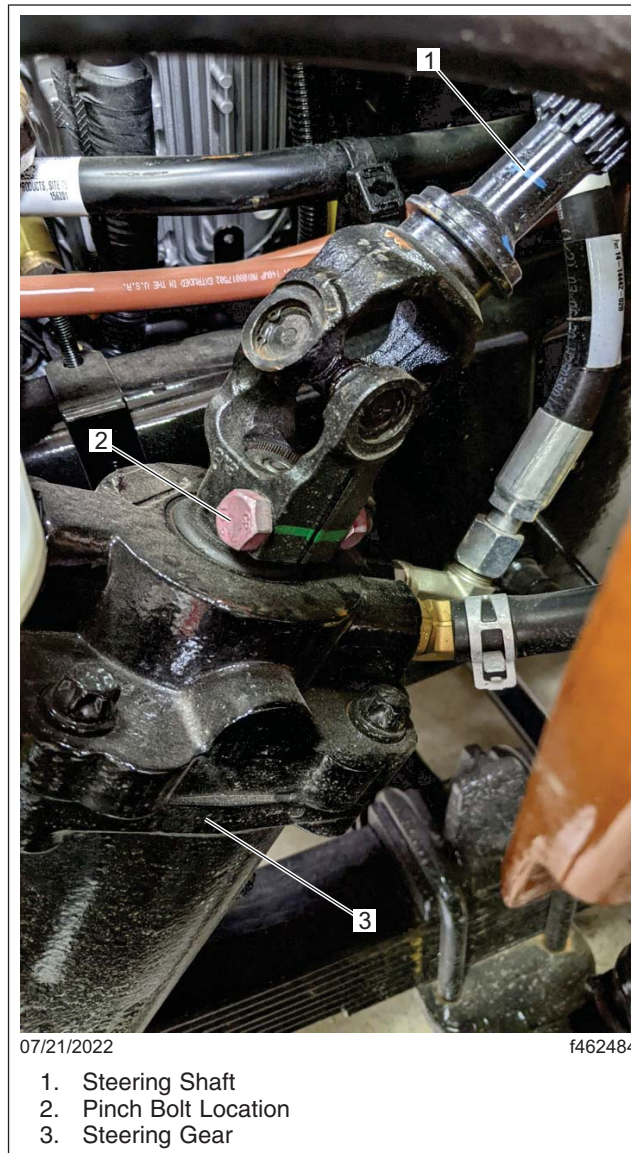
**Fig. 9, Pinch Bolt and Steering Gear Location**

1. Locate the universal joint at the steering gear. See [Fig. 7](#) and [Fig. 9](#).

2. Inspect the splines on the bolted steering shaft connection shown in [Fig. 6](#) on page 12.  
Are the splines exposed on both sides?  
**YES** → Go to step 4.  
**NO** → Go to the next step.
3. Position the steering shaft to align the hole with the groove in the shaft, and install a new fastener.

4. Using a torque wrench, tighten the fastener 33 lbf·ft (45 N·m).
5. Apply torque seal on the fastener.
6. Clean a spot on the base label (Form WAR259). Write the campaign number, FL937, on a blank red completion sticker (Form WAR260) to indicate the work has been completed, and attach it to the base label.
