Model Year 2022 Zero SR/F and SR Front Brake Caliper Bolts Recall

NHTSA Campaign Number: 22V-403

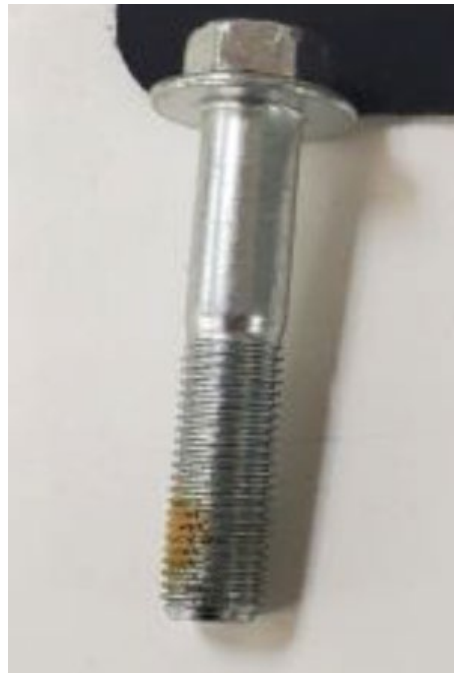
- Zero Motorcycles Part Number 90-08134 – HEX FLANG BOLT STAR DRIVE PER ZM 88-08813 M10X55X1.25 THREAD 10.9 ZM-F-01 ZM-L-02 – These bolts for the front calipers are 55 mm in length with a thread pitch of 1.25, with thread patch locking compound pre-applied.

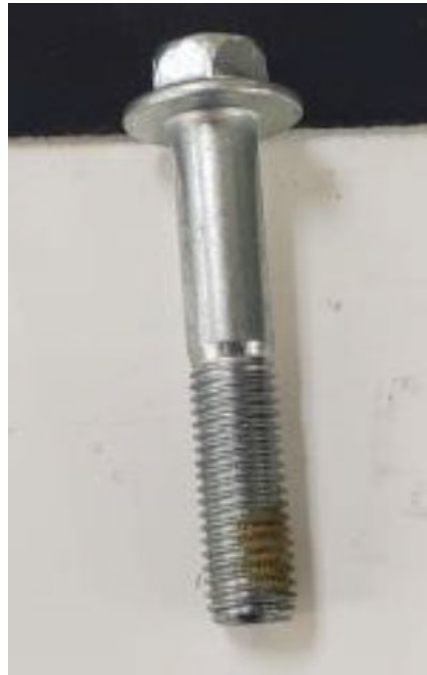
CAUTION: The incorrect brake caliper bolts are similar in appearance with measurements of: M10x60x1.50. These bolts are 5mm longer than the correct bolt with a coarser thread pitch. This difference in size and thread pitch can cause a failure in the clamping load holding the caliper to the affected fork, resulting in loss of braking force. See image below of the incorrect brake caliper bolts. Be sure to mark them and dispose of them properly.

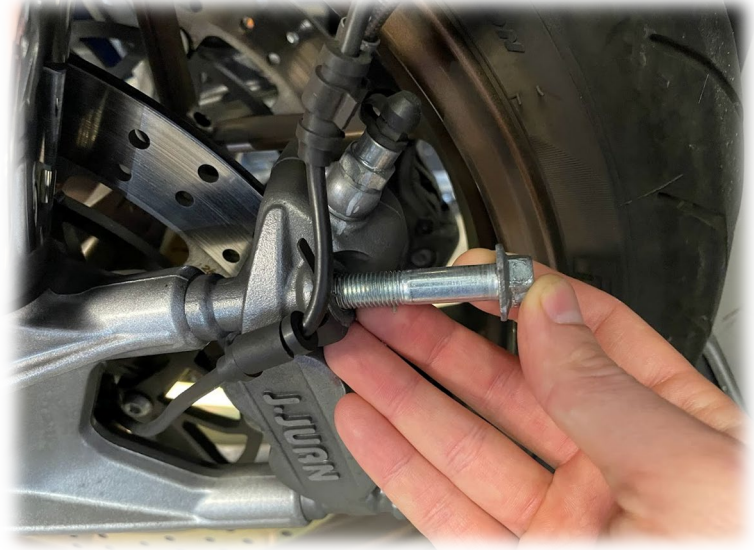
Figure 1

1. Remove front brake caliper bolts, one at a time to measure them. [Tool: T50, Torque: 30 ft-lbs]

Note: For left upper caliper bolt, take note of position of wheel speed sensor wiring clip position.

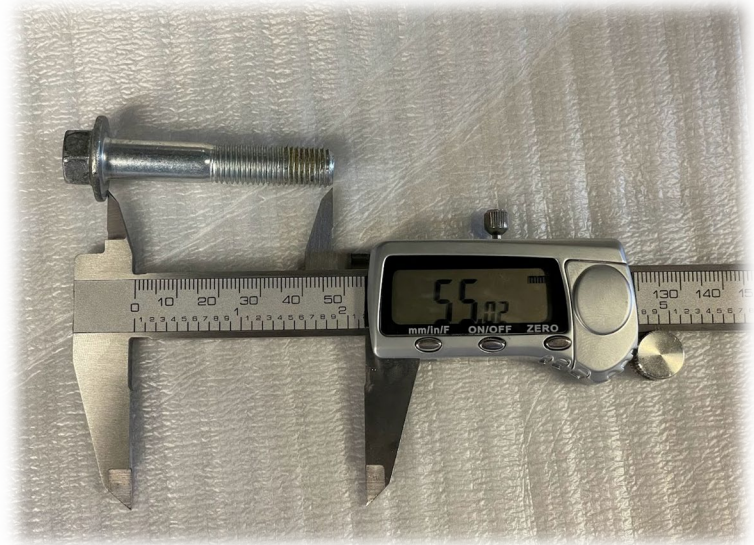
Figure 2

2. Measure and record brake caliper bolt length. Each bolt must be 55mm in length, or bolt and fork must be replaced.

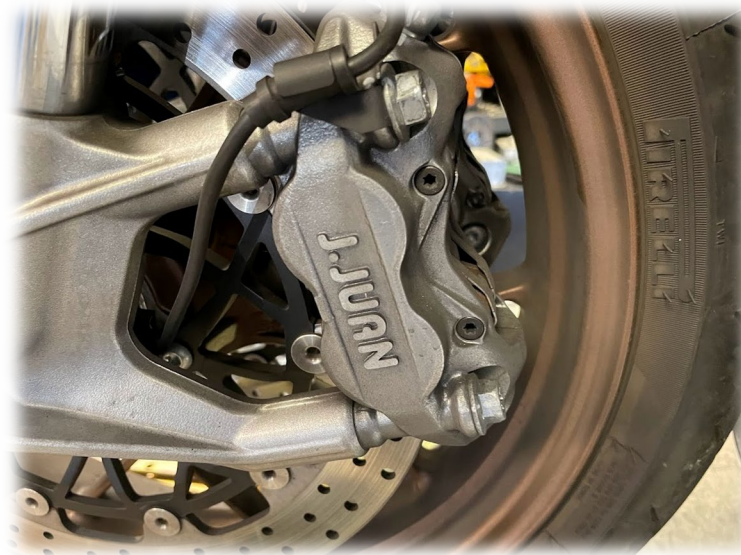
Figure 3

3. If the bolt is the correct length, 55mm, no further corrective action is required.

[Reinstall bolt and torque to 30 ft-lbs]

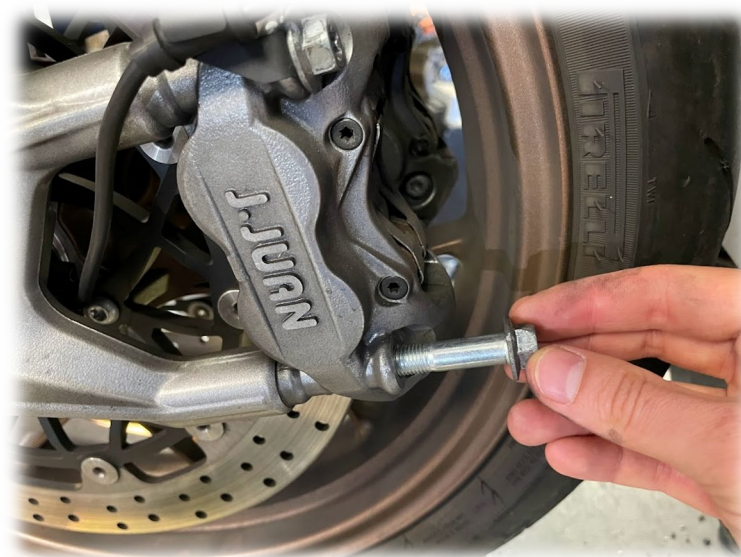
Figure 4

4. Remove next bolt in caliper to measure length.

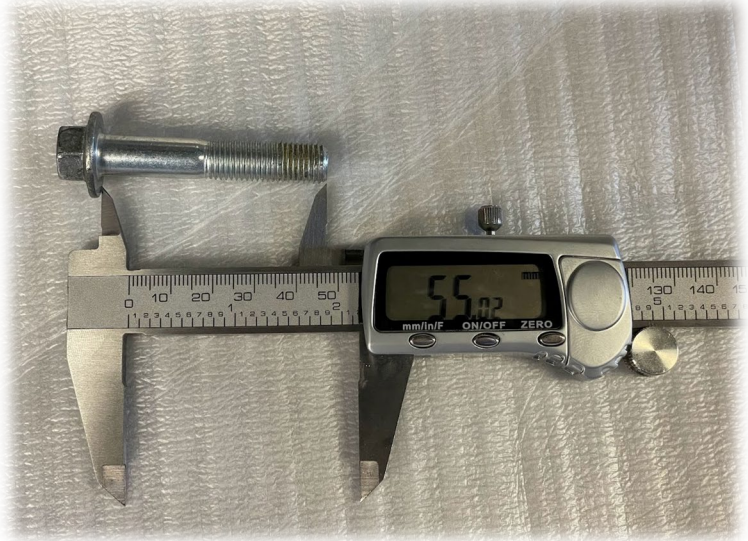
Figure 5

5. Measure and record brake caliper bolt length. Each bolt must be 55mm in length, or bolt and fork must be replaced.

If **ANY** bolt measures longer than 55mm, or is extremely difficult to remove, the associated fork and brake caliper bolts must be replaced.
