December 2022  
FL938A-E  
NHTSA #22V-405  
Transport Canada #2022-300

## Subject: Steering Gears

**Models Affected:** Specific model years 2022-2023 Freightliner Cascadia and Freightliner Custom Chassis MT45, and MT45G vehicles, manufactured June 9, 2021, through May 23, 2022, and equipped with an RH Sheppard steering gear.

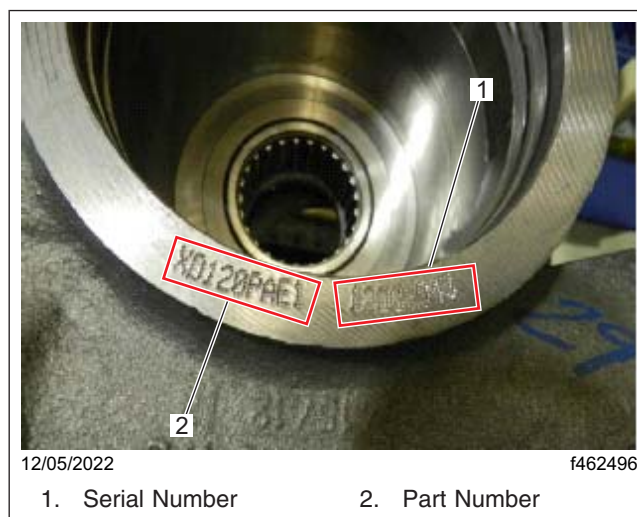
**Fig. 1, Steering Gear Identification**

1. Check the base label (Form WAR259) for a completion sticker for FL938 (Form WAR260) indicating this work has been done. The base label is usually located on the passenger door about 12 inches (30 cm) below the door latch. If a sticker is present, no work is needed. If there is no sticker, proceed with the next step.
2. Park the vehicle on a level surface, shut down the engine, and set the parking brake. Chock the tires.
3. Locate the steering gear on the front left frame rail of the vehicle.
4. Locate the serial number on the steering gear. See **Fig. 1**.

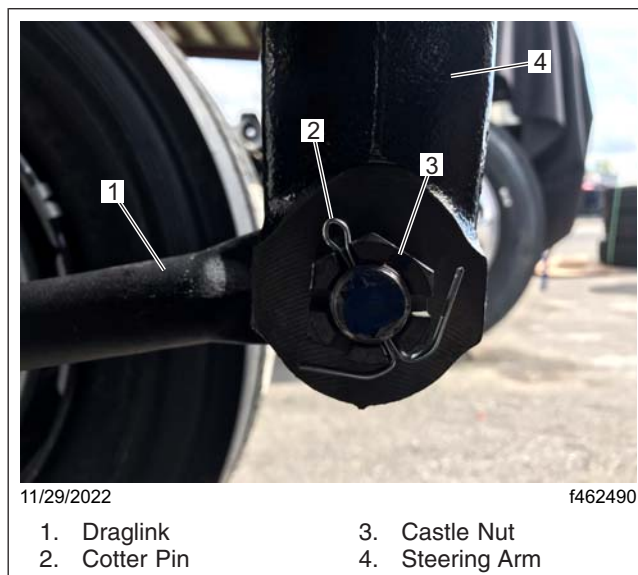
**Fig. 5, Cotter Pin Removal**

2. Remove the cotter pin from the castle nut at the steering arm-to-draglink connection. See [Fig. 5](#).

29. If the cotter pin hole is not accessible, advance the castle nut to the nearest slot, and install the cotter pin. Bend the split side of cotter pin around the nut as shown in [Fig. 5](#).

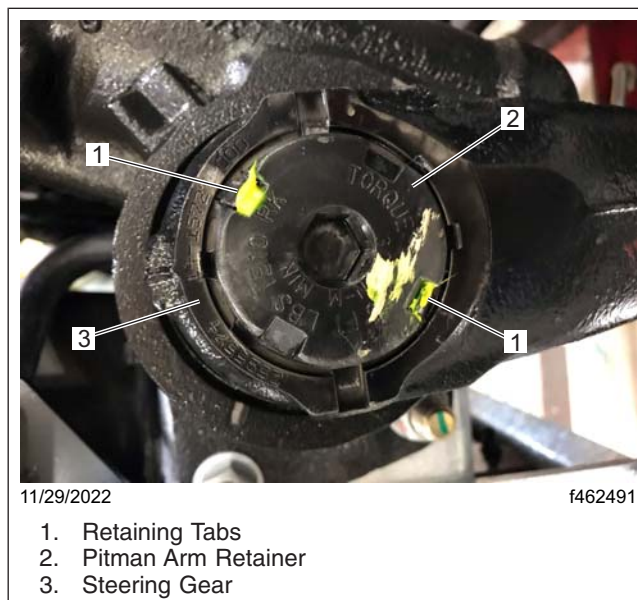
**Fig. 6, Bending the Pitman Arm Retaining Tabs**

3. Use a 1-1/8 inch socket to remove the castle nut. Retain the castle nut for installation in the later step. Remove the draglink from the pitman arm.
4. At the pitman arm-to-steering gear connection, use a punch to bend the retaining tabs out of the pitman arm retainer. See [Fig. 6](#).

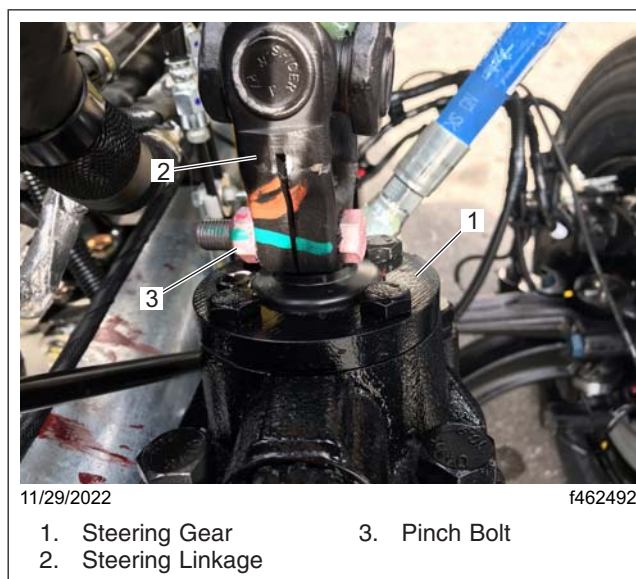
**Fig. 7, Pinch Bolt Removal**

5. Lubricate the face of the retainer with a clean chassis lube.
6. Disconnect the pitman arm from the steering gear.
  - 6.1 Slide the pitman arm puller over the pitman arm. Align the hole in the puller with the Allen socket in the retainer.
  - 6.2 Insert the Allen drive socket through the puller and into the retainer socket. Use an impact wrench to back off the retainer. The retainer will act as a jackscrew to disconnect the pitman arm from the steering gear.
7. Use a 5/8-inch wrench and a 11/16-inch socket to remove the pinch bolt that attach the steering linkage to the top of the steering gear. Discard the fasteners. See **Fig. 7**.

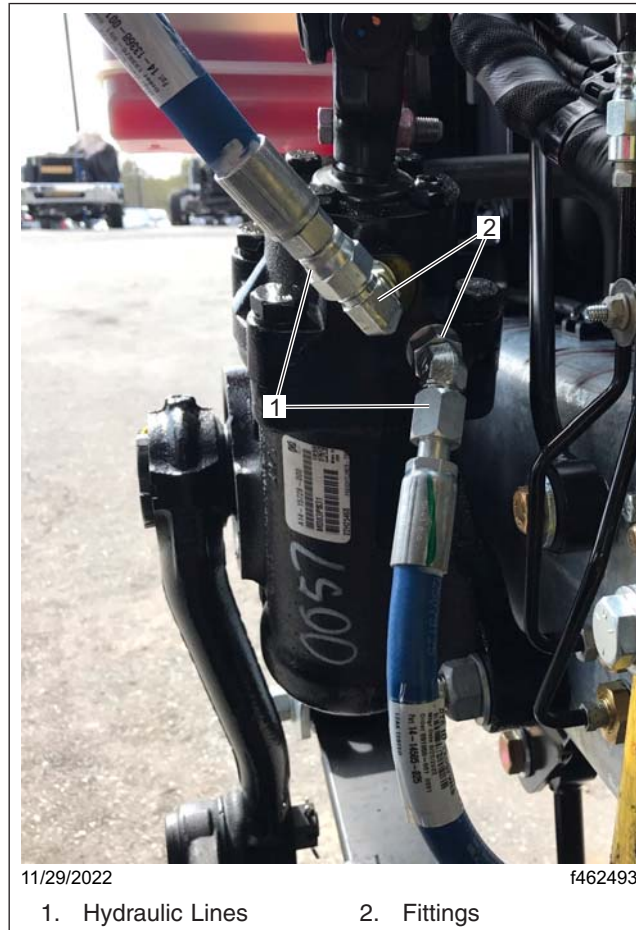
**Fig. 8, Hydraulic Lines Removal**

9. Use a 7/8-inch wrench to loosen and remove the hydraulic lines from the fittings on the rearward-facing side of the steering gear. See [Fig. 8](#)

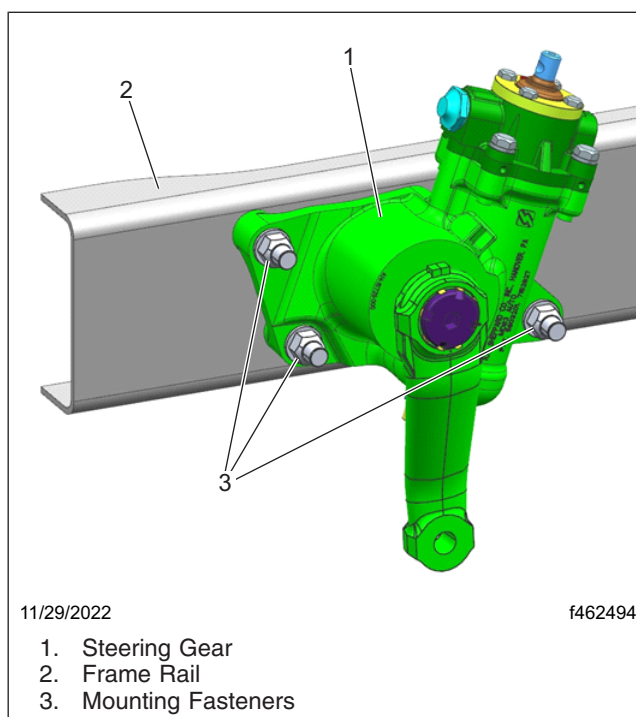
**Fig. 9, Steering Gear Removal**

11. Use a 1-1/8 inch socket and wrench to remove the three bolts and washers that attach the steering gear to the rail. Discard the fasteners. See [Fig. 9](#).
12. Remove the steering gear.

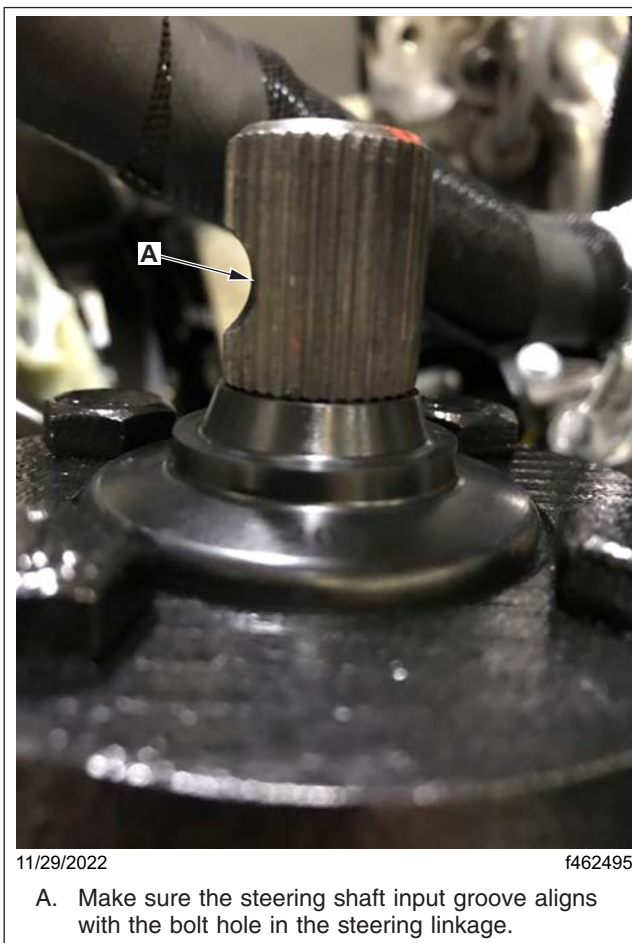
**Fig. 10, Steering Linkage Installation**

19. Make sure the bolt hole in the steering linkage, and the groove on the steering gear input shaft align properly. Install the steering linkage on top of the gear. See [Fig. 10](#).

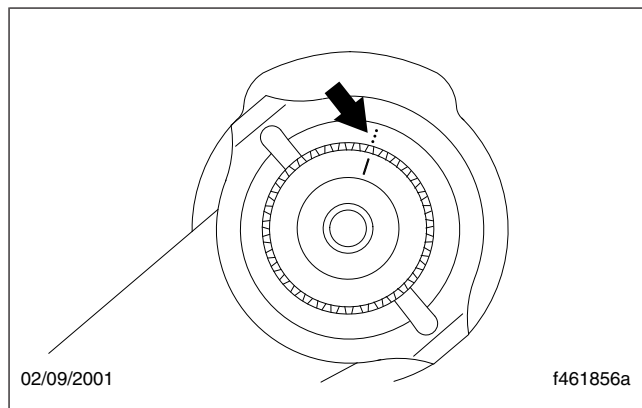
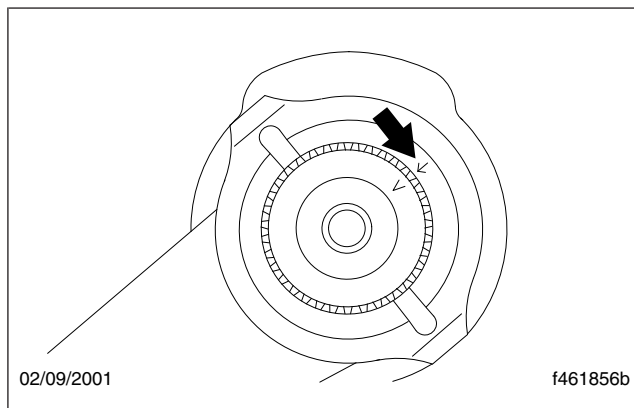
21. Align the timing marks on the pitman arm with the timing marks on the sector shaft, then install the pitman arm on the sector shaft. The timing marks will appear as shown in [Fig. 11](#) and [Fig. 12](#).
