SUBJECT: NEW VEHICLE DEMONSTRATION / DELIVERY HOLD

Safety Recall 22S43 - Supplement #2
Certain Model Years Multiple Vehicles
Transmission Shifter Cable Bushing

CERTAIN 2013-2019 ESCAPE, 2013-2016 FUSION, 2013-2018 C-MAX, 2013-2021 TRANSIT CONNECT AND 2015-2018 MODEL YEAR EDGE VEHICLES — SHIFTER CABLE BUSHING REPLACEMENT AND PROTECTIVE CAP

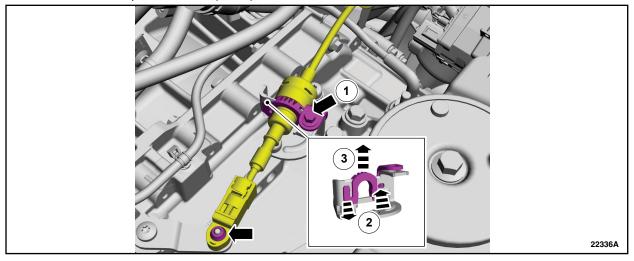
FIGURE 1

- 1. Apply the parking brake, chock wheels to make sure vehicle does not roll.
- 2. Position the gear shift lever in Drive (D).
- 3. Remove the air cleaner assembly. Please follow the Workshop Manual (WSM) procedures in Section 303-12.
- 4. Remove the air cleaner outlet pipe. Please follow the WSM procedures in Section 303-12.
- 5. Disconnect the selector lever cable from the transmission manual lever and the bracket. See Figure 1.
 - 1. Remove the selector lever cable bracket bolt.
 - 2. Disengage the selector lever cable holding clip.
 - Use caution when removing hold down bracket to avoid damage. Hold down bracket is available separate of shift cable.
 - 3. Disconnect the selector lever cable.
 - Torque to 62 lb.in (7 Nm).

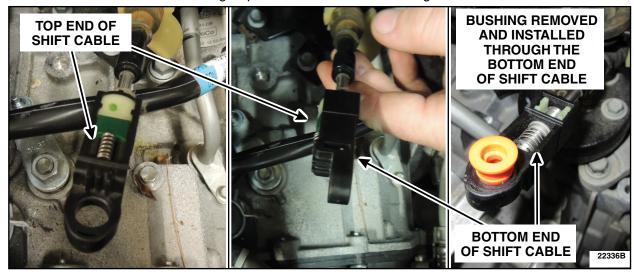
FIGURE 2

NOTE: Selector Lever Cable Bushing Replacement/Orientation. See Figure 2.

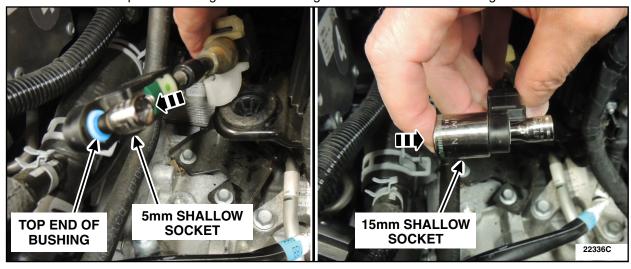
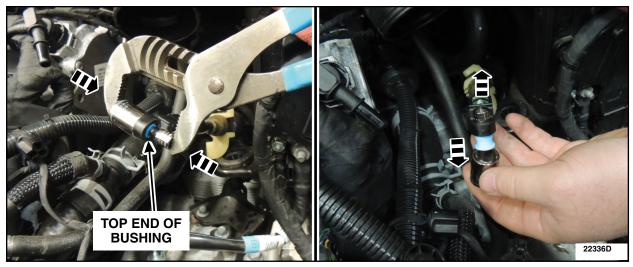
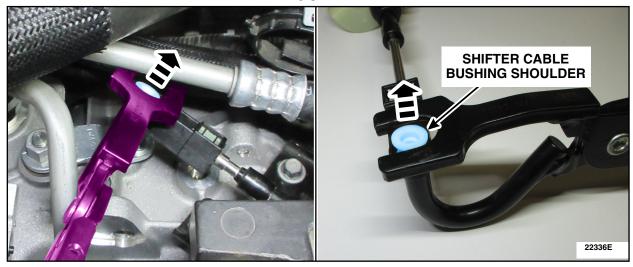
- 6. Press out the shifter cable bushing using one of the two methods below.
 - Using a 5mm and a 15mm socket with Straight Jaw Adjustable pliers the bushing can be pressed out of the shifter cable end. The 5mm socket will fit into the small part of the bushing on top, the 15mm will go against the bottom of the shifter cable end, make sure to have socket centered with the bushing to allow clearance of the bushing shoulder as it is being pressed out. See Figures 3 and 4.
 - Using a tool such as a Lisle 38350 Exhaust Hanger Removal plier to press bushing out. By viewing Figure 5 the shoulder of bushing is positioned upward, small end of plier is pressing bushing out. Proceed to Step 7.
 - Use caution not to damage the shifter cable during this procedure.
 - Inspect for damage before installing the new shifter cable bushing.

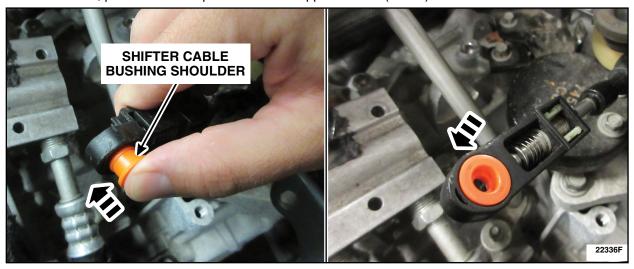
FIGURE 6

- 7. Using your hands only, install the *new* selector lever cable bushing. Do not use any grease to install, the bushing and cable end should be dry. See Figure 6.
 - Visually check shifter cable end for any signs of damage. If damage to the shifter cable end is found, please call the Special Service Support Center (SSSC).

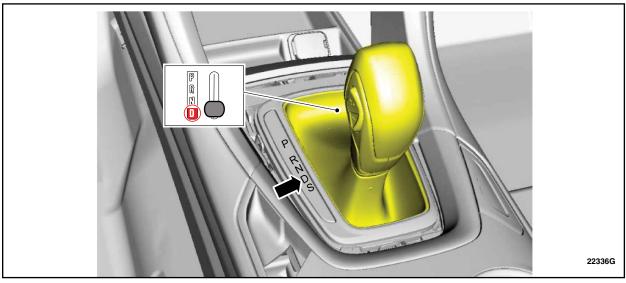
FIGURE 7

8. The vehicle's transmission gear selector lever should be in Drive position from Step 2, if not, position the selector lever to Drive (D). See Figure 7.

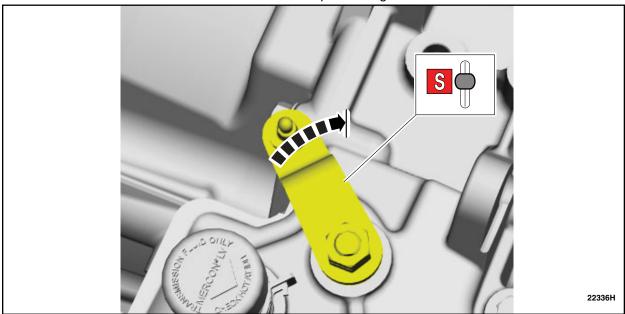
FIGURE 8

9. Rotate the manual control lever clockwise until it stops. See Figure 8.

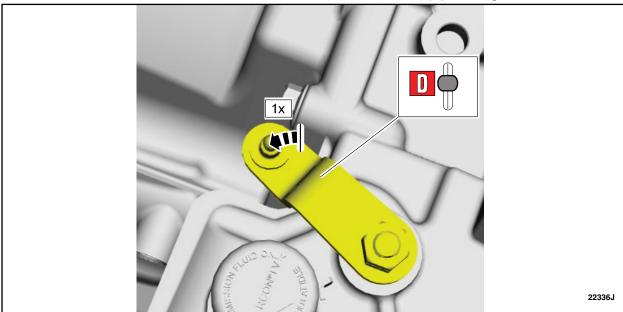
FIGURE 9

10. Rotate the manual control lever counterclockwise 1 detent into Drive (D). See Figure 9.

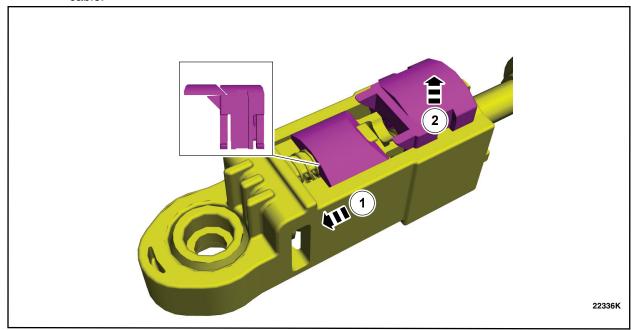
FIGURE 10

- 11. Release the selector lever cable adjuster lock. See Figure 10.
 - 1. Carefully pry the adjuster lock tabs outward.
 - 2. While holding the adjuster lock tabs outward, slide the lock out to unlock the selector lever cable.

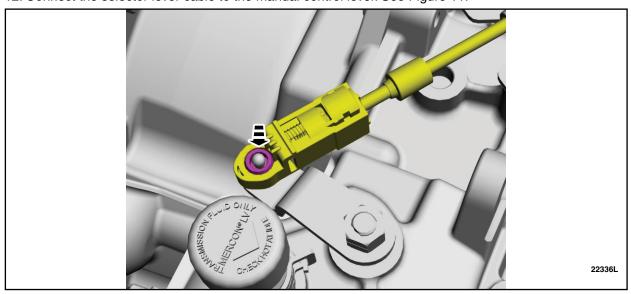
FIGURE 11

12. Connect the selector lever cable to the manual control lever. See Figure 11.

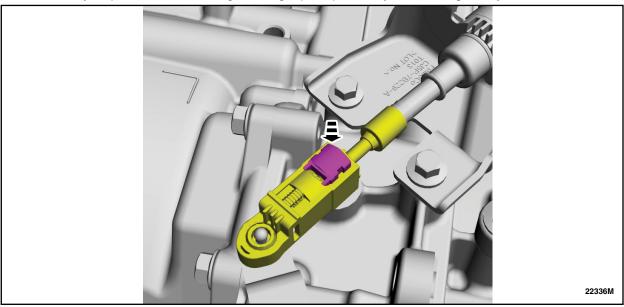
FIGURE 12

13. Slide the adjuster tab in place to lock the selector lever cable. See Figure 12.

NOTE: Visually inspect cable end and give a slight pull up to verify the bushing is fully seated.

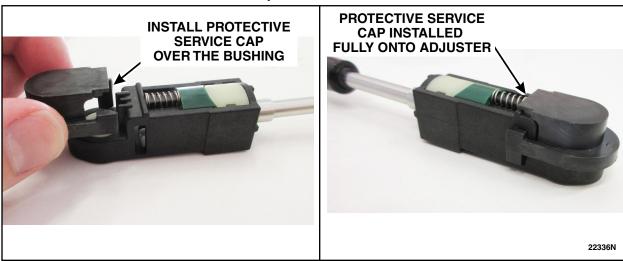
FIGURE 13

- 14. Install the *new* cap onto the selector lever cable adjuster. Clip one side into the adjuster body and then slide the other onto the housing until it snaps into place. The protective cap should cover the bushing and the terminal end of the adjuster. See Figure 13.
- 15. Verify installation by checking the cap is retained by the adjuster body.

NOTE: Selector lever cable removed for clarity.
