**SUBJECT:** **NEW VEHICLE DEMONSTRATION / DELIVERY HOLD**  
**Compliance Recall 22C13 – Supplement #1**  
 Certain 2022 Model Year Aviator and Explorer Vehicles  
 Inspect Engine Frame Rail Assembly

**REF:** **Compliance Recall 22C13**  
 Dated: August 19, 2022

**NEW VEHICLE DEMONSTRATION / DELIVERY HOLD – Supplement #1**  
**Compliance Recall 22C13**  
Certain 2022 Model Year Aviator and Explorer Vehicles  
Inspect Engine Frame Rail Assembly

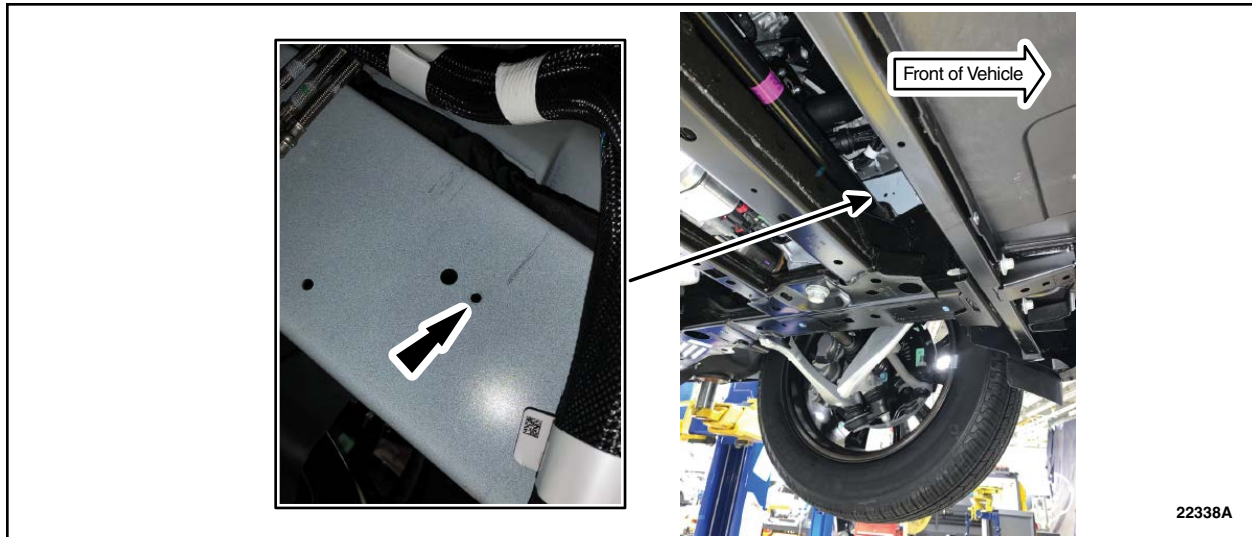
**FIGURE 2**

5. In the engine compartment, locate the existing hole on the inboard side of the LH frame rail. See Figure 2, showing the hole from underneath the vehicle for better clarity.

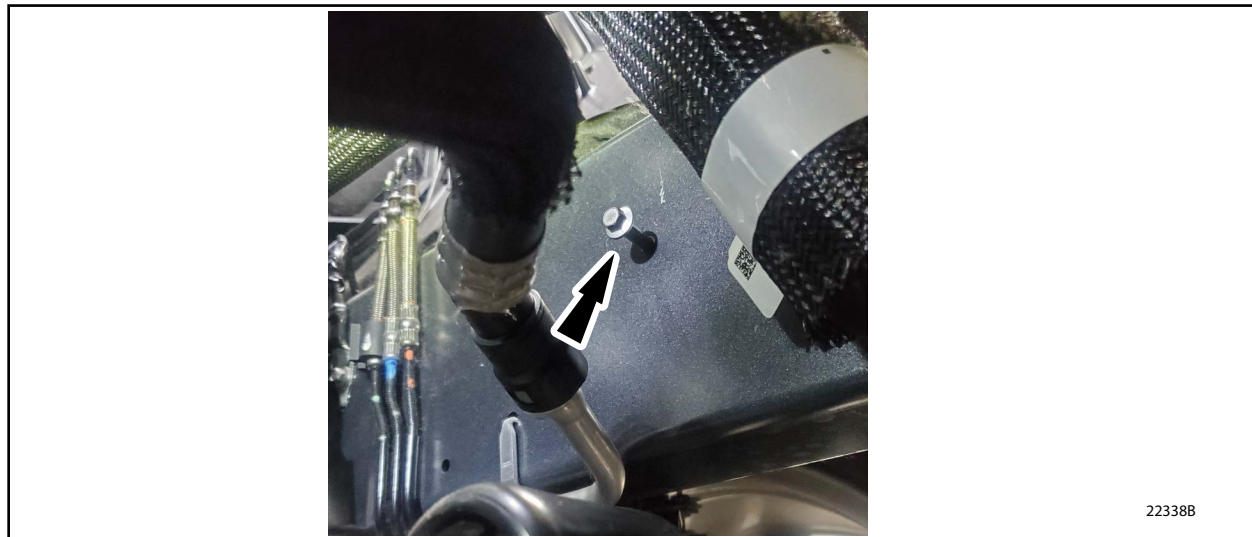
**FIGURE 3**

6. Hand start the bolt part number W505255-S450 into the existing hole. See Figure 3.

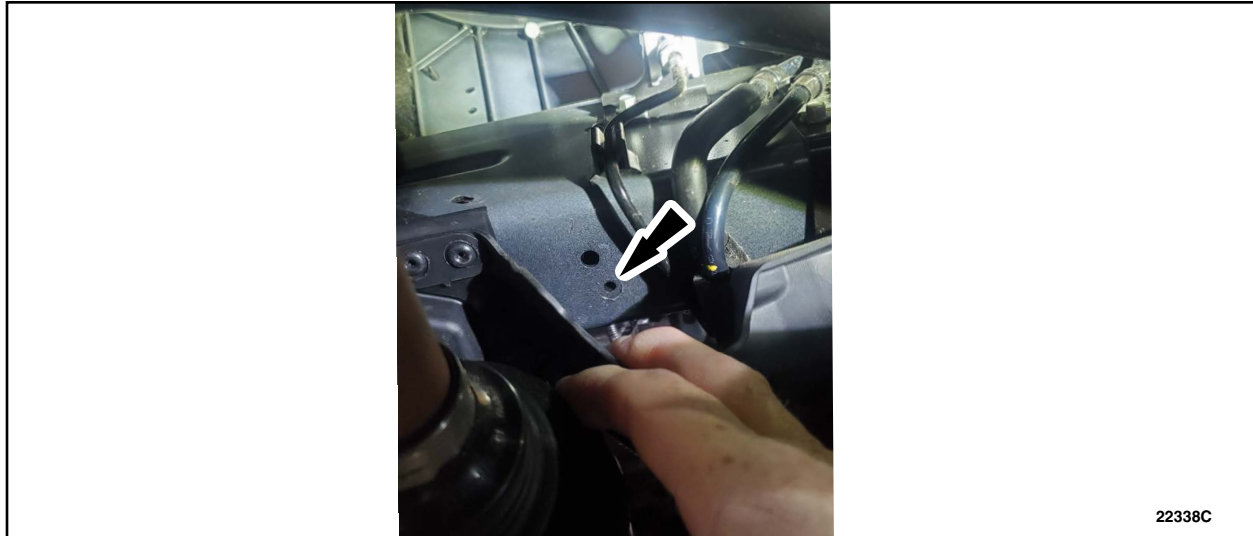
**FIGURE 4**

9. With the vehicle in NEUTRAL, position it on a hoist. Follow Workshop Manual (WSM) procedures in Section 100-02.
10. Locate the existing hole on the bottom of the RH (right-hand) frame rail, just above the CV axle. See Figure 4.

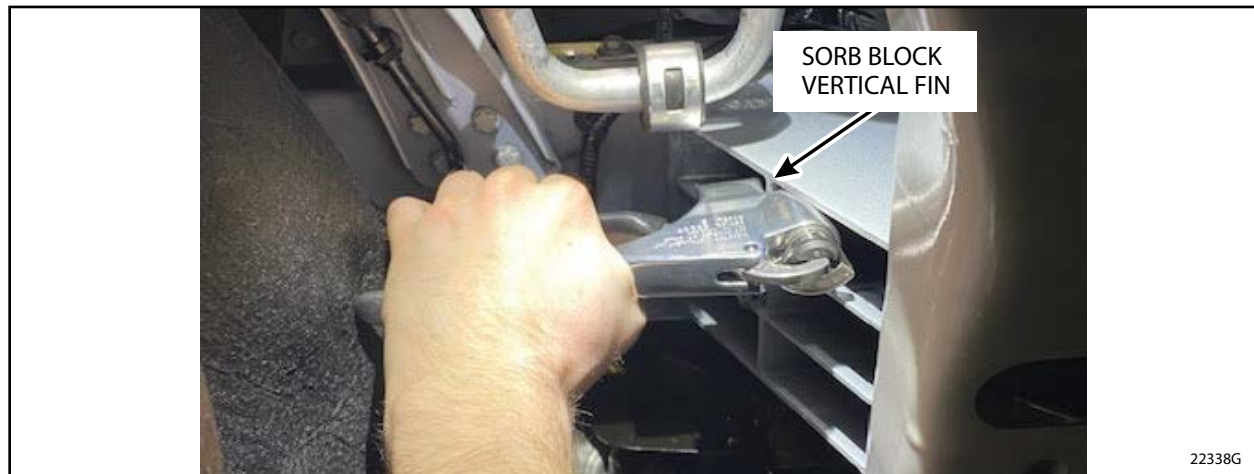
**FIGURE 6**

15. Place the hardness tester on the SORB block vertical fin and actuate the handle with the same force that was used on the gauge bar. See Figure 6.

Less than 12 – Fails inspection. Proceed to step 17.

**17. Contact SSSC for further approval to replace the front side member. Once approved, return the hardness tester and order the required parts through normal part ordering process, refer to dealer bulletin. Proceed to step 18.**

**18. Replace the front side member(s) that failed the hardness test. Refer to WSM Section 501-27.**

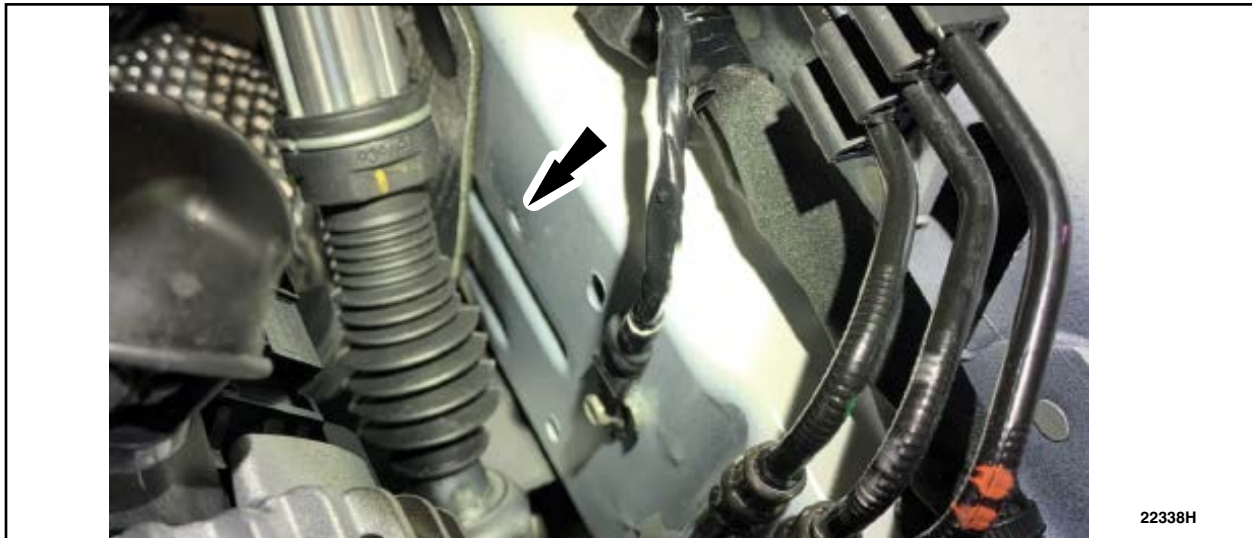
**FIGURE 11**

27. Locate the existing hole on the inboard side of the LH frame rail. See Figure 11.

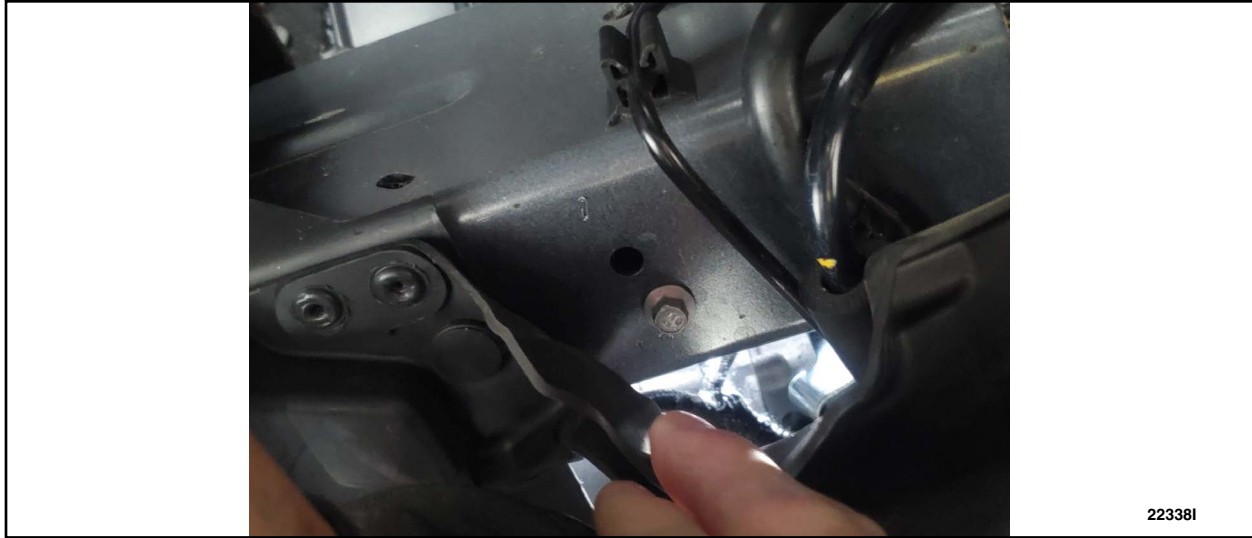
**FIGURE 12**

28. Hand start the bolt part number W505255-S450 into the existing hole. See Figure 12.

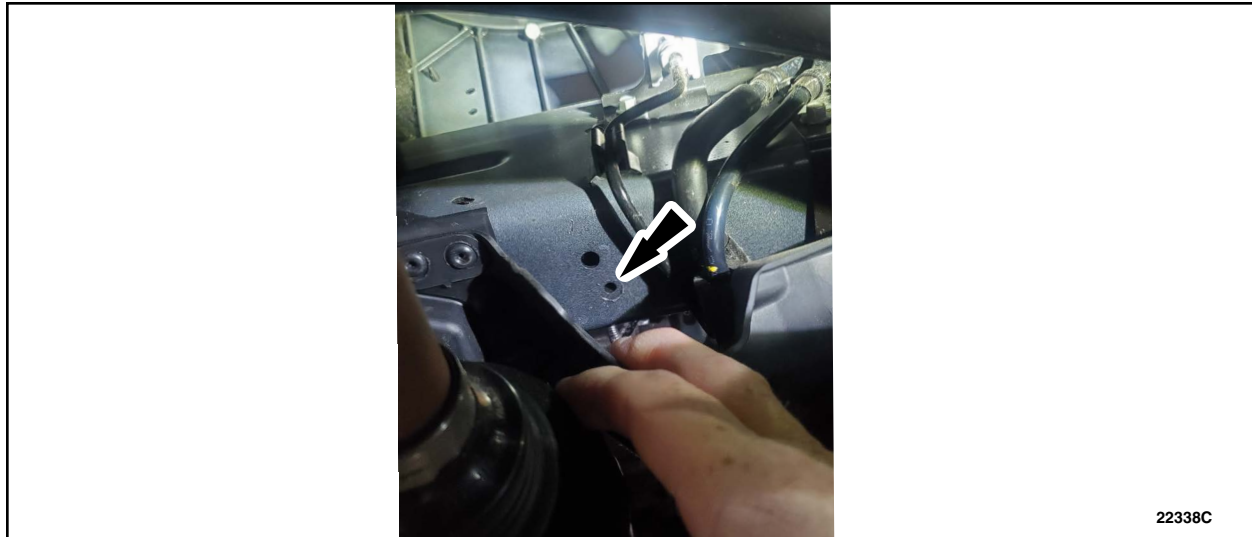
**FIGURE 13**

34. Locate the existing hole on the bottom of the RH (right-hand) frame rail, just above the CV axle.  
See Figure 13.

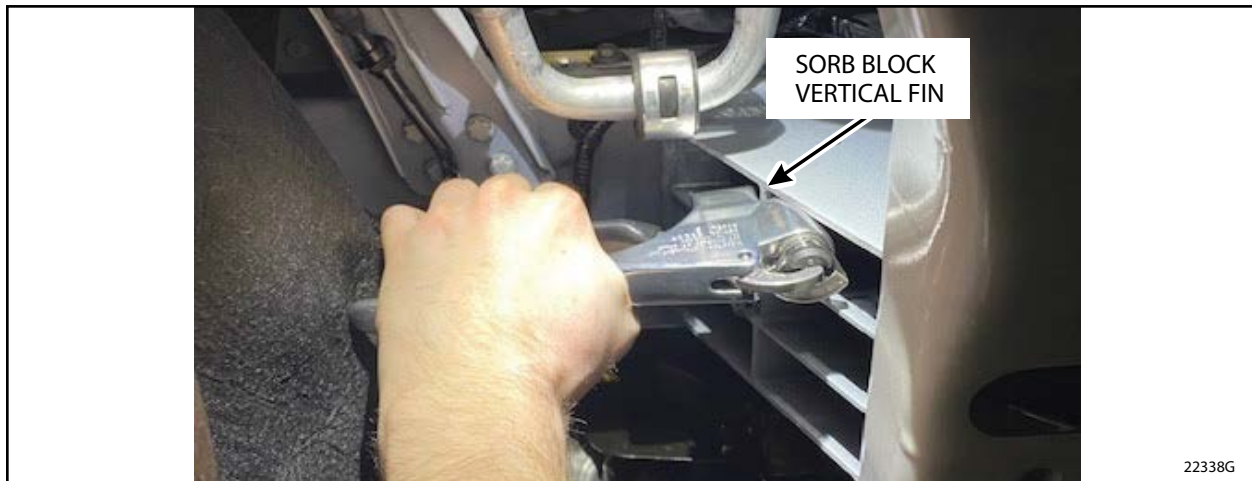
**FIGURE 15**

39. Place the hardness tester on the SORB block vertical fin and actuate the handle with the same force that was used on the gauge bar. See Figure 15.

Less than 12 – Fails inspection. Proceed to step 41.

**41. Contact SSSC for further approval to replace the front side member. Once approved, return the hardness tester and order the required parts through normal part ordering process, refer to dealer bulletin. Proceed to step 42.**

**42. Replace the front side member(s) that failed the hardness test. Refer to WSM Section 501-27.**
