VOLUNTARY RECALL CAMPAIGN

Classification: AT22-008	Reference: NTB22-065	Date: July 28, 2022
-----------------------------	-------------------------	------------------------

VOLUNTARY SAFETY RECALL CAMPAIGN 2020-2022 FRONTIER, TITAN/TITAN XD 2WD; TRANSMISSION PARKING PAWL PIN

CAMPAIGN ID #: R22A7
APPLIED VEHICLES: 2020-2021 Frontier (D40) 2WD
2022 Frontier (D41) 2WD
2020-2022 Titan and Titan XD (A61) 2WD

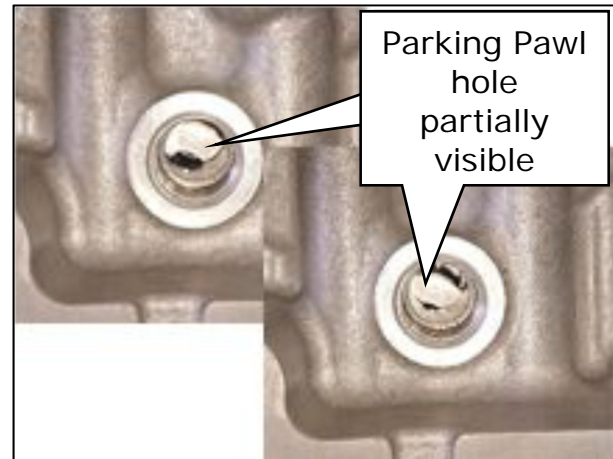
Figure 13

13. If the hole for the Parking Pawl is partially visible through the Transmission Case hole as shown in Figure 13, skip to step 16 on page 9.

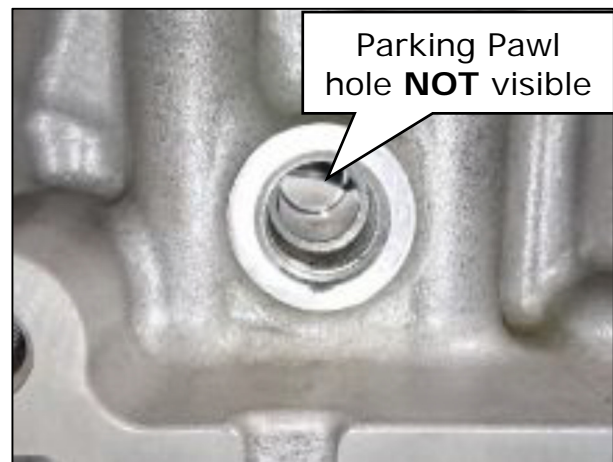
Figure 14

14. If the hole for the Parking Pawl is **NOT** visible through the Transmission Case hole as shown in Figure 14, use a small magnetic rod to raise the Parking Pawl until the hole is visible.

- If the Parking Pawl raised and the hole is visible as shown in Figure 13, skip to step 16 on page 9.
- If the Parking Pawl cannot be raised, continue to step 15.
