# VOLUNTARY RECALL CAMPAIGN

Classification: AT22-008A	Reference: NTB22-065A	Date: February 9, 2023
------------------------------	--------------------------	---------------------------

## VOLUNTARY SAFETY RECALL CAMPAIGN 2020-2022 FRONTIER, TITAN/TITAN XD 2WD; TRANSMISSION PARKING PAWL PIN

**CAMPAIGN ID #:** R22A7  
**APPLIED VEHICLES:** 2020-2021 Frontier (D40) 2WD  
2022 Frontier (D41) 2WD  
2020-2022 Titan and Titan XD (A61) 2WD

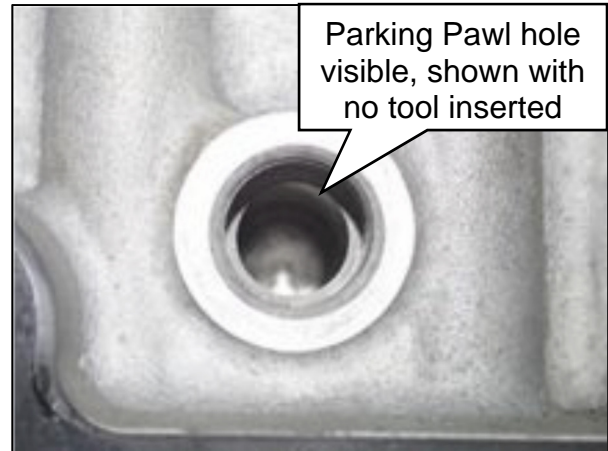
Figure 11

- If the Parking Pawl hole is fully visible as shown in Figure 11, skip to step 18 on page 11 for **Parking Pawl Pin Installation**.

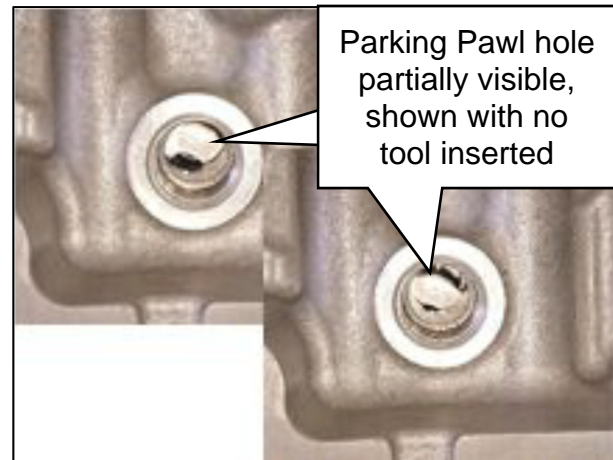
Figure 12

- If the Parking Pawl hole is partially visible as shown in Figure 12, the Parking Pawl may have moved out of position. Continue to step 13 on page 8 for **Parking Pawl Position Alignment**.

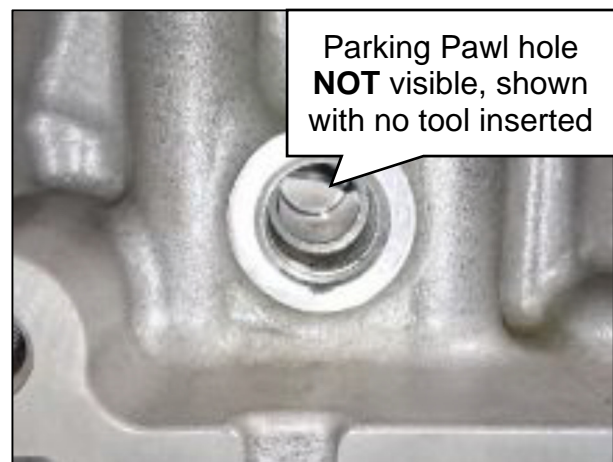
Figure 13

- If the Parking Pawl hole is **NOT** visible as shown in Figure 13, the Parking Pawl may have moved out of position. Continue to step 12 on page 8 for **Parking Pawl Position Alignment**.

12. Use a small magnetic rod to raise the Parking Pawl until the Parking Pawl hole is visible.
  - If the Parking Pawl hole is visible after raising it with a magnetic rod, continue to step 13.
  - If the Parking Pawl hole is NOT visible after multiple attempts, skip to step 14 on page 9 for **Parking Pawl Position Recovery**.

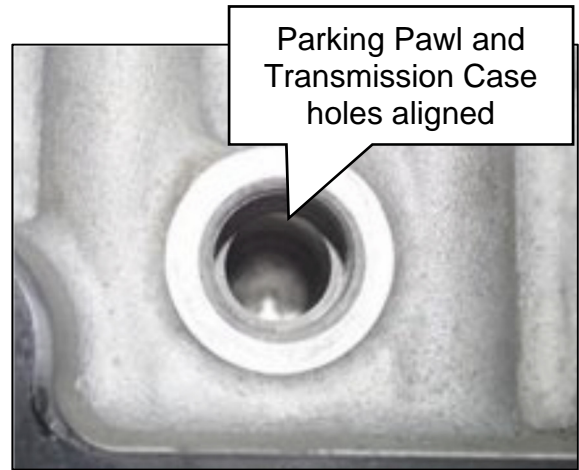
Figure 16

- Remove the Phillips head screwdriver and verify the Parking Pawl and the Transmission Case holes are aligned as shown in Figure 16.
- If the Parking Pawl and the Transmission Case holes are aligned as shown in Figure 16, skip to step 18 on page 11 for **Parking Pawl Pin Installation**.
- If the Parking Pawl and the Transmission Case holes are NOT aligned as shown in Figure 12 and Figure 13 on page 7, continue to step 14 for **Parking Pawl Position Recovery**.
