TO: Mercedes-Benz Dealer Principals, General Managers, Sales Managers, Service Managers, Parts Managers	FROM: Gregory Gunther, Department Manager, Vehicle Compliance and Analysis, Engineering Services
RE: Recall Campaign Launch Notification Repair Upfront Airbag Sensor Wiring Harness Routing MY20 GLS-Class (167 platform)	DATE: August 9, 2022

**Repair Upfront Airbag Sensor Wiring
Harness Routing**

Campaign No. 2022070006, August 2022

SUBJECT: **Model GLS-Class (167 platform)**
Model Year 2020

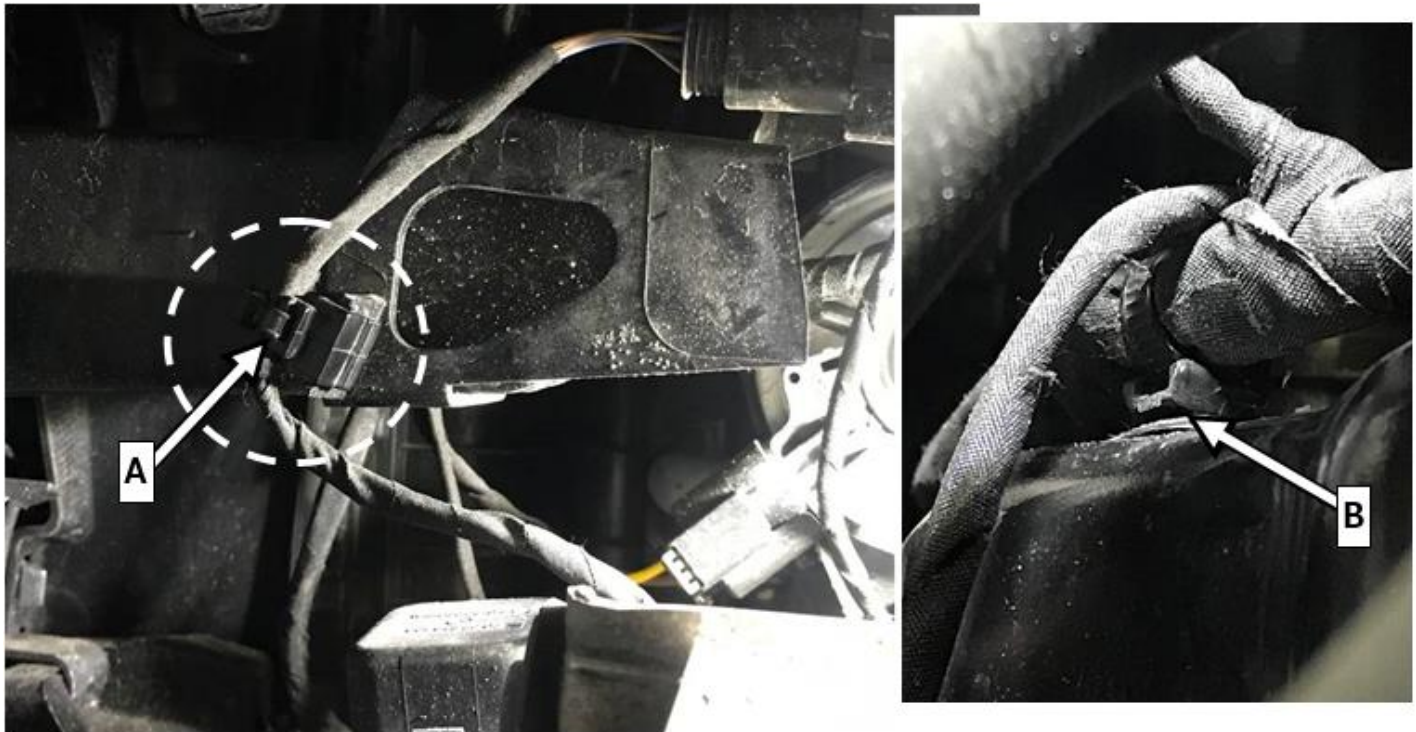
Figure 3

i **Figure 3** depicts the original brackets, cable ties, and wire routing for easier identification.
