Recall Campaign Bulletin

Campaign No. 2022070020, August 2022

SUBJECT: **Model EQS-Class (297 platform)**
Model Year 2022

Inspect Thread Tow Points

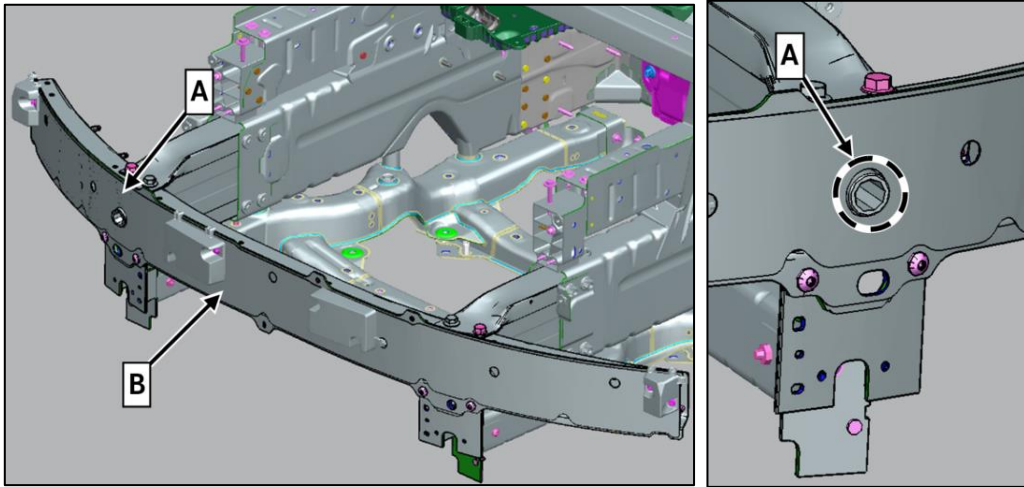
Figure 1

1. Screw towing eye (A) into front crossmember (B) by hand. It must be possible to rotate the towing eye up to the end stop completely by hand.

i Rotate the towing eye at least 9 revolutions in the crossmember (B).

1. Replace crossmember under front bumper
 - i** For basic data, see AR88.30-P-1064EQS

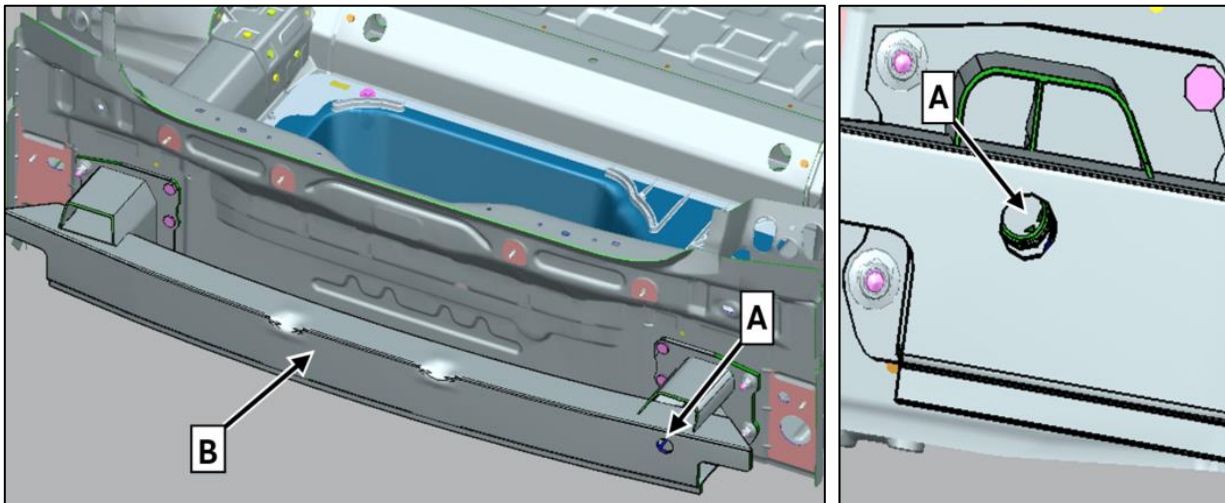
Figure 2

2. Screw towing eye (A) into rear crossmember (B) by hand. It must be possible to rotate the towing eye up to the end stop completely by hand.

i Rotate the towing eye at least 9 revolutions in the crossmember (B).

i For vehicles with **code 550** (trailer hitch) this process is **not required**.

1. Replace crossmember under rear bumper
 - i** Basic data for rear bumper AR88.20-P-2250EQS.
 - Nm** Rear crossmember nut on rear-end floor **55 Nm**.
