TO: Mercedes-Benz Dealer Principals, General Managers, Sales Managers, Service Managers, Parts Managers	FROM: Gregory Gunther, Department Manager, Vehicle Compliance and Analysis, Engineering Services
RE: <b>Recall Campaign Launch Notification</b> <b>Check the Transmission Wiring Harness</b> <b>MY20 GLC-Class (253 platform)</b>	DATE: August 12, 2022

## Check the Transmission Wiring Harness

Campaign No. 2022080001, August 2022

## **Check the Transmission Wiring Harness**

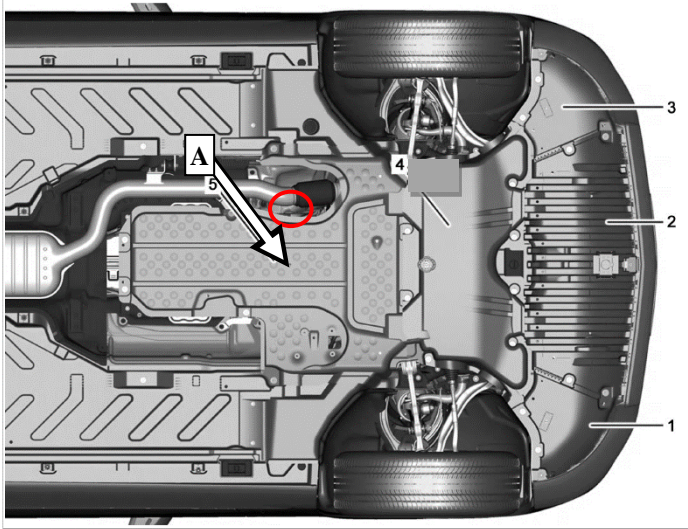
Figure 1

1. Remove rear engine compartment lining (A, Figure 1).

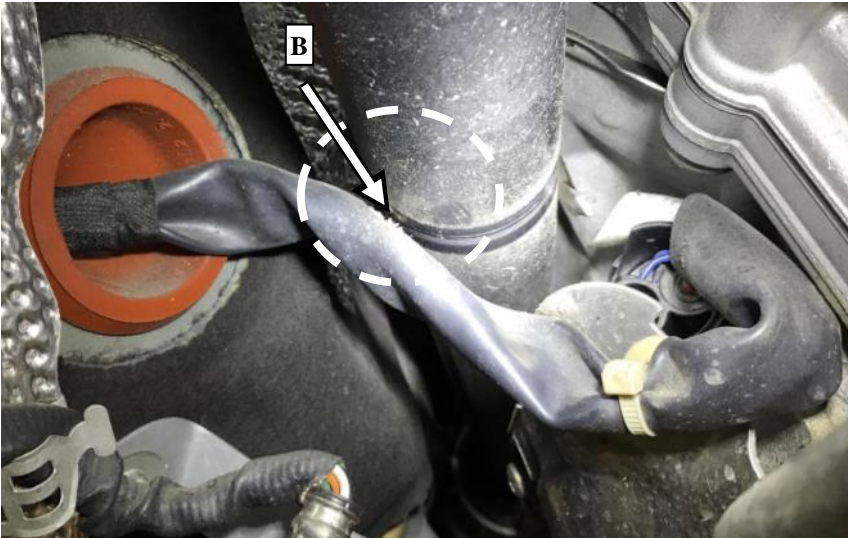
Figure 2, not OK condition

2. Check clearance (B, Figure 2) between transmission wiring harness, transmission tunnel and transmission.

**i** The transmission wiring harness **must not** lie on the drive shaft/transfer case for the front axle differential.

- a. Transmission wiring harness is in contact but **not damaged**: Perform **work procedure A**.
- b. Transmission wiring harness is in contact and **is damaged**: Perform **work procedure B**.
- c. Transmission wiring harness is **correctly routed**: **End measure**.
