# Recall Campaign Bulletin

Campaign No. 2022080001, August 2022

SUBJECT: **Model GLC-Class (253 platform)**  
**Model Year 2020**

## **Check the Transmission Wiring Harness**

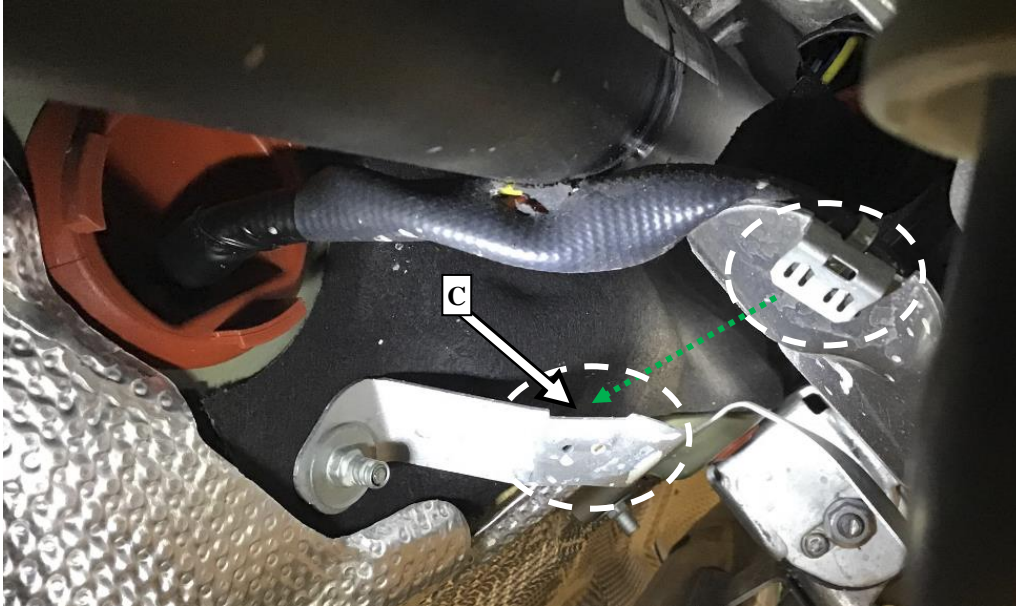
Figure 3, shown on model 253

1. **For model 253** - Clip the wiring harness in at the **correct** bracket (C, Figure 3).
  -

Unclip wire and retaining clamp, re-use retaining clamp on bracket (C, Figure 3).
  -

It is not necessary to turn the red grommet for model 253.
