Safety Recall: 22V512
July 2022

IMPORTANT SAFETY RECALL

Alliance RV has decided that a defect which relates to motor vehicle safety exits in some 2023 Alliance RVs. Units impacted are select Alliance RV Fifth Wheels (Paradigm, Valor).

Product Safety Notice

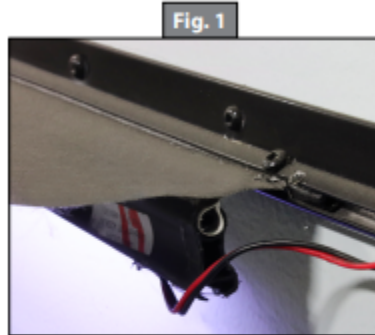
The purpose of this document is to provide guidance, as well as visual aides, to dealers performing inspection on units that may have insufficient awning weld(s). The inspection point is at the awning fabric seam at the awning rail at the wall of the unit (Fig. 1). This only affects awnings manufactured January 17, 2022 – June 14, 2022. The date of manufacture can be located on the variant code label (Fig. 2) located on the awning.

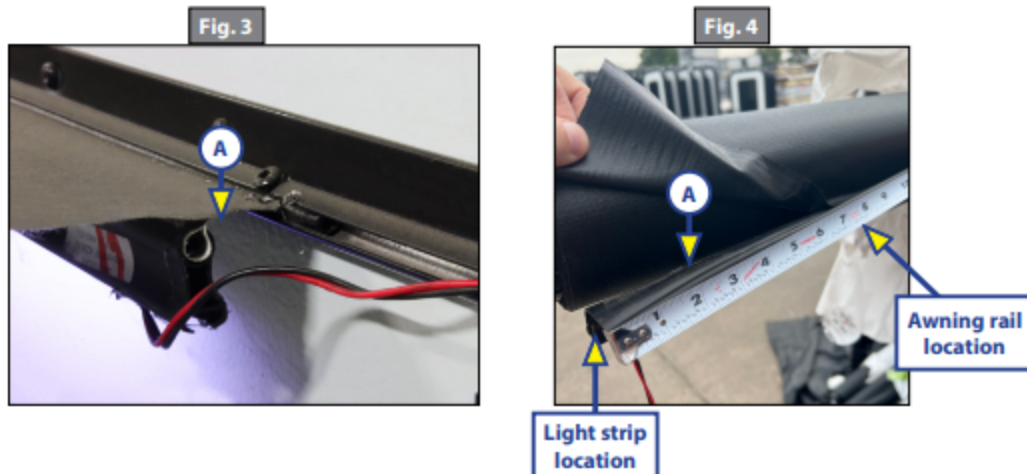
1. Position stepladder next to the unit to view the topside of the awning at the unit wall from either end (drive/idler side).
2. Inspect the weld near the awning rail (Fig. 3A).
 - A. Fig. 3 shows no separation at the seam. It does not require repair or replacement.
 - B. Fig. 3 shows separation at the seam (Fig. 4A).
 - I. If the separation is less than 6 inches, repair can be accomplished using the procedure described in [TI-434](#).
 - II. If the separation is over 6 inches it will require awning fabric replacement using the procedure described in [TI-166](#).

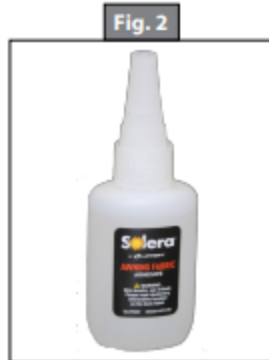
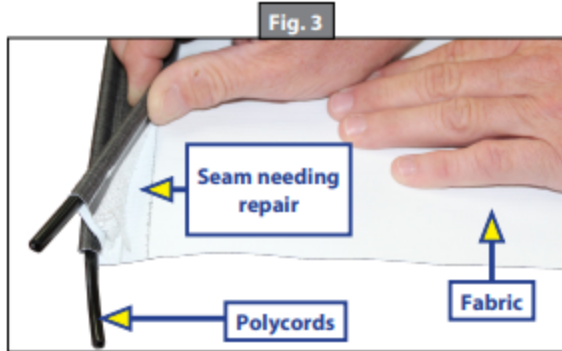
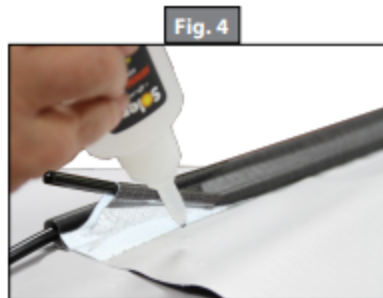
NOTE: The repair procedure is optimal for 6 to 8" seam separations or less.

1. Extend the awning:
 - A. For a seam fix at the awning rail, extend the awning a few feet.
 - B. For a seam fix at the roll tube, extend the awning completely.
2. Tie both awning arms slightly back to gain some slack in the fabric.
3. Clean the area to be repaired with mild soap and water. Allow to dry completely.
4. Spread open the seam area needed repair and apply a continuous bead of Awning Seam Repair Adhesive PN 2022107896 along the entire separation (Fig. 4).
5. Press down firmly and hold for several minutes.
6. Allow to dry for at least four hours.
