TECHNICAL INSTRUCTIONS

SAFETY (NONCOMPLIANCE) RECALL 22TA08

AIRBAG MAY NOT DEPLOY PROPERLY

Certain 2022 RAV4 Certain 2022 RAV4 Hybrid Certain 2022 RAV4 Prime

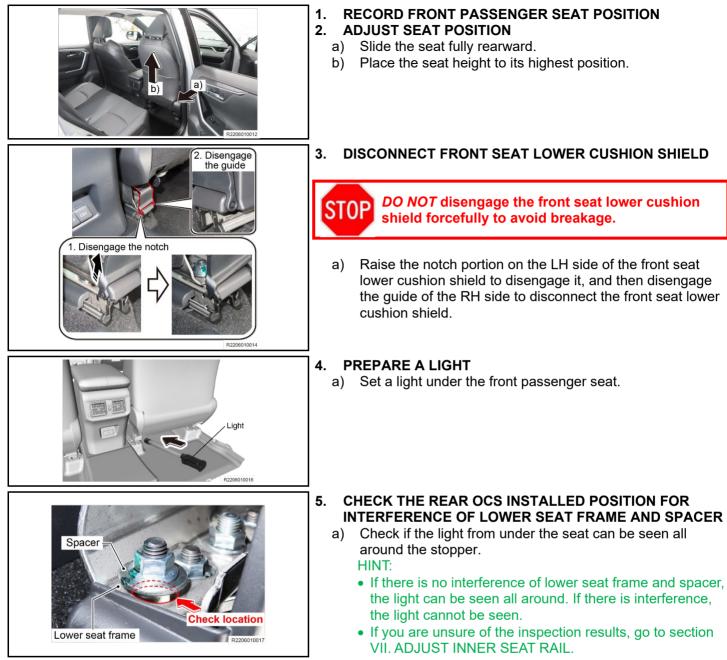
VI. CHECK THE REAR OCS INSTALLED POSITION FOR INTERFERENCE OF LOWER SEAT FRAME AND SPACER

Interference of spacer	Result	Action
NO interference	OK	Go to next step
Interference exists	NG	Inner seat rail adjustment is required. Go to VII. ADJUST INNER SEAT RAIL
 A constraint of the sector of t		gage the front seat lower cushion efully to avoid breakage. de on the RH side of front seat lower and then engage the notch portion on the II it.
