## PRODUCT CAMPAIGN BULLETIN

**APPLICABILITY:** 2015-2021 MY WRX STI

**NUMBER:** WRE-22R

**SUBJECT:** Safety Recall – Back-Up Lamp Switch Failure

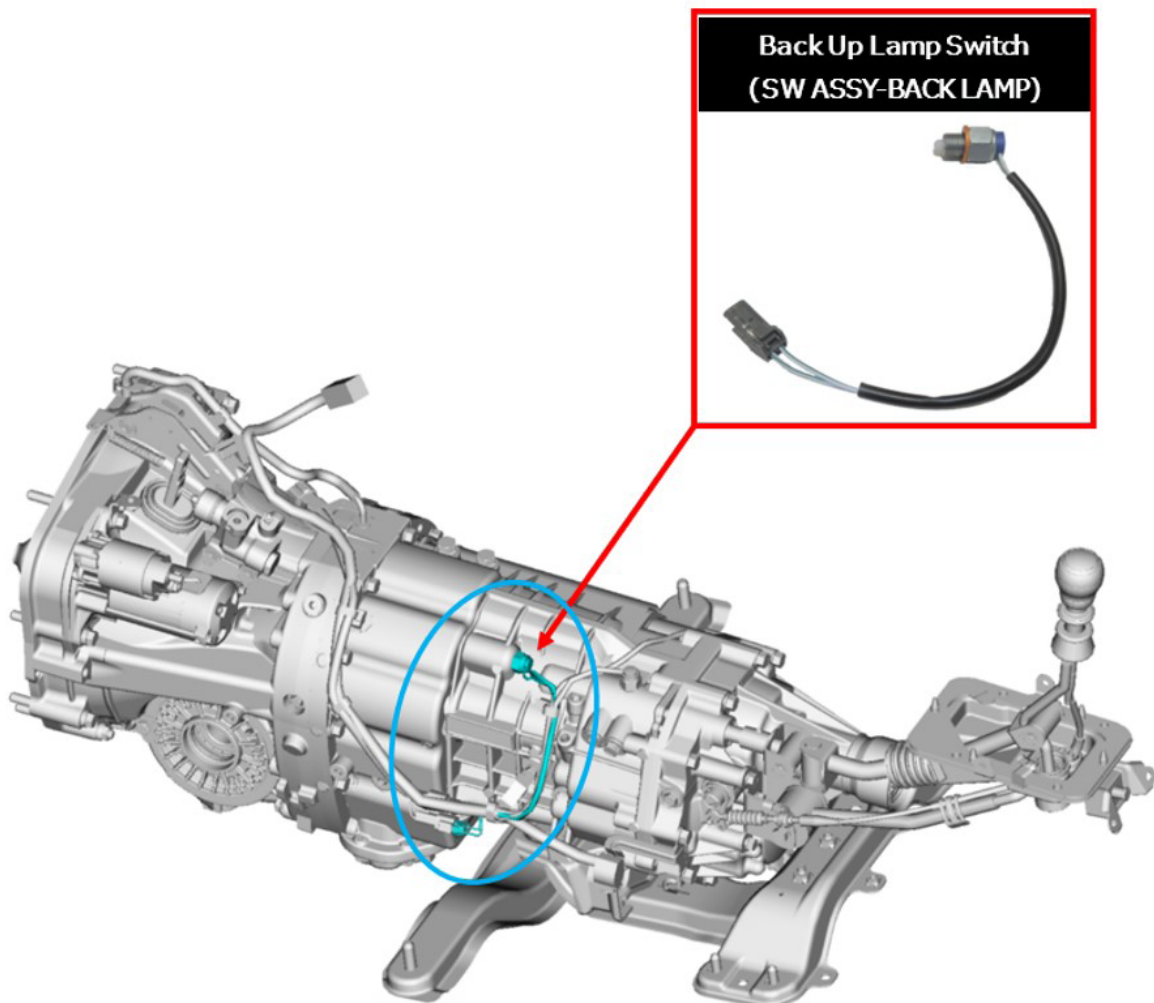
## COMPONENT DESCRIPTION:

The operating environment of the back-up lamp switch may expose the internal switch contacts to heated oil. When heated, sulfur in the oil may cause a chemical reaction with the materials used on the switch terminal contact surfaces and plate spring. This chemical reaction may cause corrosion and a non-conductive film to form on the contacts resulting in poor electrical conductivity.

Over time, the back-up lamp switch may become inoperative which may result in the back-up lamps not illuminating when in reverse gear, the rear-view camera (if equipped) not displaying an image, and the select lever/gear position indicator in the combination meter not displaying ‘R’ for reverse gear.

For all potentially affected vehicles, Subaru retailers will conduct an inspection and replace the back-up lamp switch with improved one, if necessary, at no cost to the customer.

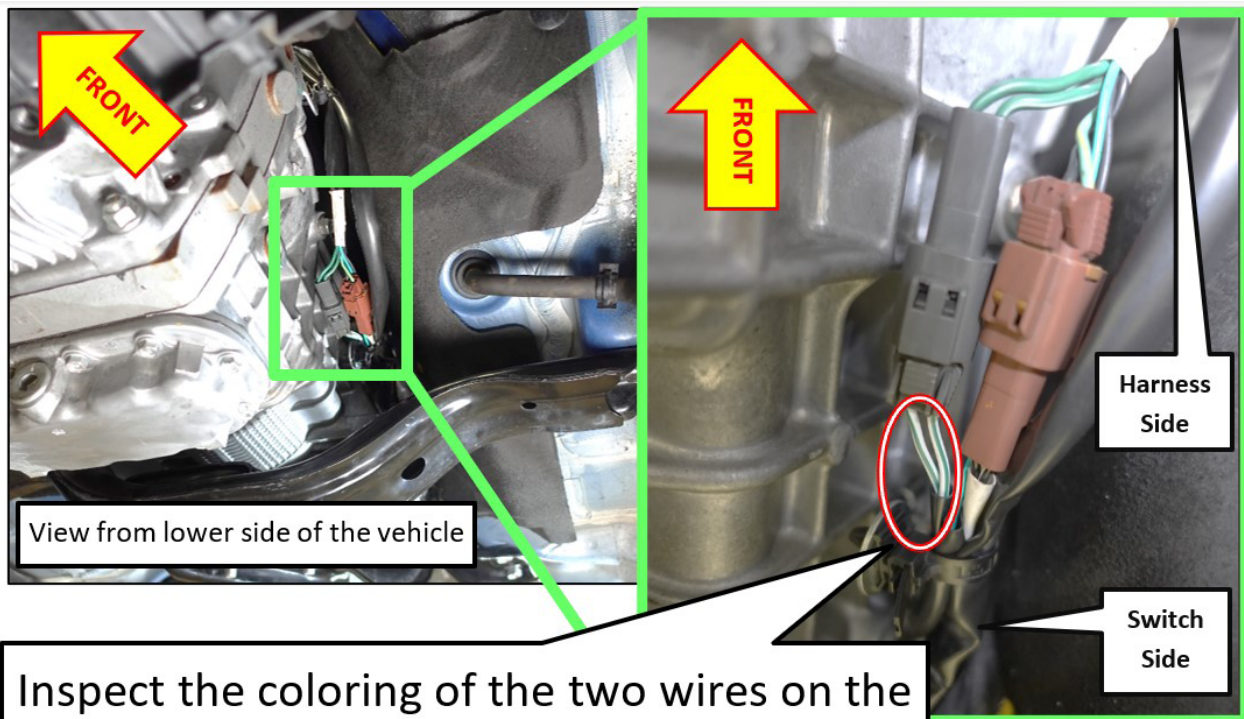
**STEP 4:** Perform a visual inspection of the wiring harness colors on the back-up lamp switch.

Inspect the coloring of the two wires on the switch side of the gray connector

The black protection tube can be pulled back for inspection

**STEP 5:** Apply the visual inspection results from **STEP 4** to the table below to verify the next course of action.

Back-Up Lamp Switch Version	<b>OLD</b>	<b>NEW</b>
Back-Up Lamp Switch Replacement	<b>REQUIRED</b>	<b><u>NOT</u> REQUIRED</b>
Next Step	<b>Proceed to STEP 6</b>	No further action is required. Reinstall the removed parts in the reverse order of disassembly.
