SAFETY RELATED RECALL

Global Recall Action
Number: H404NAS1

Subject: Incorrect Specification Tailgate Lamp Assemblies	Publication No.: H404NAS1
	Model: F-PACE (X761)
	Model Year: 2021 - 2022
	Date of Issue: 17 August 2022

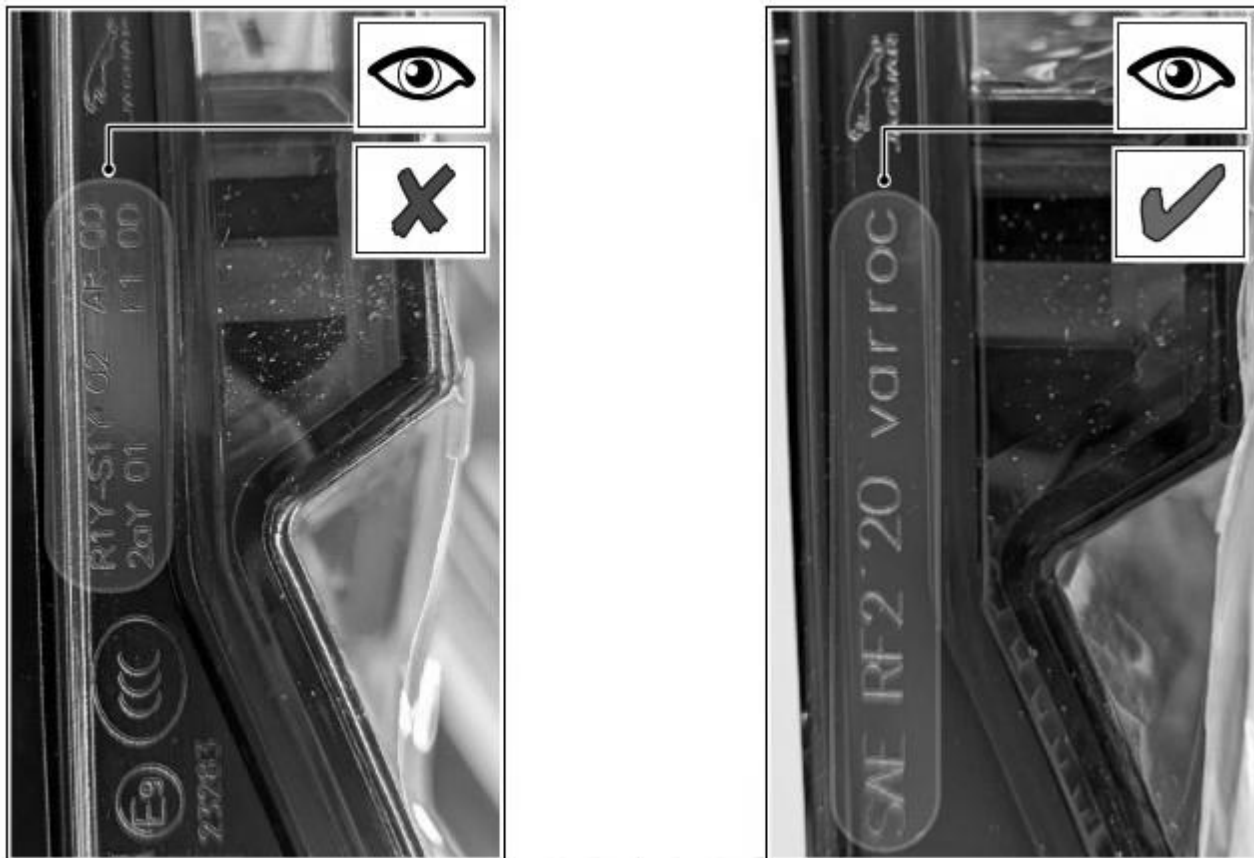
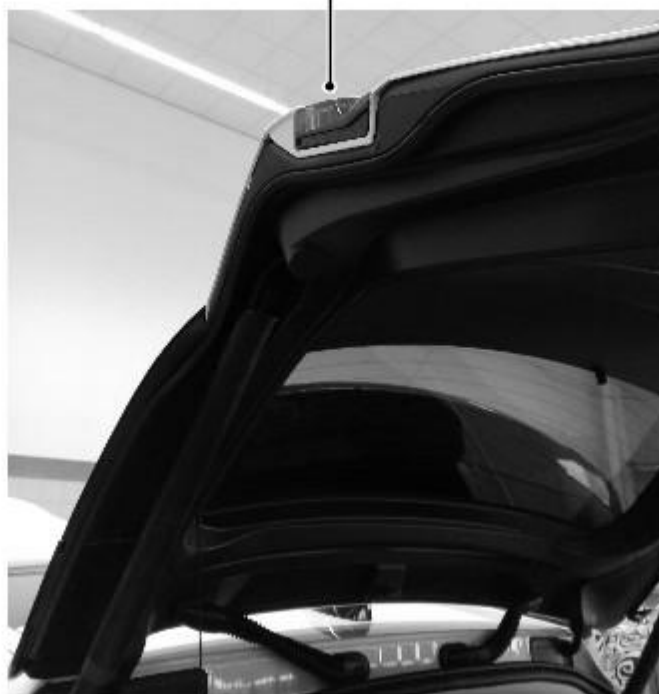
E313286

The specification data on Rest of the World (ROW) tailgate lamp assemblies is made up of 2 separate lines of text, as shown in the illustration marked with a red 'X'.

The specification data on North American Specification (NAS) tailgate lamp assemblies is made up of 1 line of text, as shown in the illustration marked with a green '✓'.

Inspect **BOTH** tailgate lamp assemblies to make sure the correct tailgate lamps assemblies have been installed for the NAS market.

- The illustration marked with a red 'X' shows a ROW tailgate lamp assembly, which should only be installed to vehicles manufactured for ROW markets.
- The illustration marked with a green '✓' shows a NAS tailgate lamp assembly, which should only be installed to vehicles manufactured for NAS markets.
- If **both** tailgate lamp assemblies are the **correct** specification for the NAS market, do not continue, close the tailgate and release the vehicle.
- **Any** tailgate lamp assemblies which are the **incorrect** specification for the NAS market must be renewed with correct specification tailgate lamp assemblies, continue to the SERVICE INSTRUCTION to renew any incorrect tailgate lamp assemblies.

1. Renew any incorrect tailgate lamp assemblies, (see TOPIx Workshop Manual section 417-01: Exterior Lighting - Removal and Installation - Tailgate Lamp Assembly).
