SIB 61 15 22

RECALL 22V-541: HIGH-VOLTAGE BATTERY

This Service Information Bulletin (Revision 4) replaces SI B61 15 22 dated November 8, 2022.

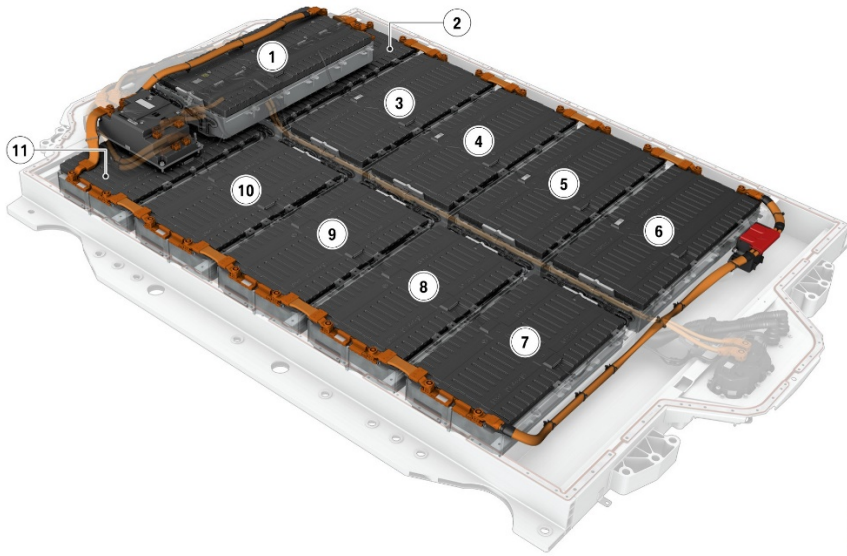
I20 xDrive50/xDrive60 - SE10 HV Battery module locations shown below-

During supplier production, the high-voltage battery may not have been produced to specifications. A short-circuit could occur which could lead to a thermal event. The affected high-voltage battery cell module will be replaced.

Some high-voltage battery modules may not have been produced to specifications.

3. Replace the defective high-voltage cell modules using repair instructions **61 27 703** to **61 27 877** depending on the affected cell module location.
