SIB 61 14 22

2022-10-04

RECALL 22V-541: HIGH-VOLTAGE BATTERY

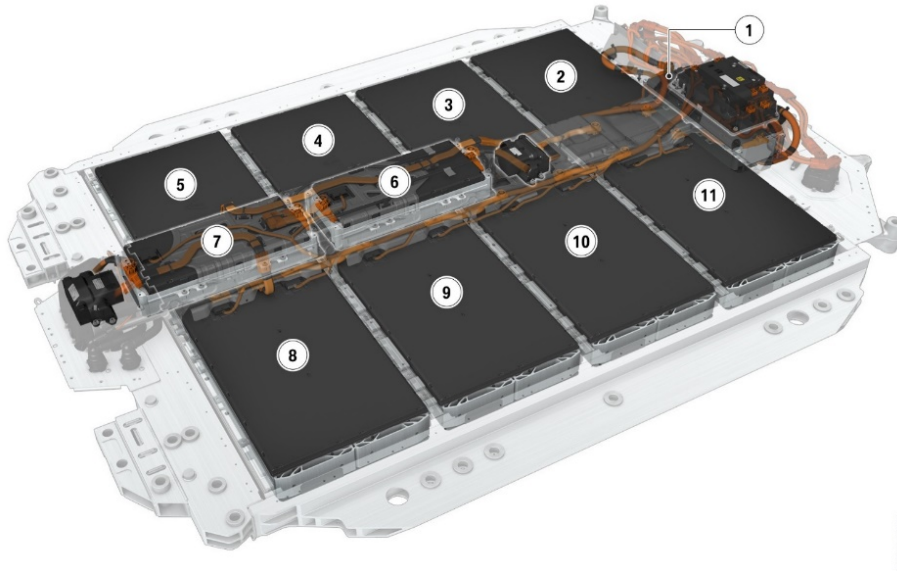
G26 BEV SE27 HB Battery module locations shown below-

During supplier production, the high-voltage battery may not have been produced to specifications. A short-circuit could occur which could lead to a thermal event. The affected high-voltage battery cell module will be replaced.

- Replace the defective high-voltage cell modules using repair instructions **61 27 703** to **61 27 877** depending on the affected cell module location.

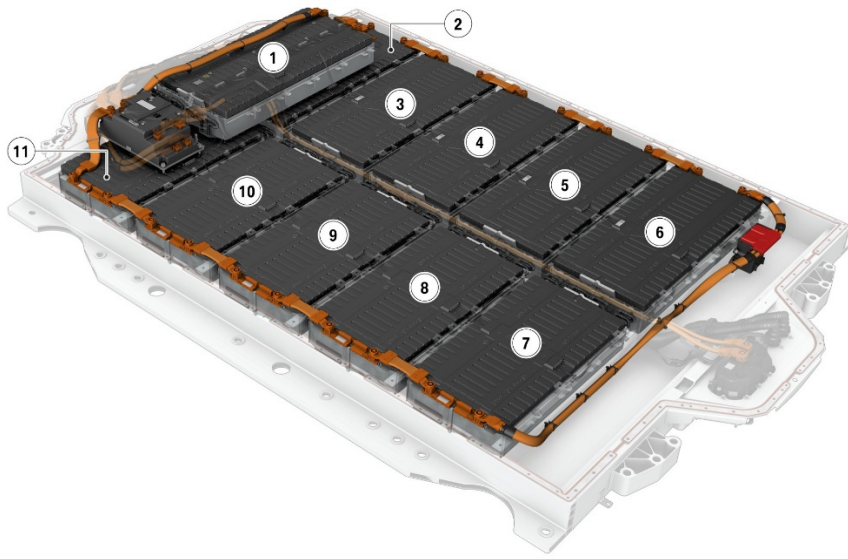
I20 xDrive50/xDrive60 - SE10 HV Battery module locations shown below-

During supplier production, the high-voltage battery may not have been produced to specifications. A short-circuit could occur which could lead to a thermal event. The affected high-voltage battery cell module will be replaced.

3. Replace the defective high-voltage cell modules using repair instructions **61 27 703** to **61 27 877** depending on the affected cell module location.
