RECALL 22V558, 2022-415 REMEDY INSTRUCTIONS

Make(s): ROCKWOOD & FLAGSTAFF
Model(s): SEE BELOW
Model Year(s): SEE BELOW

Concern:
The axle may be installed backwards on certain single axle tent campers.

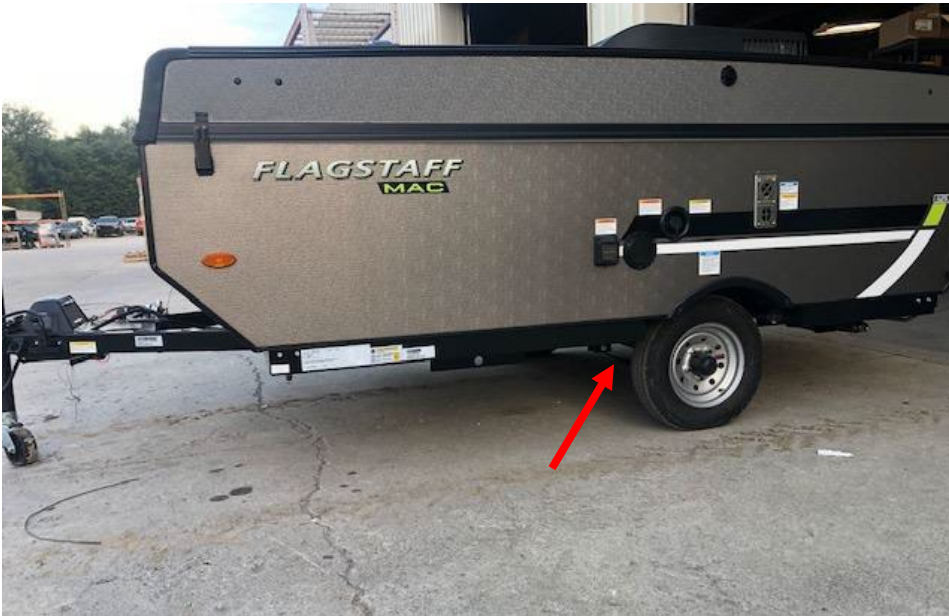
FIGURE 1:

STEP 1: LOCATE THE AXLE SPRING ON THE FRONT SIDE OF THE AXLE (PORTION OF AXLE TOWARDS THE FRONT/HITCH) (FIGURE 1);

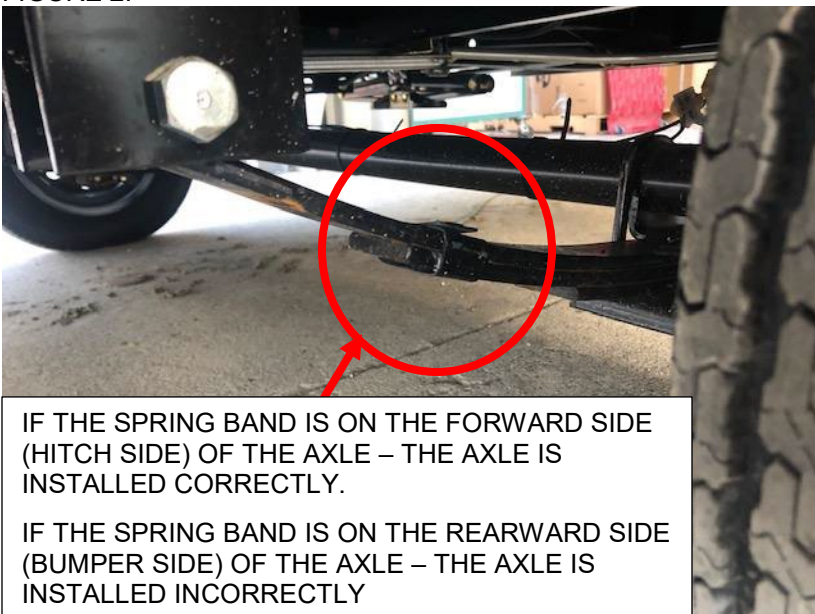
FIGURE 2:

STEP 2: IF THERE IS A STEEL BAND (FIGURE 2) ON THE FORWARD SIDE OF THE SPRING PACK, THE AXLE IS INSTALLED CORRECTLY;

STEP 3: IF THE STEEL BAND (FIGURE 2) IS ON THE REARWARD SIDE OF SPRING PACK, THE AXLE IS INSTALLED INCORRECTLY AND REQUIRES REMEDY. MOVE ON TO "REMEDY";

IF THE SPRING BAND IS ON THE FORWARD SIDE (HITCH SIDE) OF THE AXLE – THE AXLE IS INSTALLED CORRECTLY.

IF THE SPRING BAND IS ON THE REARWARD SIDE (BUMPER SIDE) OF THE AXLE – THE AXLE IS INSTALLED INCORRECTLY

- ROTATE THE AXLE 180°, ENSURING STEEL BAND IS ON THE FRONT SIDE OF THE VEHICLE NOW;
- MANOUVER AXLE UNDER VEHICLE AND LIFT TO INSERT THE FRONT SPRING PACK EYELET INTO THE FRONT AXLE HANGERS ON THE DOOR SIDE AND OFF DOOR SIDE;
- SEAT SHACKLE BOLTS WITH A HAMMER UNTIL BOLT HEAD IS FLUSH TO HANGER(S);
- ATTACH SHACKLE PLATES TO REAR OF THE AXLE EYELET ON THE DOOR SIDE AND OFF DOOR SIDE;
- ROTATE AXLE UP AND SEAT SHACKLE PLATE(S) TO REAR AXLE HANGERS ON DOOR SIDE AND OFF DOOR SIDE. SEATING SHACKLE BOLTS WITH A HAMMER;
