## Awning Fabric Weld Repair Instructions

<b>Bulletin Type:</b>	Recall	<b>Publication Date:</b>	August 2022
<b>Bulletin #(s):</b>	22V-571 US 2022-424 Canada	<b>Revision Date:</b>	December 2022
<b>Job Code(s):</b>	9901578	<b>Revision Date:</b>	January 2023
<b>Flat Rate(s):</b>	9901578A - 0.30 Inspection only 9901578B - 0.60 Inspection and Repair 9901578C - 1.8 Inspection and Replace	<b>Revision Date:</b>	<b>February 2023</b>
		<b>Make(s):</b>	Jayco
		<b>Model(s):</b>	Eagle, Jay Flight, North Point, Pinnacle, Seismic
		<b>Model Year(s):</b>	2022-2023

<b>Incident:</b>	<b>Insufficient Fabric Awning Weld</b>
<b>Affected Units:</b>	<b>2022-2023 Jayco Eagle, Jay Flight, North Point, Pinnacle, Seismic</b>
<b>Parts Kit: 22V-571</b>	Parts Kit #: 22V-571
	Part Kit Contents: Adhesive, RPR Seam Awning (Jayco Part #2040196)
<b>Misc. Tools &amp; Supplies: N/A</b>	<b>Stepladder</b>

## INSUFFICIENT AWNING WELD(S) INSPECTION

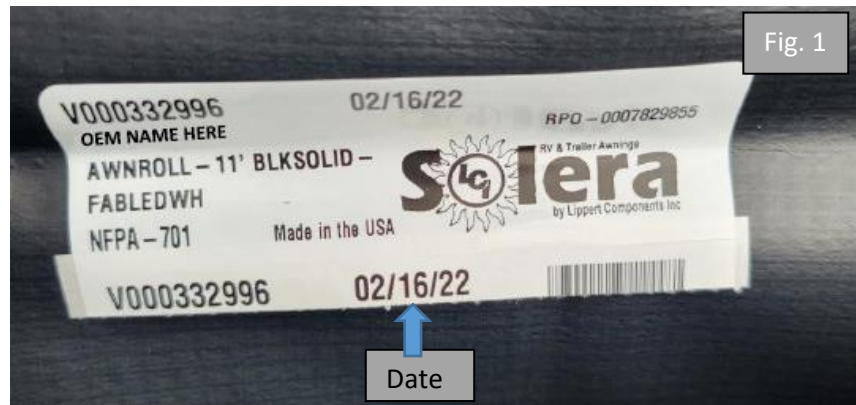
- b. Clear photo of the awning tag.
    - c. Photos documenting any weld separation concerns.
  2. This recall only affects awnings manufactured between January 17, 2022 - June 14, 2022. The date of manufacture can be located on the variant code label located on the awning fabric. (Figure 1) File for inspection only if the date range is outside January 17, 2022 - June 14, 2022. Proceed with inspection instructions of awning fabric weld if date range is between January 17, 2022 - June 14, 2022.

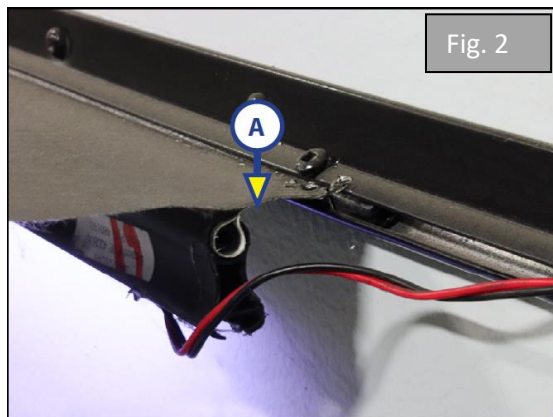
4. Figure 2 shows no separation at the seam. File a claim for inspection only.
  5. Figure 3 shows separation at the seam:
    - a. If the separation is less than 6 inches, it will require the repair described in the INSUFFICIENT AWNING FABRIC WELD REPAIR INSTRUCTIONS.

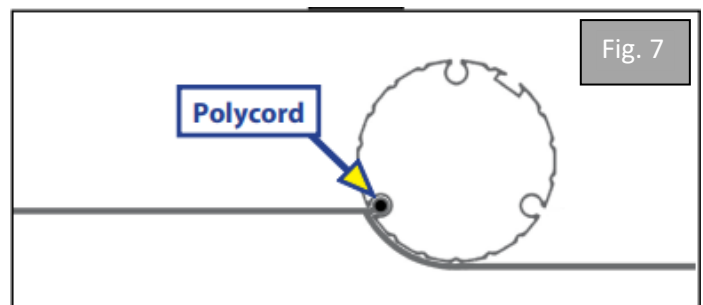
Fig. 7

- **CAUTION: Moving parts can pinch, crush or cut. Keep clear and use caution.**
- **Note: Previous awning versions had two (2) polycords and fabric stitching along the hem. The current awning model has one (1) polycord (see Figure 7) and no fabric stitching. This should not be mistaken as defective.**
- **Manual Awning Fabric Replacement**
  1. Order the Awning Fabric using the Compliance Order Form. You must include with order form:
    - a. Clear photo of the awning tag.
    - b. Photos documenting any weld separation concerns.
  2. Remove the drip cap (if equipped) from the end of the awning from which the fabric will be removed.
  3. Extend the awning out approximately 12" and insert cotter pins through both end caps into the shafts on the head assemblies. (Figure 8)
