Recall 22KWF: T680 NextGen Split Fender Mudflap Fuel Tank Rub

22KWF / 22V582 / 2022-430

Kenworth Truck Company

9/19/2022

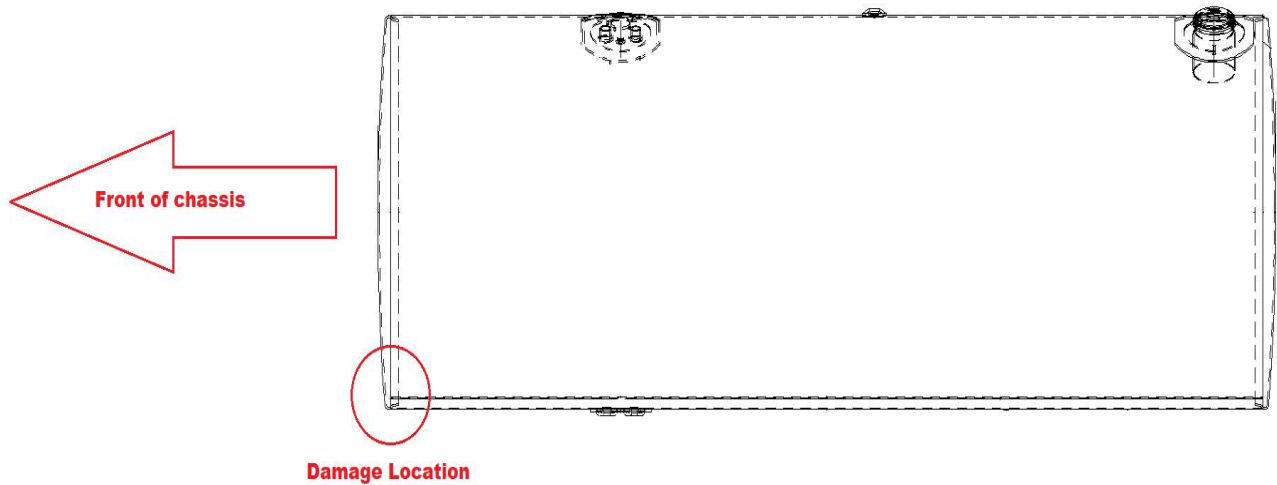
Left Hand Under Cab (LHUC) Fuel Tank

1. Clean the exterior of the fuel tank and inspect the forward lower area of the fuel tank.

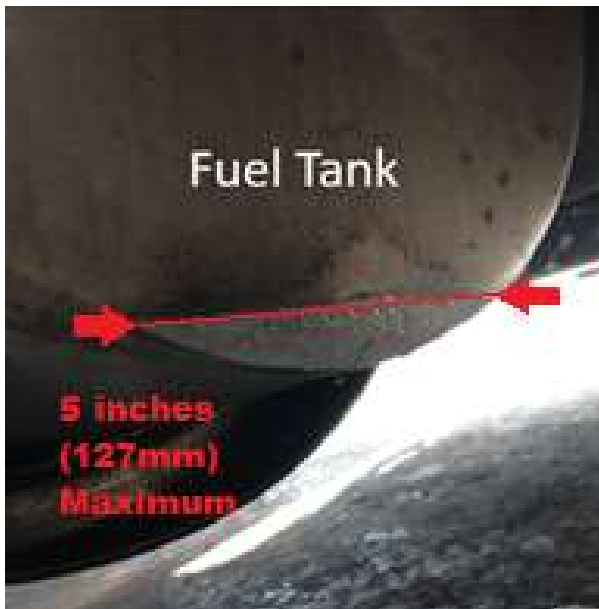
Fuel tanks with damage that meets one or more of the following criteria should be replaced:

- Any fuel leak from the rubbed area, regardless of damage area size.
- Rubbed area is 5 inches (127 mm) wide at the widest point. (See picture below)
- Any gouges or deep scratches that are more than 1mm deep ($\frac{1}{2}$ the original thickness of the fuel tank material) - measure using a tire tread depth gauge or similar tool.

- Obtain a new fuel tank and mudflap (if damaged) using the part number(s) listed in ECAT for the specific chassis.
- Replace fuel tank.
- Prime fuel system after new fuel tank installation.

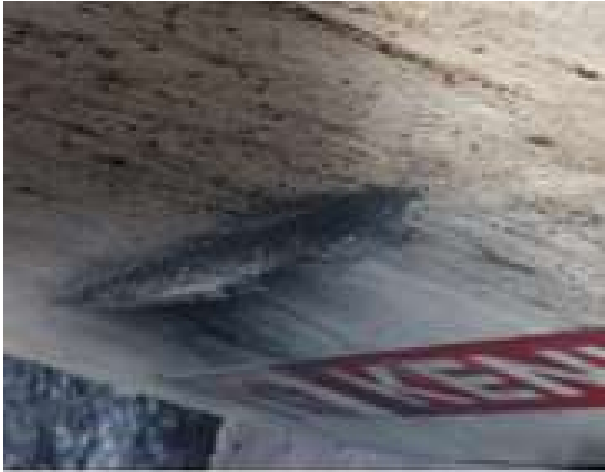
Mudflaps should be replaced if the damaged area creates a visible hole completely through the

mudflap.
