# HUSQVARNA TECHNICAL BULLETIN HTB2207

JULY 25, 2022

## CONTINENTAL TKC 80 TIRE RECALL

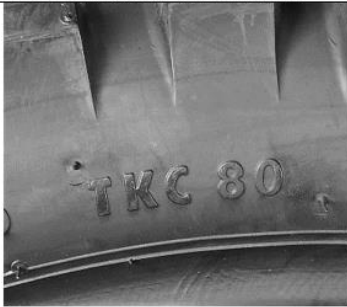
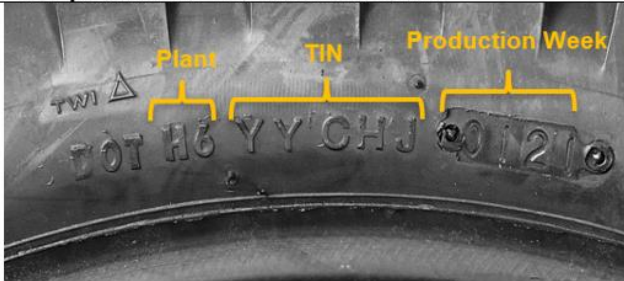
**Attachment no. 2 – how to identify Tire line, DOT Plant + TIN Code and Production Week**

Tire Line	Tire Line Sidewall Picture	Examples of DOT Plant and TIN Code
TKC80

<p>Multiple TIN codes affected – see Attachment 1</p>
