Recall Number:	NHTSA 22v593 - TC 2022-438	Cruiser WCC: 99.03.24
Product:	Awnings	
Date:	July 15, 2022	Labor Rate: .20 hours inspection only .30 hours repair only 1.5 hours fabric replacement only

Purpose

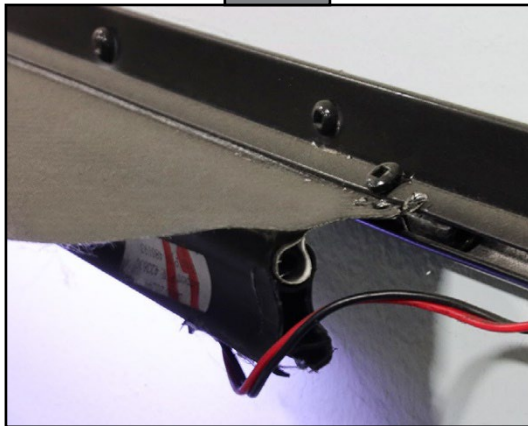
Fig. 1

The purpose of this document is to provide guidance, as well as visual aides, to dealers performing inspection on units that may have insufficient awning weld(s). The inspection point is at the awning fabric seam at the awning rail at the wall of the unit (Fig. 1). This only affects awnings manufactured January 17, 2022 - June 14, 2022. The date of manufacture can be located on the variant code label (Fig. 2) located on the awning.

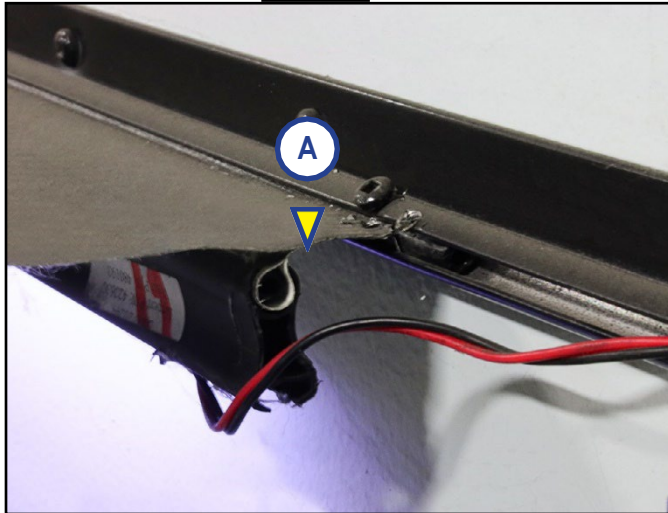
1. Position stepladder next to the unit to view the topside of the awning at the unit wall from either end (drive/idler side).
2. Inspect the weld near the awning rail (Fig. 3A).
 - A. Fig. 3 shows no separation at the seam. It does not require repair or replacement.
 - B. Fig. 3 shows separation at the seam (Fig. 4A).
 - I. If the separation is less than 6 inches, repair can be accomplished using the procedure described in [TI-434](#).
 - II. If the separation is over 6 inches it will require awning fabric replacement using the procedure described in [TI-166](#).
