# Keystone RV Company

## SAFETY ADVISORY # 22-434

### Lippert Awnings

# AWNING INSPECTION AND WELD/SEAM REPAIR

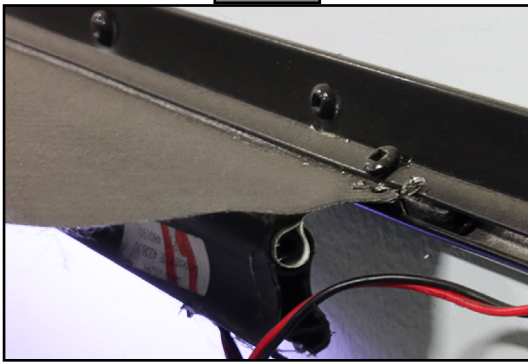
**Fig. 1**

The purpose of this document is to provide guidance, as well as visual aides, to dealers performing inspection on units that may have insufficient awning weld(s). The inspection point is at the awning fabric seam at the awning rail at the wall of the unit (Fig. 1). This only affects awnings manufactured January 17, 2022 – June 14, 2022. The date of manufacture can be located on the variant code label (Fig. 2) located on the awning.

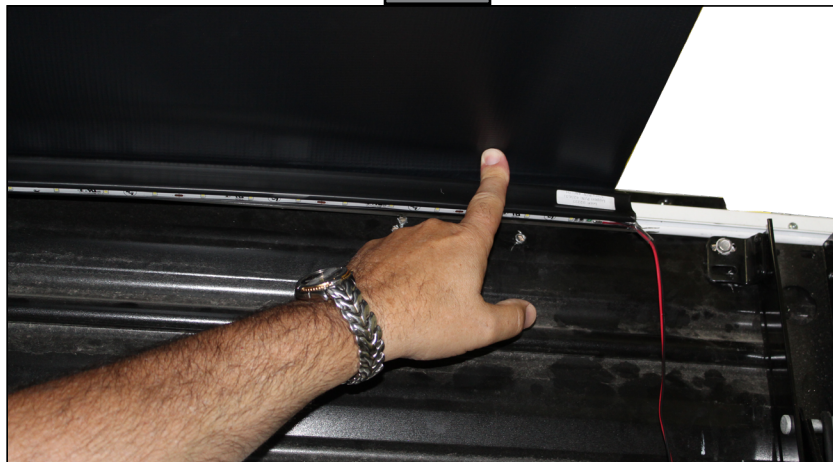
**Fig. 3**

1. Extend the awning.
2. From underneath the awning, about 1" to 1.5" from the fabric edge, push up on the fabric with one finger (Fig. 3) until the awning fabric is flush with the top of the awning rail. Look for any separation or visible daylight at the seam. Perform push test at both ends of the awning.

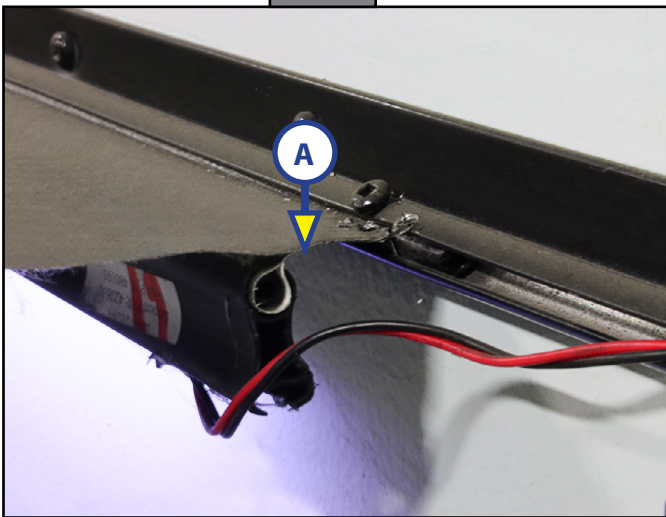
**Fig. 4**

1. Position stepladder next to the unit to view the topside of the awning at the unit wall from either end (drive/idler side).
2. Inspect the weld near the awning rail (Fig. 4A).
  - A. Fig. 4 shows no separation at the seam. It does not require repair or replacement.
  - B. Fig. 5 shows separation at the seam (Fig. 5A).
    - I. If the separation is less than 6 inches, repair can be accomplished using the procedure described in [TI-434](#).
    - II. If the separation is over 6 inches it will require awning fabric replacement using the procedure described in [TI-166](#).
