WRG-22 / SSLP VEHICLES ONLY

APPLICABILITY: 2017-19MY Impreza / Halogen Head Lamps

NUMBER: WRG-22

SUBJECT: Halogen Headlamp Low Beam & Side Reflector

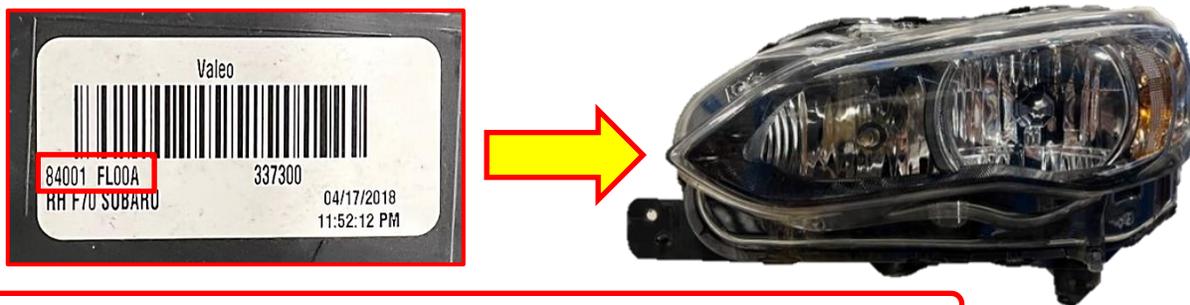
Locate the part numbers labeled on the both the left and right headlamp assemblies. The part identification label is located on the inner front portion of the headlamp. See the images below.

The example part identification label pictured above shows part number **84001FLOOA**

Headlamps with part number **84001FLOOB** or **84001FL01B** will not require replacement and can be reinstalled and adjusted. ALL other part numbers will require replacement and adjustment.
