SAFETY BULLETIN

Communication #: I-19-02-A/B/C

Model Year(s): 2014-2020

SUBJECT: INDIAN MOTORCYCLE - FORWARD LIGHTING

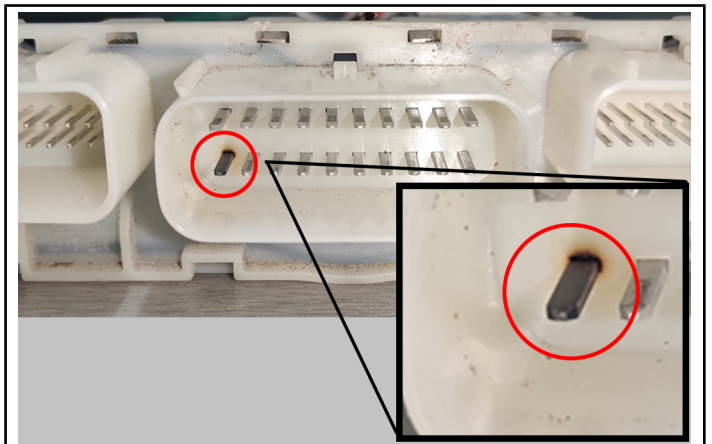
Inspect the male pin on the VCM board for damage.
