ANB4 - Retrofitting Locking Caps on the Front Left and Right Headlights (Stop Delivery / Recall Campaign)

Model Line: **Cayenne (92A)**

Model Year: **As of 2011 up to 2018**

Concerns: **Locking caps on headlight**

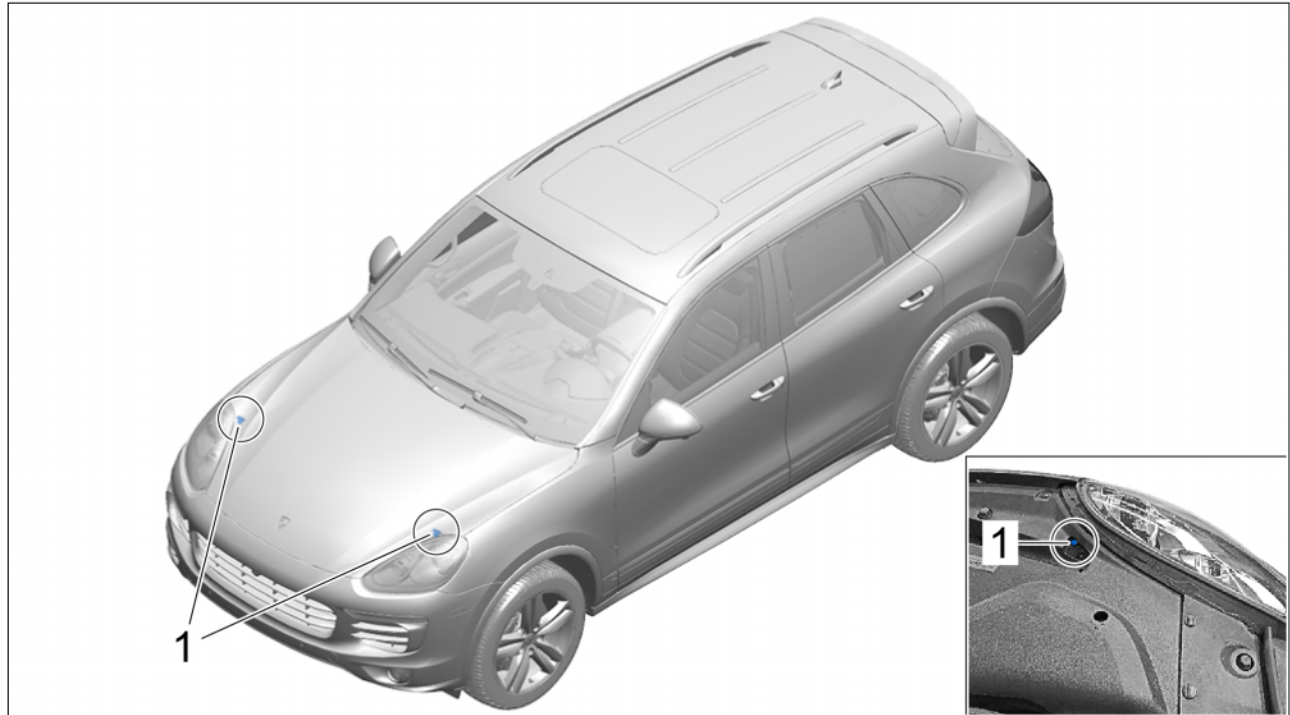
Installation position of caps (e.g. Cayenne MY 2016)

1 – Cap (retrofit)

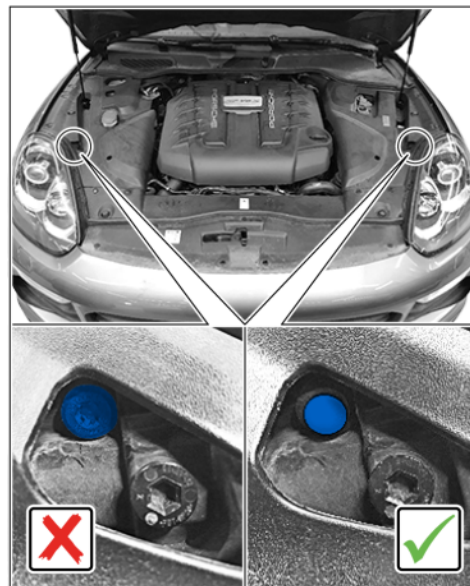
Checking locking caps

- 2 Check whether a cap is installed on the adjusting screw for the horizontal adjustment on the left and right headlights. ⇒ *Checking locking caps*

Assessment		Action
(✓)	A locking cap is installed on the left and right headlight.	End of remedial action. Continue with Step 4.
(✗)	There is no locking cap or only one cap installed on one headlight .	Retrofit locking cap. Continue with Step 3.
