ANB4 - Retrofitting Locking Caps on the Front Left and Right Headlights (Stop Delivery / Recall Campaign)

Model Line: **Boxster (986)**

Model Year: **As of 2000 up to 2004**

Concerns: **Locking caps in luggage compartment**

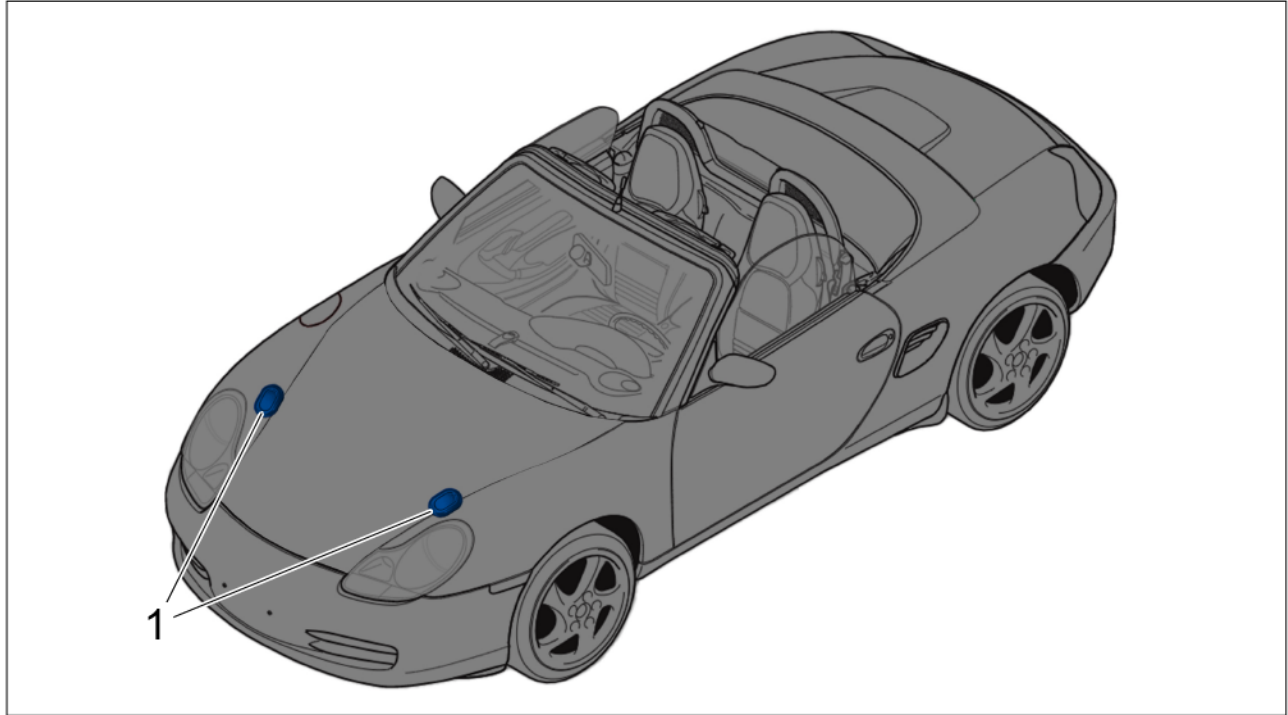
Installation position of cap

Cause: **There is a possibility that a locking cap that prevents the adjustment of the headlights in the horizontal direction was not installed on the affected vehicles during vehicle assembly. If this is the case, certain legal requirements will not be met in the USA and Canada markets.**

1 – Locking cap (retrofit)

Action required: Check installation of the locking caps and retrofit a locking cap in the front luggage compartment on the left and right if necessary.

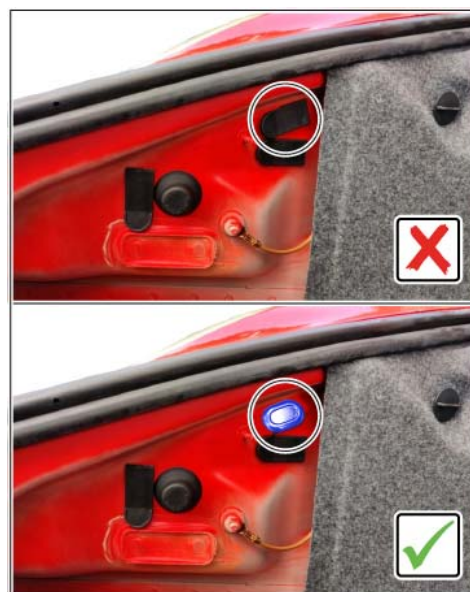
Checking locking cap

Assessment		Action
(✓)	A locking cap is installed in the front luggage compartment on the left and right.	End of remedial action. Continue with Step 5.
(✗)	There is no or only one locking cap installed in the front luggage compartment on the left and right.	Retrofit locking cap. Continue with Step 4.

- 3 Check that a locking cap is installed in the front luggage compartment on the left and right.
⇒ *Checking locking cap*
