ANB4 - Retrofitting Locking Caps on the Front Left and Right Headlights (Stop Delivery / Recall Campaign)

Model Line: **Macan (95B)**

Model Year: **As of 2014 up to 2022**

Concerns: **Cap on headlight**

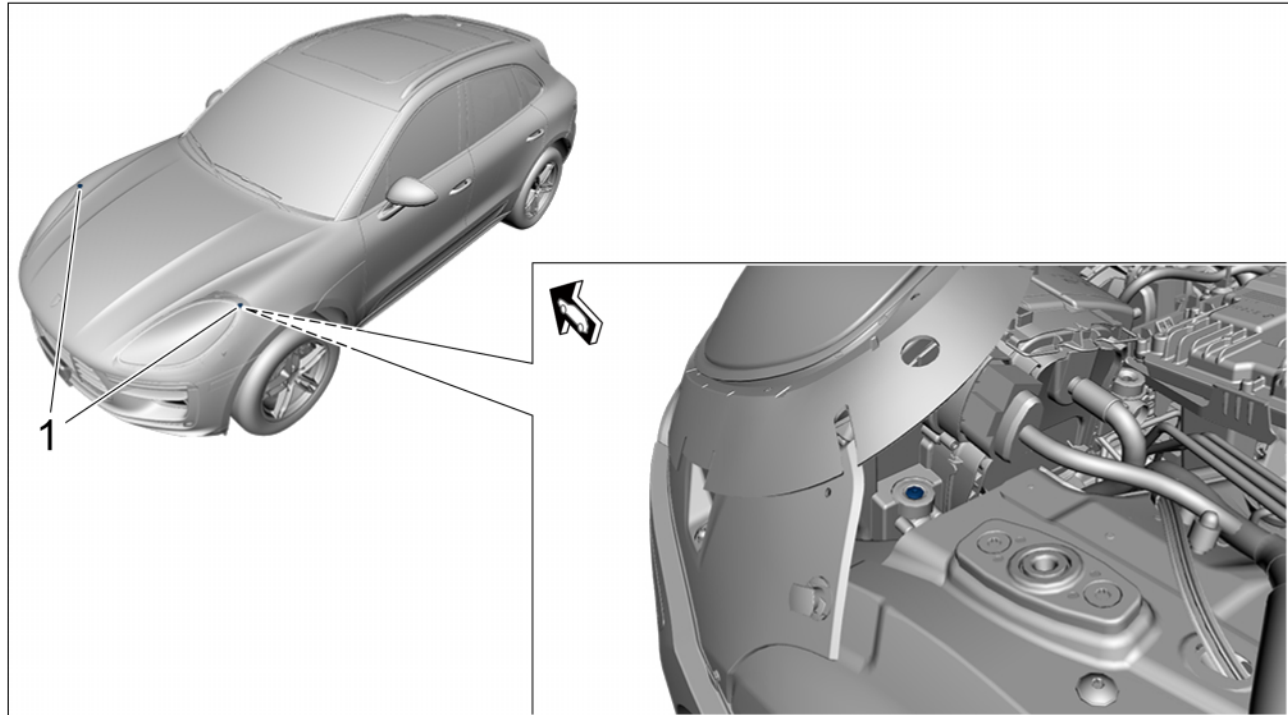
*Installation position of cap*

1 – Cap (retrofit)

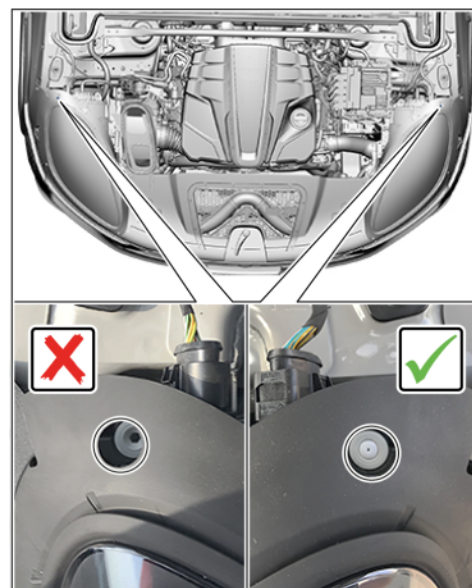
- 2 Check that a cap is installed on the adjusting screw for the horizontal adjustment on the left and right headlight. ⇒ *Adjusting screw for horizontal adjustment*

Adjusting screw for horizontal adjustment

Assessment		Action
(✓)	A cap is installed on the left and right headlight.	End of remedial action. Continue with Step 4.
(✗)	There is no cap or only one cap installed on one headlight.	Retrofit cap. Continue with Step 3.

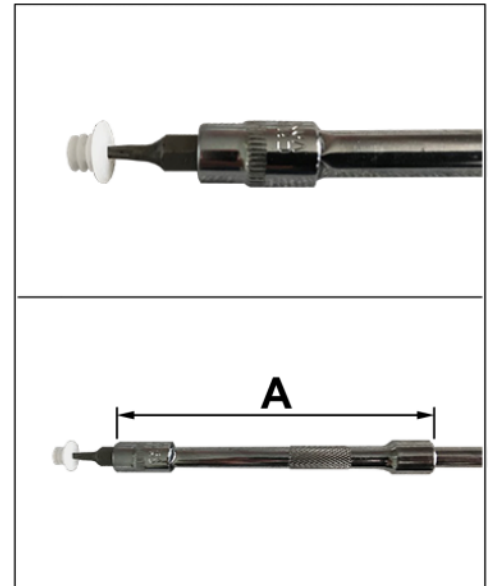
Installing cap

- 3.1 Install cap on a Torx screwdriver (TX 7). ⇒ *Installing cap -Top-*
The free blade length ⇒ *Installing cap -A-* should be at least 115 mm.

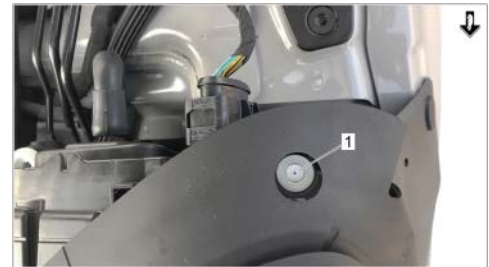
Installing cap (e.g. left headlight)

- 3.2 Press the cap onto the adjusting screw for horizontal adjustment ⇒ *Installing cap (e.g. left headlight) -1-* on the left and right headlights from above using the Torx screwdriver.

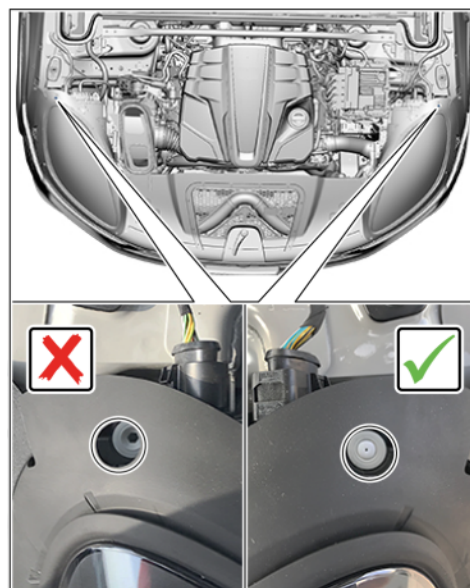
- 2 Check that a cap is installed on the adjusting screw for the horizontal adjustment on the left and right headlight. ⇒ *Adjusting screw for horizontal adjustment*

Adjusting screw for horizontal adjustment

Assessment		Action
(✓)	A cap is installed on the left and right headlight.	End of remedial action. Continue with Step 4.
(✗)	There is no cap or only one cap installed on one headlight.	Retrofit cap. Continue with Step 3.

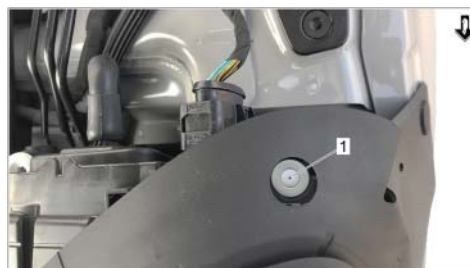
Installing cap (e.g. left headlight)

- 3 Press the cap on the left and right headlight into the adjusting screw for horizontal adjustment ⇒ *Installing cap (e.g. left headlight) -1-*.
- 4 Close front lid.
- 5 Enter the campaign in the Warranty and Maintenance booklet.
