SIB 61 06 22

RECALL 22V-672: REPLACE HORN MOUNTING SCREW

2022-09-09

Model	Model Description	Production Date
K07	CE-04	8/31/21-8/29/22

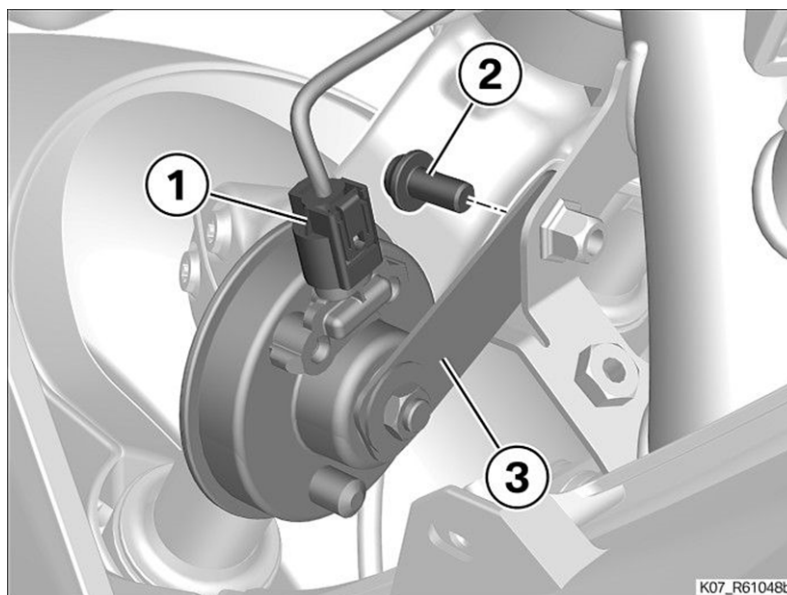
The Screw (Item 2) of the screw connection to the frame is short. Under certain circumstances the screw may come loose and drop down causing a restriction in the left turn steering angle.

The short screw for attaching the horn must be replaced with a new longer screw, according to the repair operation "61 33 011 Replacing the horn".
