# Safety Recall

## Code: 20DS

<b>Subject</b>	Fuel Tank Internal Vent Pipe															
<b>Release Date</b>	November 15, 2022															
<b>Revision Summary</b>	Updated parts and claiming information with additional exhaust clamp part number															
<b>Affected Vehicles</b>

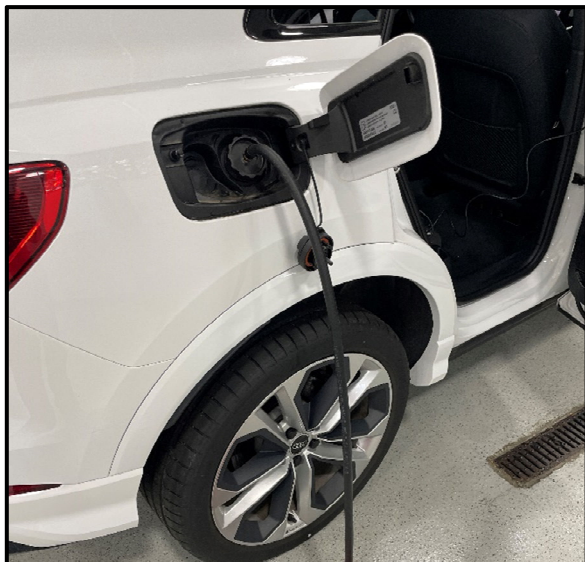
**What is the issue?** The vent pipe within the fuel tank may have been damaged during fuel tank assembly. In cases where the vent pipe has been damaged, fuel might enter this pipe and rise to the fuel filler cap due to the pressure within the fuel tank. Upon opening the fuel filler cap, this might lead to fuel spilling out of the filler neck, increasing the risk of injury. Fuel within the vent pipe can also lead to the fuel pump clicking off while trying to re-fuel the vehicle.

- Perform test procedure to check for a hole in the fuel tank vent line.
- Replace fuel tank, if necessary.
