Recall Campaign Bulletin

Campaign No. 2022090011, November 2022

SUBJECT: **Model C-Class Sedan (206 platform)**
Model Year 2022

Retrofit a Cover for the Rear SAM

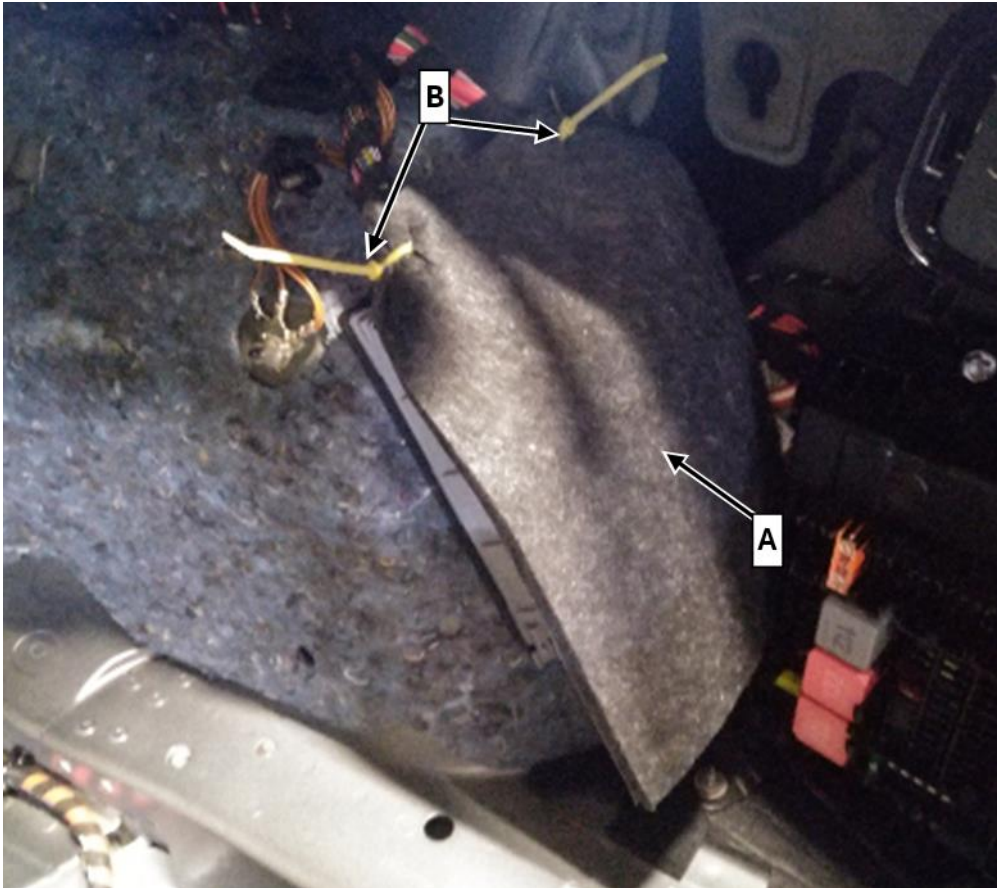
Figure 1

Mercedes-Benz AG (“MBAG”), the manufacturer of Mercedes-Benz vehicles, has determined that in the event of water ingress into a particular section of the trunk in certain Model Year (“MY”) 2022 C-Class Sedan (206 platform) vehicles, moisture might enter into the rear signal acquisition and actuation module (SAM). In this case, a short circuit might occur in the rear SAM. In this connection, a risk of fire cannot be completely ruled out. Additionally, a short circuit could lead to various malfunctions. Among others, the exterior lighting at the rear of the vehicle might fail, the rear seatbacks might fold unintentionally, and the rearview camera might not be available. Thus, the risk of a crash or injury could be increased. When the issue occurs, depending on the affected function, a respective warning message would be shown in the instrument cluster. An authorized Mercedes-Benz dealer will retrofit a cover over the rear SAM on the affected vehicles.

1. Loosen rear right trunk lining and fold inward.
2. Retrofit felt (A, figure 1)
 - i** To do this, dispose of the 2 clips from the new felt and attach two cable ties (B, figure 1) to both electric lines.
 - i** The grey smooth side has to face against the control unit.

3. Shorten protrusion of the cable tie.
 4. Assemble in reverse order.
-
