October 2022
FL952A
NHTSA #22V-681
Transport Canada #2022-513

Subject: Western Star 47X and 49X Steering Pinch Bolt

Models Affected: Specific model years 2022-2023 Western Star 47X and 49X model vehicles manufactured October 8, 2021, through August 10, 2022.

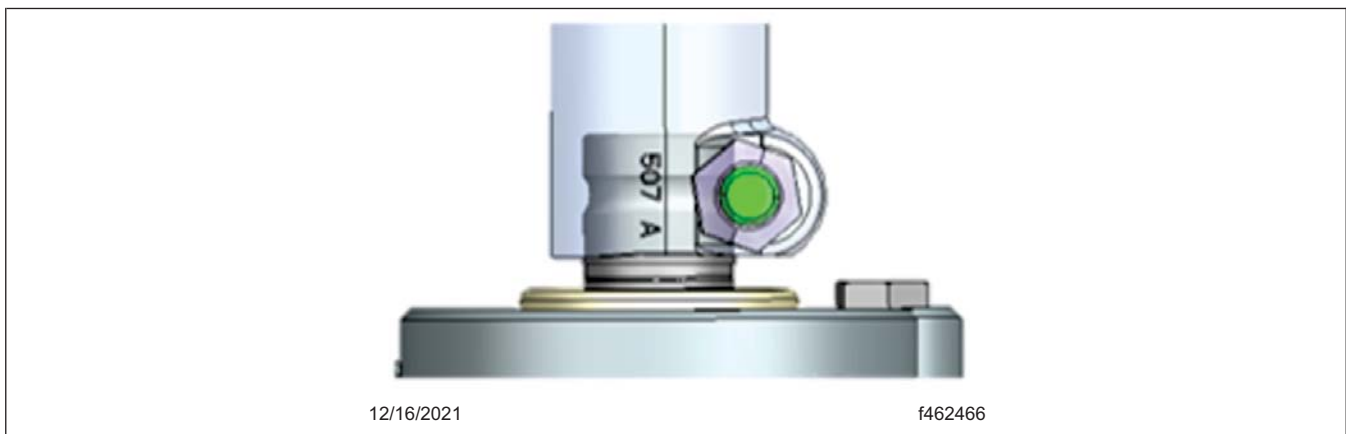
Fig. 1, I-shaft Installed Properly

1. Check the base label (Form WAR259) for a completion sticker for FL952 (Form WAR260) indicating this work has been completed. The base label is usually located on the passenger-side door, about 12 inches (30 cm) below the door latch. If a completion sticker is present, no work is needed. If a completion sticker is not present, go to the next step.
2. Park the vehicle on a level surface with the front tires pointed straight ahead. Shut down the engine, set the parking brake, and chock the tires.
3. Open the hood.
4. With the truck running, turn the wheel so the pinch bolt is accessible at the top of the steering shaft.
5. Inspect the I-shaft to ensure it is seated all the way down to the steering gear. For correct installation, see [Fig. 1](#). For incorrect installation, see [Fig. 2](#).

If installed properly, no further action is required. Proceed to step 6.

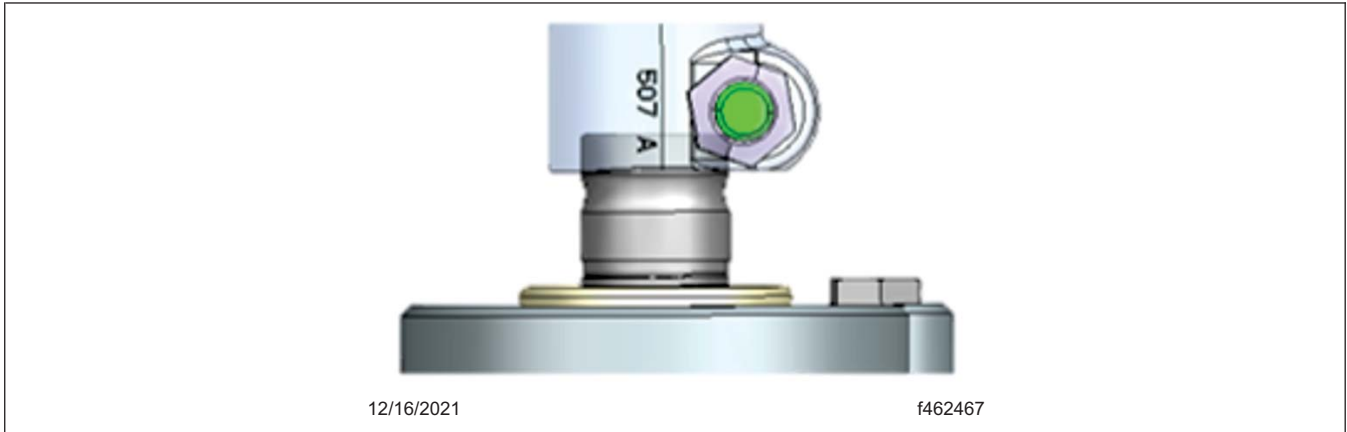
Fig. 2, I-shaft is Lifted or Displaced

On certain vehicles, the steering shaft may not have been properly installed on the steering gear. If the steering shaft has not been properly installed, it may separate from the steering gear, resulting in a loss of steering control, which may lead to a vehicle crash.

If lifted and not seated correctly, go to the **Pinch Bolt Replacement** procedure below.

NOTICE: Do not remove the steering shaft from the steering gear; it is only necessary to slide it the rest of the way on the steering gear until seated completely. Removal of the I-shaft could result in the steering wheel being rotated and damaging the clock spring. Once the shaft is seated and the new pinch bolt is installed, torque the nut on the pinch bolt until required torque is achieved.

1. Remove and discard the pinch bolt and nut on the gearside of the I-shaft.
2. Slide the steering shaft down so it is flush with the steering gear.
3. Install the new pinch bolt and nut.
4. Tighten the pinch bolt 30 to 35 lbf·ft (41 to 47 N·m).
5. Use blue torque seal after the required torque has been set.
6. Clean a spot on the base label (Form WAR259), write the recall number, FL952, on a blank red completion sticker (Form WAR260), and attach it to the base label, indicating this work has been completed.
