Recall Service Bulletin RSB22-330-001

APPLIES TO: This service bulletin applies to certain 2022 model year, Gladiator and Metro Star model emergency response vehicles built between November 2021 and February 2022.

CONDITION: Certain trucks equipped with front wheel park brake and the Hendrickson NXT front suspension may be plumbed incorrectly, resulting in a non-functional front park brake.

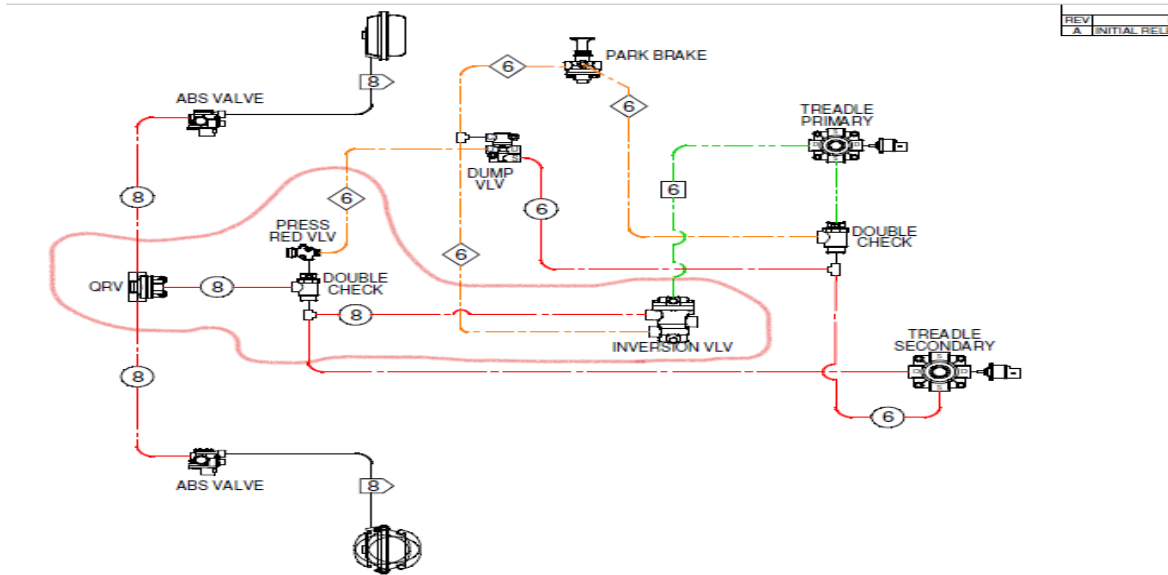
Figure 3.1 Correct Plumbing

- a. The size 8 line that comes out of the side of the double check valve should go to the quick release valve.
- b. The two size 8 lines that come out of the tee out of the end of the double check should go to the inversion valve and the treadle secondary valve.

- 4) If the front ABS modulators are not chuffing air as described in step 1 and the plumbing does not match the diagram in Figure 3.1 or the picture in Figure 3.2, then the plumbing will need to be corrected. Proceed to step 5.

- b. Trace the lines and ensure they are plumbed in accordance with Figure 3.1.
 - c. Repeat the test outlined in step 1 to validate the correct plumbing through the use of the ABS modulator self-test. If air chuffing is heard on the front modulators only during master/ignition activation, then the system is now plumbed correctly.
