Stacy L. Balzer  
Operating Director  
Service Engineering Operations  
Ford Customer Service Division

**SUBJECT:** **NEW VEHICLE DEMONSTRATION / DELIVERY HOLD**  
**Compliance Recall 22C22 - Supplement #2**  
Certain 2022 Model Year Bronco Sport and F-150 Vehicles  
Front Park Lamp Flicker

The affected vehicles may not conform to the requirements specified by Federal Motor Vehicle Safety Standard (FMVSS) No. 108 Lamps, reflective devices, and associated equipment. FMVSS 108 requires the park/position lamp function to be “steady burning”. Vehicles may exhibit a front park/position lamp flickering that results in a park/position lamp function that is not “steady burning”. A front park/position lamp that flickers could increase the risk of a crash.

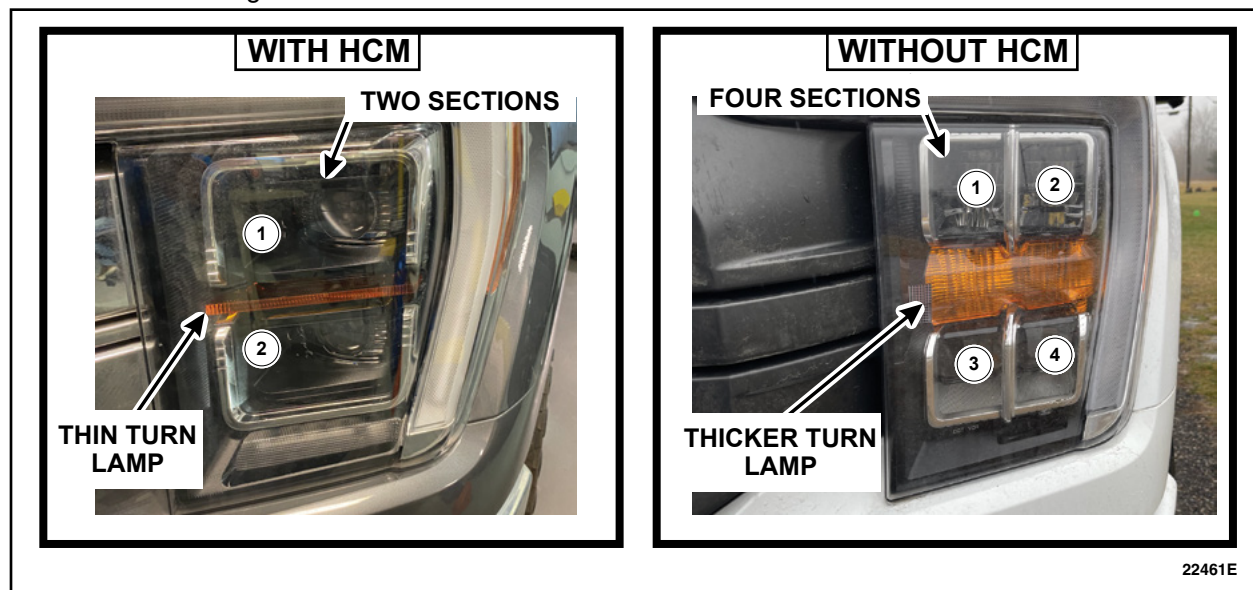
**FIGURE 1**

1. Inspect the headlamps to determine if the vehicle is equipped with a Headlamp Control Module (HCM). Which headlamps are equipped on this vehicle? See Figure 1.

**With** HCM Identification: Headlamp is split into 2 sections and has a thin turn lamp.  
- Proceed to the **TWO STEP** HCM Reprogramming Procedure on Page 8.

**Without** HCM Identification: Headlamp is split into 4 sections and has a thicker turn lamp.  
- Proceed to the Non-HCM Light Emitting Diode (LED) Control Module Inspection on Page 2.

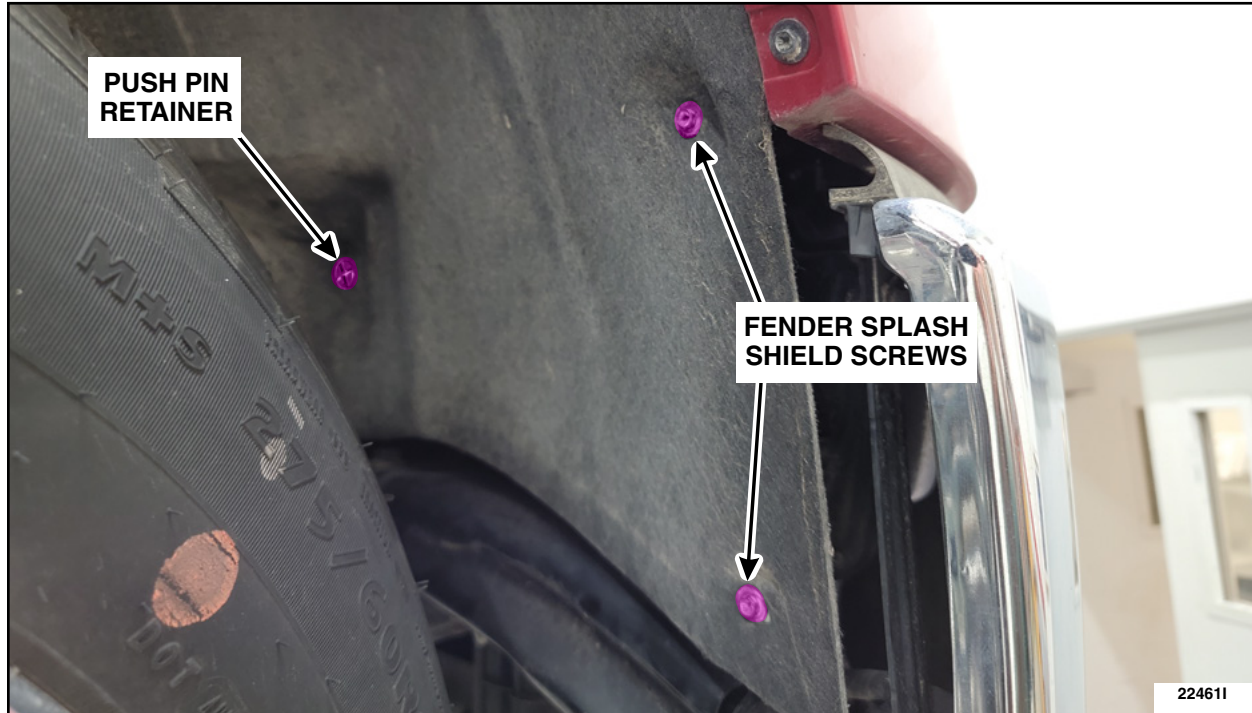
FIGURE 2

2. Position the vehicle on a hoist.
3. On both sides of the vehicle, remove the two fender splash shield screws and the push pin retainer. See Figure 2.

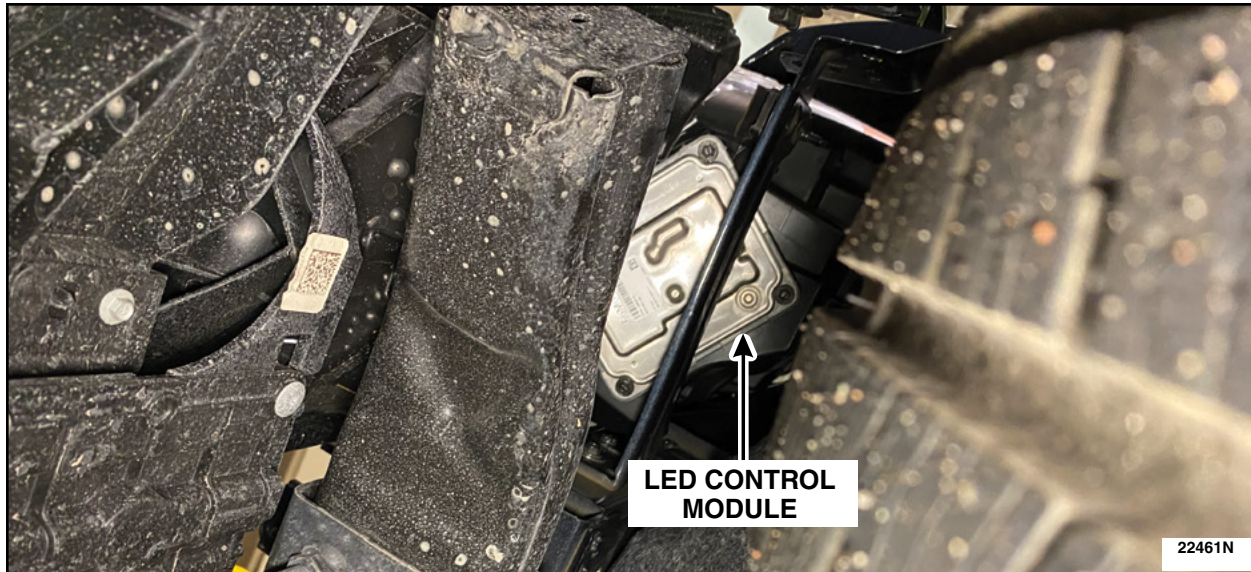
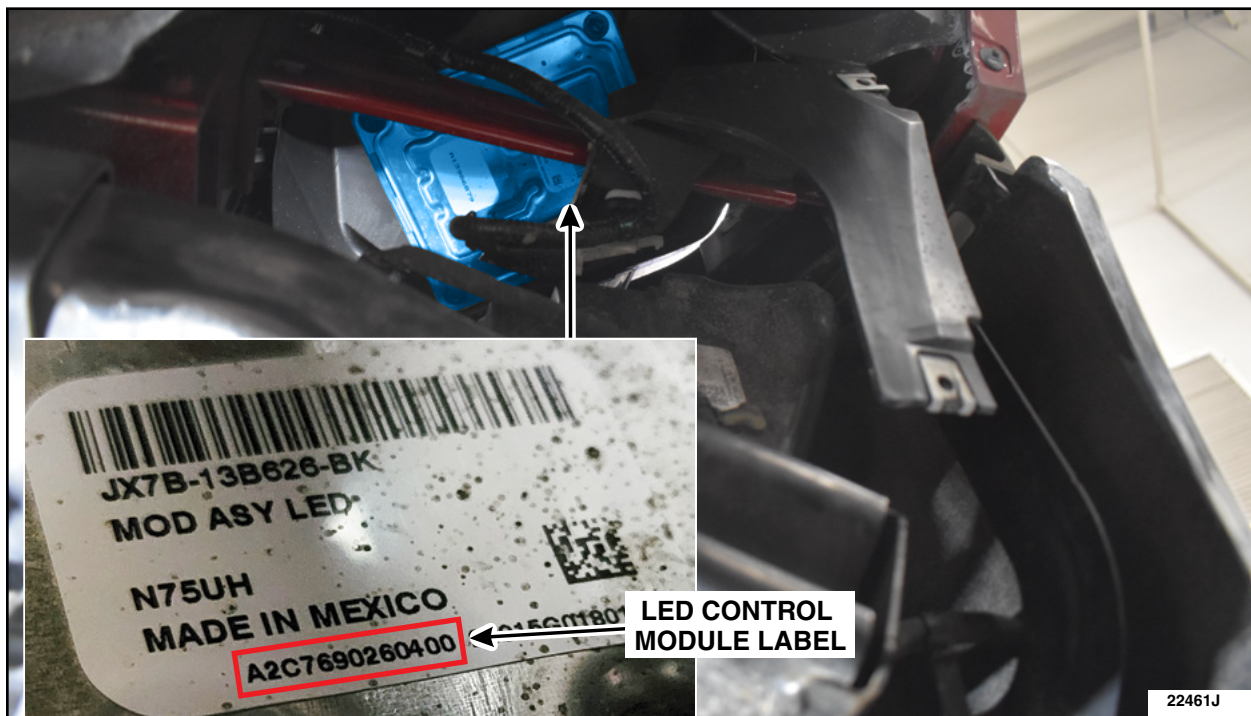
4. On Left Hand (LH) side, position aside the fender splash shield.
5. Look up at the bottom of the headlamp so the LED module label is visible. See Figures 3, 4 and 5.

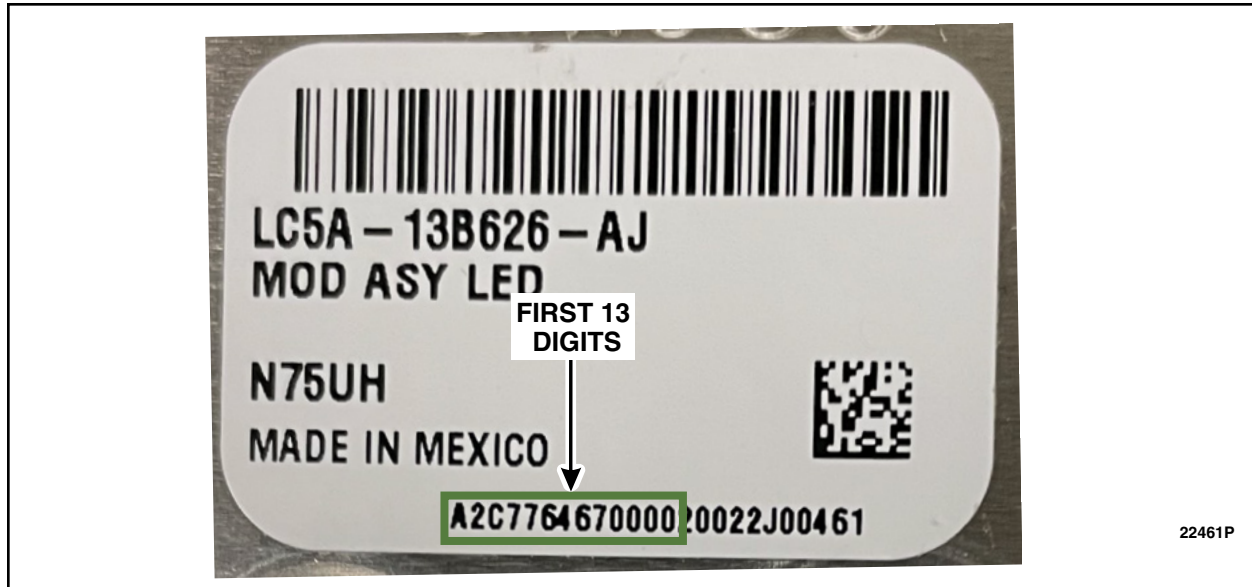
FIGURE 5

6. Take a CLEAR photo of the label with the **13-digit number** on the LED module as shown in Figure 5.
7. Repeat steps 4 – 6 on the Right Land (RH) side.
8. Compare both RH and LH 13 digit label numbers to the list below.

9. Does either the LH or RH label **EXACTLY** match the **13 digits** of one of the label numbers on the list above? See Figure 5 for an example that does not match.

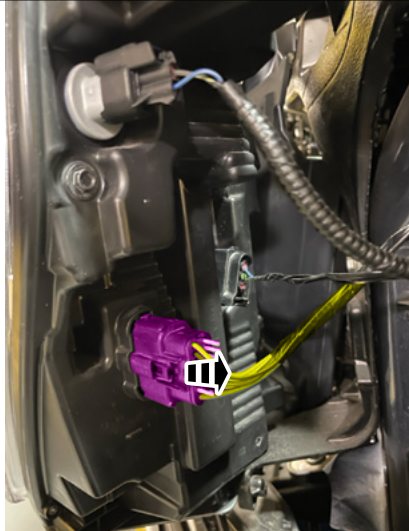
**FIGURE 6**

**LH ONLY label matches one of the 13 digit numbers**

1. Disconnect the **RH** headlamp connector C1285 located on the back of the headlamp assembly.  
See Figure 6.

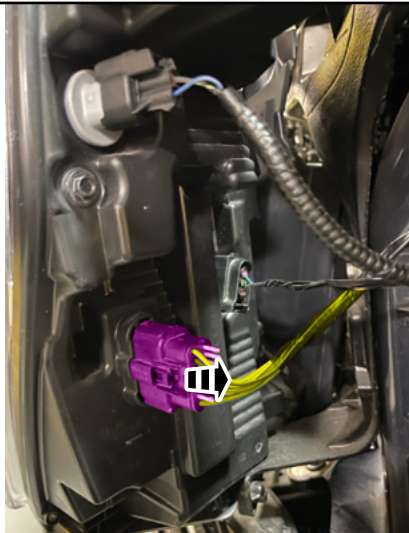
**FIGURE 7**

**RH ONLY label matches one of the 13 digit numbers**

1. Remove both **LH** and **RH** LED modules from the headlamp assemblies. Follow the Workshop Manual (WSM) procedures in Section 417-01.
  2. Install the **LH** LED module on the **RH** side headlamp assembly.
  3. Install the **RH** LED module on the **LH** side headlamp assembly.
- NOTE:** Make sure the **LH** side headlamp has an LED module installed that now has a label matching a 13 digit number from the list on page 4.
4. Reinstall both **LH** and **RH** headlamp assemblies. Follow the Workshop Manual (WSM) procedures in Section 417-01.
  5. Disconnect the **RH** headlamp connector C1285 located on the back of the headlamp assembly. See Figure 7.
