# VOLUNTARY RECALL CAMPAIGN

Classification: ST22-001	Reference: NTB22-079	Date: September 15, 2022
-----------------------------	-------------------------	-----------------------------

## VOLUNTARY SAFETY RECALL CAMPAIGN 2021 KICKS AND 2021 VERSA; STEERING COLUMN

**CAMPAIGN ID #:** PMA10  
**APPLIED VEHICLES:** 2021 Kicks (P15)  
2021 Versa (N18)

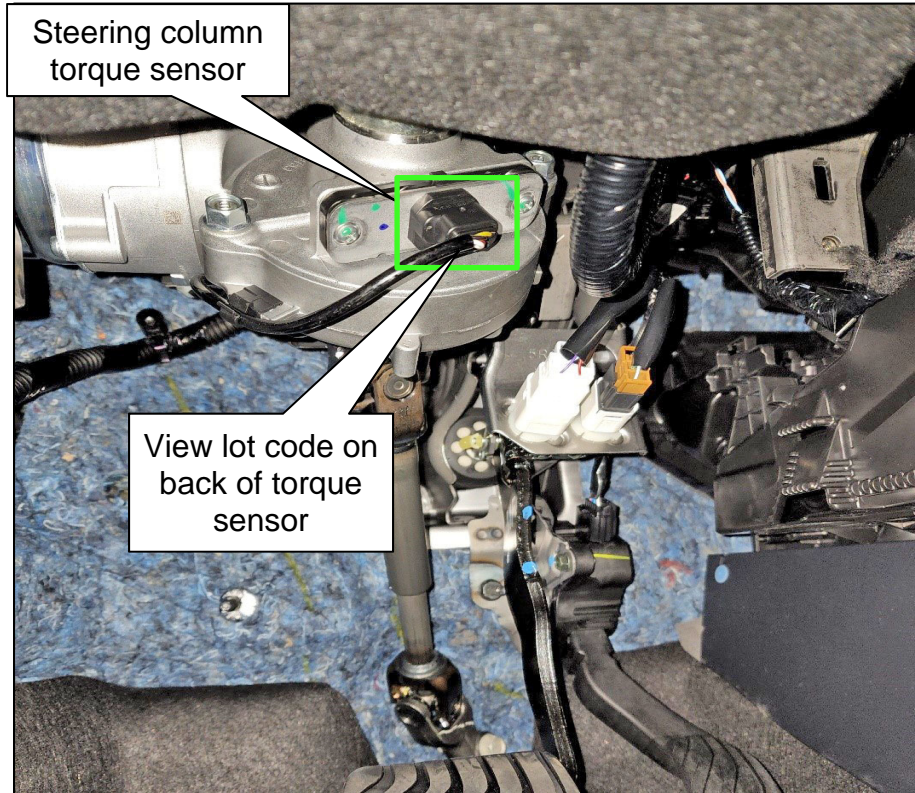
Figure 2

6. Locate the steering column torque sensor (Figure 2).
  - The torque sensor lot code is located on the back side of the torque sensor and is visible by looking upward at the torque sensor.

**IMPORTANT:** DO NOT remove or disconnect the steering column torque sensor.

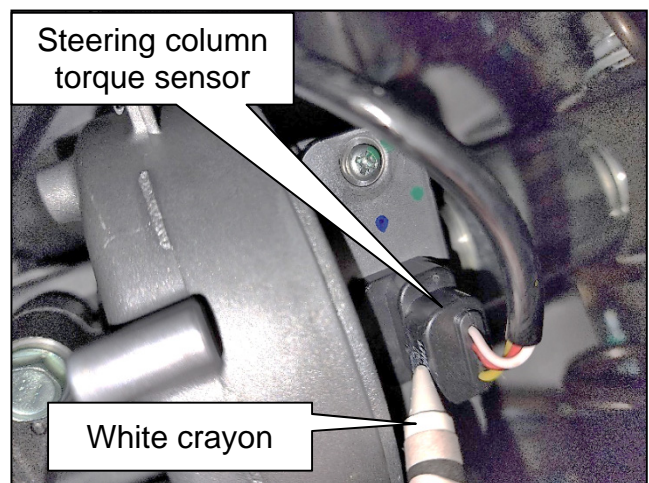
Figure 3

7. Highlight the lot code of the steering column torque sensor.
  - Using a white crayon, with light pressure, rub the crayon over the lot code until the lot code is legible.

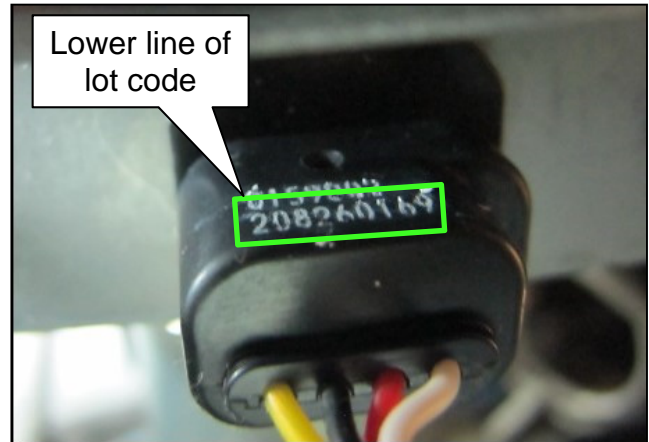
Figure 4

8. Document the lower line of the lot code on the repair order.

9. Review the first five (5) characters of the lot code obtained in step 8 and compare to the **LOT CODES** listed in **Table A**.

MODEL	MODEL YEAR	LOT CODES
Kicks, Versa	2021	21624, 21625, 21626, 21627, 21628

- If the first five (5) characters of the lot code matches one of the sets of numbers in **Table A**, replace the steering column assembly, and then proceed to step 10.
    - Refer to the ESM: **STEERING > STEERING SYSTEM > REMOVAL AND INSTALLATION > STEERING COLUMN > Removal and Installation**
  - If the first five (5) characters of the lot code does NOT match one of the sets of numbers in **Table A**, steering column replacement is not necessary. Continue to step 10.
10. Reassemble the vehicle in the reverse order.
    - Replace the LH side knee air bag module bolts with the ones listed in **PARTS INFORMATION** on the last page.
      - LH side knee air bag module bolt torque: 10.8 N•m (1.1 kg-m, **8 ft-lb**)
  11. Connect both battery terminals, negative battery terminal last.
    - Battery terminal bolt torque: 5.5 N•m (0.6 kg-m, **49 in-lb**)
