Product Safety Recall

N222378380 Rear View Camera Intermittent or Inoperative

Release Date: January 2023

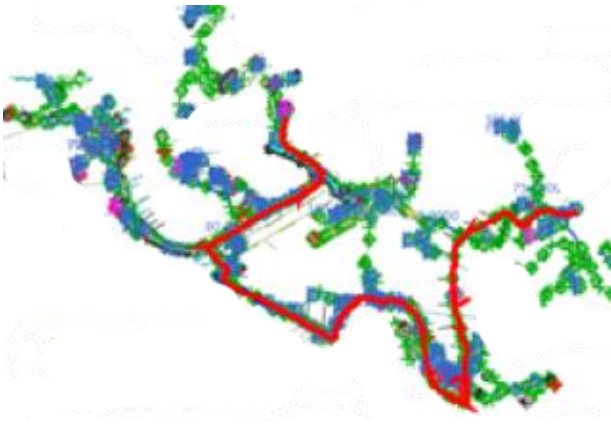
6178293

Coax Routing Shown in Red
