Product Safety Recall

N222378380 Rear View Camera Intermittent or Inoperative

Release Date: January 2023

Condition	General Motors has decided that a defect which relates to motor vehicle safety exists in certain 2020-2021 model year Cadillac XT5, XT6, and GMC Acadia vehicles equipped with the optional Surround Vision feature. The rear view camera in these vehicles may fail or function intermittently. If the rear view camera is not functioning properly, rear visibility is reduced, increasing the risk of a crash during a backing event.
Correction	Dealers will replace the affected coaxial cables.

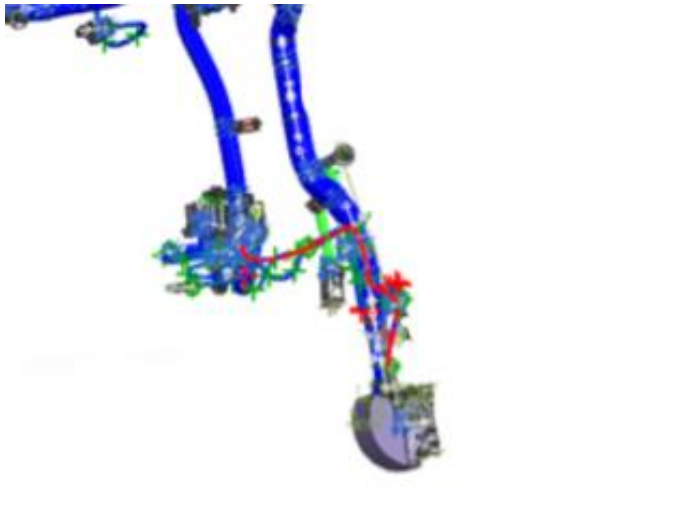
6179550

Coax Routing Shown in Red

1. Remove the right front side door sill garnish molding. Refer to *Front Side Door Sill Garnish Molding Replacement* in SI.
2. Remove the right-side instrument panel insulator. Refer to *Instrument Panel Insulator Replacement - Right Side* in SI.

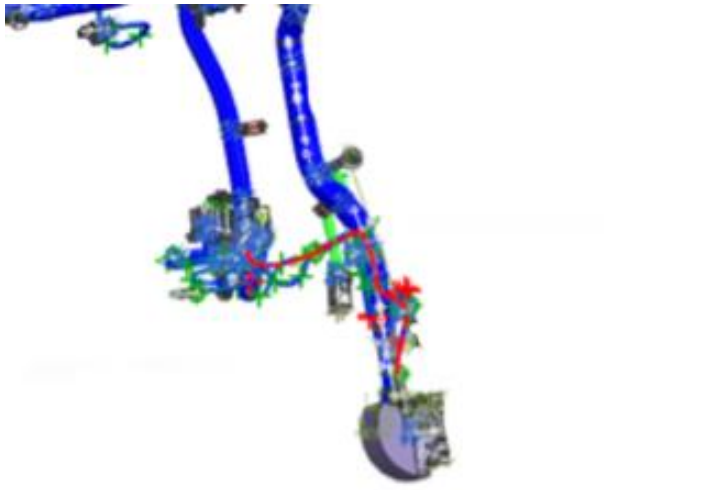
6179550

Coax Routing Shown in Red

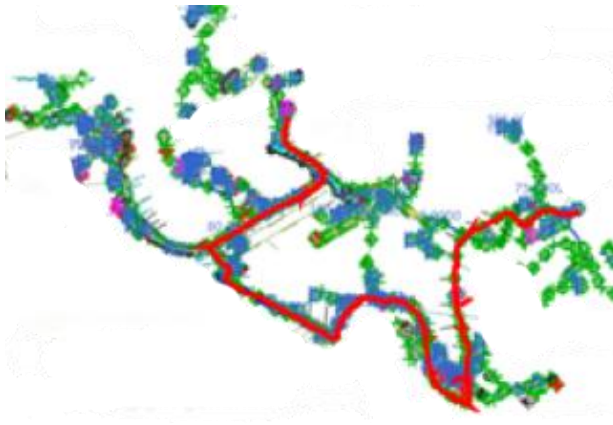
6178293

Coax Routing Shown in Red

19. Route the short side of the new coax to the rear headliner location.
20. Feed the coax through the rubber grommet from the body to the liftgate.
21. Route the long side of the coax forward in the vehicle following the body harness that runs along the left lower side of the vehicle. This will lead to the driver side area of the floor under the front seat.
