SERVICE PROCEDURE

22520

SUBJECT: SAFETY RECALL

REPLACING TIE ROD END CLAMPS WITH KIT FRK-22-1002

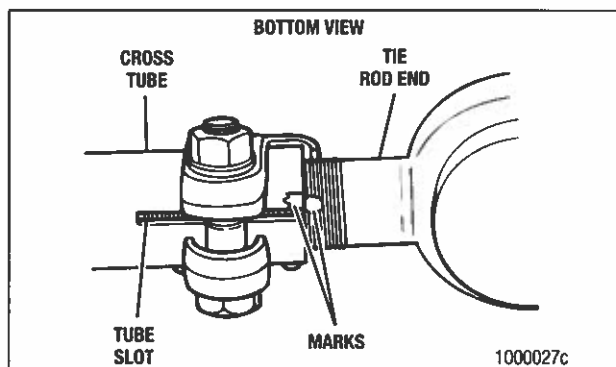
Figure 1

3. Use a paint pen to mark the position of both tie rod ends as shown. Be sure to mark it well so the tie rod end can be screwed back into the exact same position on the threads. Also count the amount of visible threads to confirm proper depth upon re-installation. Figure 1.

10. Thread the tie rod end back into the same position utilizing the paint pen marking. Exposed threads should match the value noted in Step 3.
11. Be sure that the clamp tab is firmly seated against the end of the cross tube. Align the clamp opening with the cross tube slot as shown in Figure 1. Tighten the clamp bolt nut to 150-175 lb-ft (203-237 Nm).

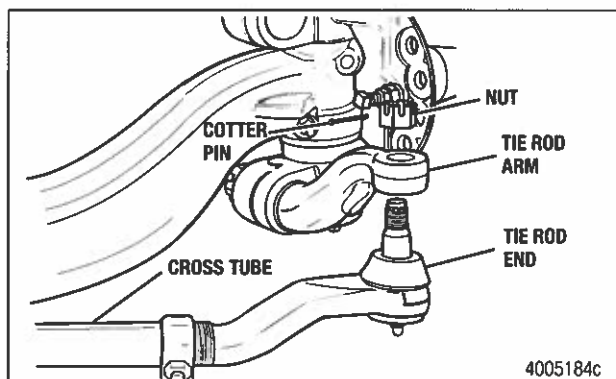
Figure 2

4. Remove the cotter pin and nut that fastens the tie rod end to the tie rod arm. Figure 2.

5. Disconnect the cross tube assembly from the tie rod arm. If available, use a tie rod end puller to separate the tie rod end from the tie rod arm. Figure 2. If necessary, use a leather or plastic mallet to tap on the end of the tie rod arm.
