Vehicle Safety Recall - Technical Service Bulletin

Attention: McNeilus Product Owner
Subject: Zero Radius Ejector Weld Inspection
Models Affected: Zero Radius Side Loader (48)
Model Years: 2020-2022
Date: November 2022

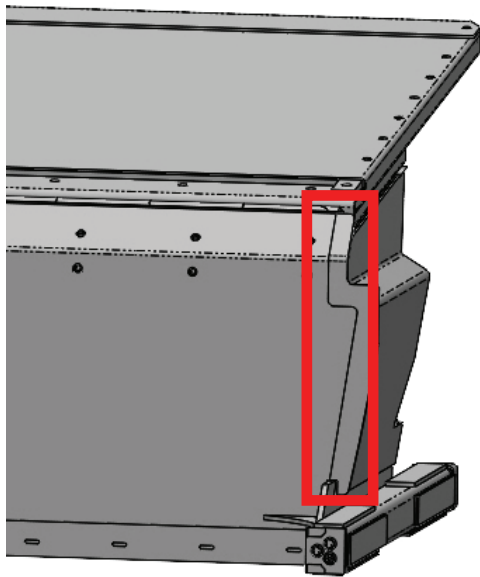
Figure 1 – Daily inspection point

1. Inspect the face of the ejector daily for cracking.
2. Ensure the trash is ejected from the hopper.
3. Fully extend the ejector to the rear of the truck and raise tailgate.
4. Perform your company's Lockout/Tagout procedure. If your company does not have a Lockout/Tagout procedure, follow OSHA 1910.147 and 1910.146 Confined Space as appropriate. Make sure the vehicle on a flat surface and block tires.
5. Inspect both the street side and curb side of the ejector for cracking at the welds (see Figures below).

- Daily – the face of the ejector
- Monthly – the pillow block area

6. If cracking is **NOT** found, continue daily inspection until cracking is found. If no cracking is found, remove your company's Lockout/Tagout procedure. If your company does not have a Lockout/Tagout procedure, follow OSHA 1910.147 and 1910.146 Confined Space as appropriate. Procedure is complete. Return truck to service.
7. **Once cracking is discovered**, the truck must be taken out of service. Contact McNeilus Truck and Manufacturing Service at 888-686-7278 for next steps. Photographs of the cracking will be requested by McNeilus in order to determine the best next steps.
