March 2023
FL955A-C
NHTSA #22V-722
Transport Canada #2022-546

Subject: Tie Rod Clamps

Models Affected: Specific model years 2022-2023 Freightliner 108SD, and 114SD; and Western Star 4700, 4900, 6900, 47X, and 49X vehicles manufactured December 16, 2021, through July 29, 2022.

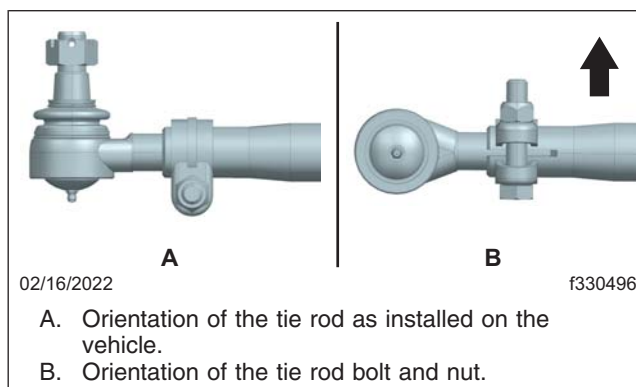
Fig. 3, USK Tie Rod Bolt Orientation

NOTE: The tie rod clamp bolt must be on the bottom of the tie rod and the nut on the bolt must face to the rear of the vehicle. An alignment rib on the tie rod prevents incorrect installation. To properly align the clamp on the tie rod (left and right, side to side), the tie rod rib must fit inside of the corresponding groove in the tie rod clamp.

1. Remove the plastic protective covers from both castle nuts of the new tie rod assembly.
2. On one side of the vehicle, install the tie rod end in the spindle. Install the new castle nut and hand tighten it.
3. Adjust the tie rod until the other end of the tie rod can be installed into the spindle on the other side of the vehicle. Install the other tie rod end into the spindle. Install the new castle nut and hand tighten it. **Fig. 3** shows the USK tie rod bolt orientation. **Fig. 4** and **Fig. 5** show adjustments for each type of the tie rod.
