N222377890 Inspection Available: Seat Height-Adjust Pivot Bolt May Be Loose

Release Date: September 2022 Revision: 00

Condition	General Motors has decided that a defect which relates to motor vehicle safety exists in certain 2022 –					
	2023 model year Chevrolet Equinox and 2022 model year GMC Terrain vehicles equipped with power					
	driver seats that are not equipped with memory function. The driver seats in these vehicles may have					
	stripped or loose bolt at the seat frame height-adjust pivot. If the seat frame height-adjust pivot bolt					
	comes out of the pivot joint, the seat structure may have reduced ability to restrain the occupant in a					
	crash, increasing the risk of injury.					
Correction	Dealers will inspect driver seats and replace seat cushion frames if necessary.

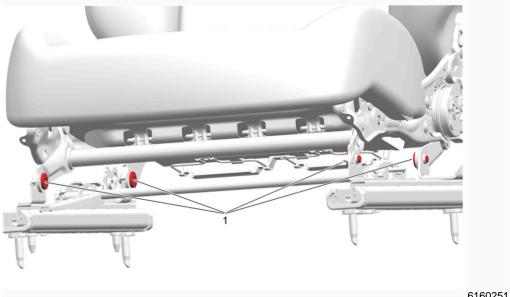
- 616025
- 2. Locate the four Front Seat Vertical Adjuster Bracket Bolts (1), shown above.
 - If all four bolts are in place, proceed to step 3.
 - If any of the four bolts are missing and the vehicle is in dealer inventory, hold the vehicle until remedy parts become available. Proceed to step 6.
 - If any of the four bolts are missing and the vehicle is customer owned, place customer into a rental/loaner vehicle until remedy parts are available. See General Motors Service Policies and Procedures Manual or Warranty Administration Bulletin 17-NA-073: Field Action Courtesy Transportation Policy for further information. Proceed to step 6.

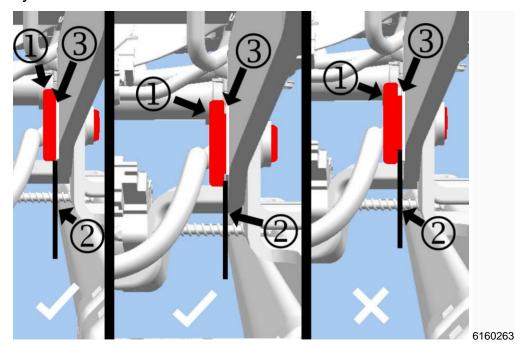
Note: The gap is considered good if the feeler gauge can fit as shown in the center image of the graphic above but cannot go in far enough to touch the shaft of the bolt. The feeler may touch the outside diameter of the bushing, as shown in the center image of the graphic above but should not pass between the head of the bolt and the bushing flange, touching the shaft of the bolt as shown in the right image of the graphic above.

- 3. On all four bolts, check the gap between the Front Seat Vertical Adjuster Bracket Bolts (1) and the Front Seat Cushion Frame Bushing (3) using a 0.25 mm (0.010 inch) feeler gauge (2) as shown above.

- If the gap is less than 0.25 mm (0.010 lnch) on all four bolts, shown in the left and center image of the graphic above, proceed to step 5.
 - If the gap is 0.25 mm (0.010 lnch) or more on any of the four bolts, shown in the right image of the graphic above, proceed to step 4.

- 4. Inspect the failed bolts for cross threading.
 - If no cross threading is found, proceed to step 5.
 - If cross threading is found and the vehicle is in dealer inventory, hold the vehicle until remedy parts become available. Proceed to step 6.

- 5. Torque all four bolts to 39 Nm (20 lb ft).
 - If all four bolts achieve torque, proceed to step 6.
 - If any of the four bolts can't achieve torque and the vehicle is in dealer inventory, hold the vehicle until remedy parts become available. Proceed to step 6.
 - If any of the four bolts do not achieve torque and the vehicle is customer owned, place customer into a rental vehicle until remedy parts are available. See *General Motors Service Policies and Procedures Manual* or *Warranty Administration Bulletin 17-NA-073: Field Action Courtesy Transportation Policy* for further information. Proceed to step 6.
- 6. Return the seat to the original location.
