Keystone RV Company

SAFETY ADVISORY # 22-436

Dexter 8k Axles

U-Bolt Fastener Torque on D80 Axle Models (RE-TORQUE)

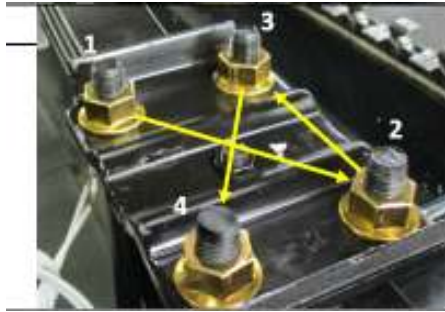
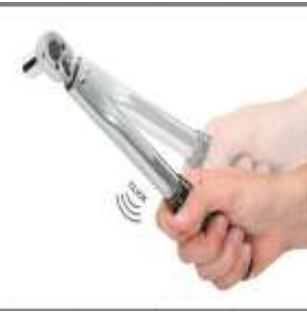
Keystone is conducting a voluntary RECALL notification campaign in accordance with the National Highway Transportation and Safety Act. It has been decided that vehicles in the recall population have a Dexter axle using a spring pack with U-bolts that may not be properly torqued. Under certain conditions during travel, if the improperly torqued U-bolts come loose there is an increased risk of the axle sliding back on the springs, which could result in poor vehicle handling and/or vehicle crash.

The remedy is to torque the axle U-bolt nuts in a cross pattern to 110 ft lbs.

Part #: 006-301-00
Description: 9/16-12 FLANGED HEX NUT (SILVER)
Application: TIE PLATE U-BOLT NUT
Minimum Torque: 100 ft. lb.
Maximum Torque: 120 ft. lb.

Using click torque wrench, apply specified torque to fasteners in sequential criss-cross pattern as shown. ***APPLY TORQUE WITH AXLE INSTALLED AND IN LOADED STATE***

If any of the U-bolt nuts on this tie plate do not meet torque specifications, repeat step 3.
