RECALL 22V729 / 2022-556 REMEDY INSTRUCTIONS

Make(s): SALEM, WILDWOOD & OZARK
Model(s): MANY, SEE BELOW
Model Year(s): MANY, SEE BELOW

A secondary means of strapping to the fresh water tank to the chassis may not have been installed.

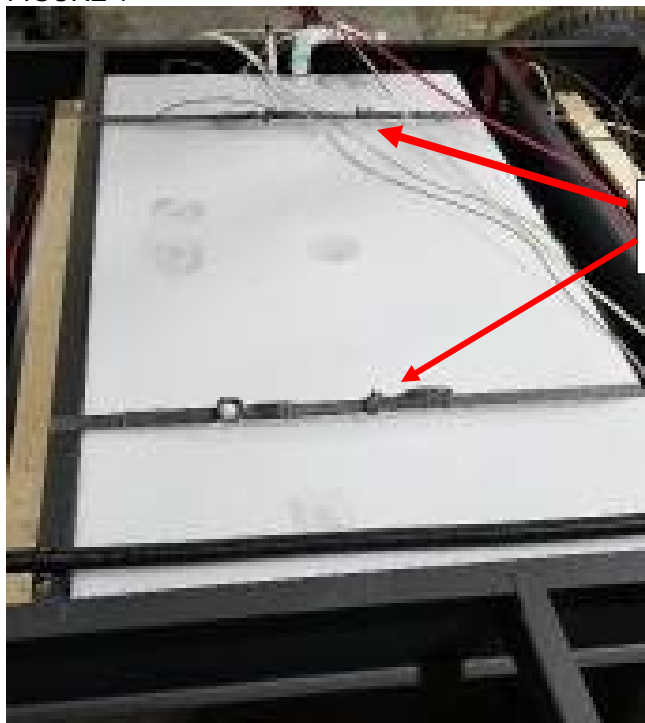
FIGURE 1

- REMOVE UNDERBELLY PANEL AND SET ASIDE WITH FASTENERS;
- IF THE HOLDING TANK HAS STRAPS AROUND THE TANK AND CROSS-MEMBERS (FIG. 1) TAKE PHOTOS;
- INSPECT THE FLOATING CROSS-MEMBER AND ENSURE IT HAS TWO FASTENERS ON EACH SIDE (TOTAL OF 4) (FIG. 2);
- REASSEMBLE ANY REMOVED UNDERBELLY;
- SUBMIT PHOTOS WITH CLAIM INSPECTION CODE ONLY.

FACTORY INSTALLED 1 1/4" NYLON WEB STRAPPING

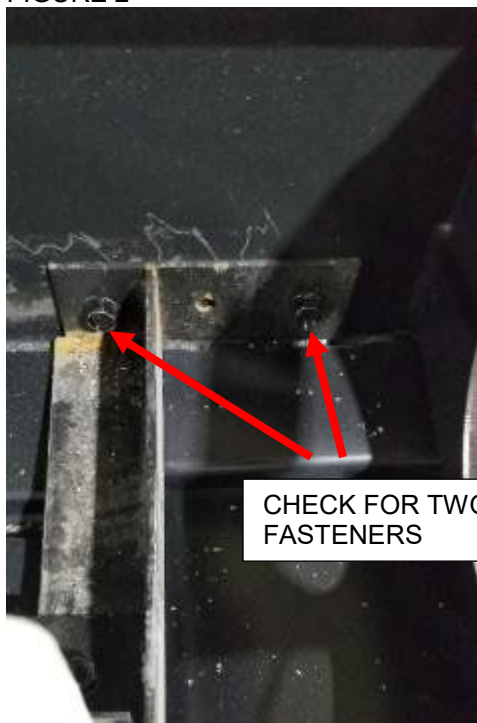
FIGURE 2

CHECK FOR TWO FASTENERS

STEP 3: INSPECT AND ENSURE THE FLOATING CROSS-MEMBER HAS A MINIMUM OF TWO (2) 3/8" SELF-TAPPING FASTENERS (FIG. 2), ADD IF MISSING;

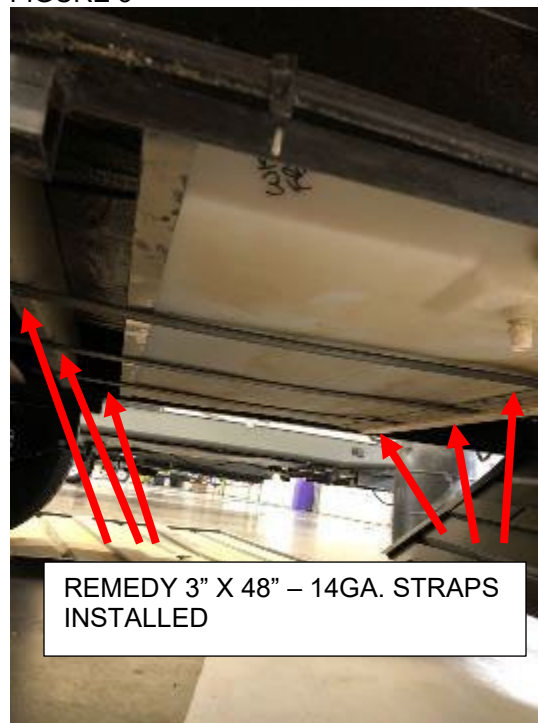
FIGURE 3

REMEDY 3" X 48" – 14GA. STRAPS INSTALLED

STEP 2: USE THE 3" X 48" – 14GA. FLAT STOCK FROM THE REMEDY KIT (FIG. 3);

- USE THE 3/8" SELF-TAPPING LAGS TO SECURE THE THREE – 3" X 48" – 14GA. FLAT STOCK TO THE BOTTOM OF THE FULL HEIGHT CROSS-MEMBERS, ONE IS BEHIND THE FRESH WATER TANK AND ONE IS IN FRONT OF THE FRESH WATER TANK;
- DO NOT LAG INTO THE FLOATING CROSS-MEMBER AS THE FASTER WILL PENETRATE THE FRESH TANK;
