R22CB

SUBJECT: R22CB: 7.3L Gas Supply Line And Shifter Cable Interference

7.3L SHIFT CABLE-GASOLINE FUEL LINE INTERFERENCE

Models Affected: Certain 2022 & 2023 Model Year Blue Bird Vision Buses equipped with 7.3L Gasoline engine

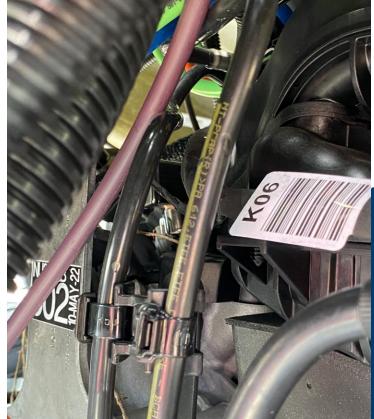
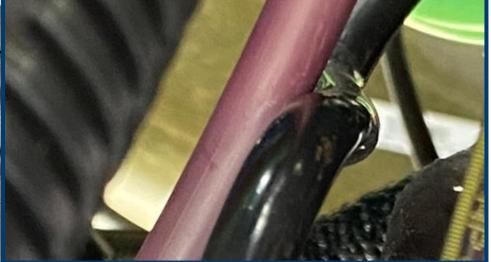
Step 1: Inspect the left rear corner of the engine from the top, and the bottom. If there is greater than 3" of clearance between the shift cable and the fuel line, no further action is required. Ref. Figure 1 for an example of insufficient clearance. If <3" of clearance, proceed to step 2.

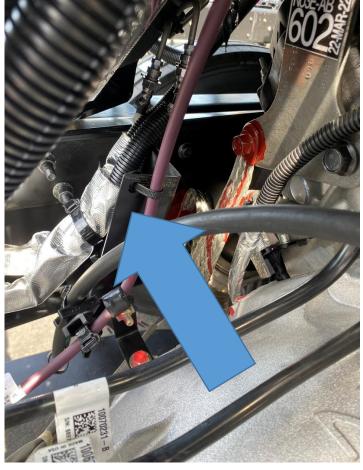
🔊 Fig 2

- Step 3: Verify the heat shield bracket (Item 2), regardless of brake type is in place. Reference Figure 2. If missing, install per Figure 3.
- Step 4: Verify shift cable is routed properly and secured to the bracket with the HD button cable tie, p/n 00024076 per Figure 3
