Safety Recall

Code: 13i4

Subject Engine Connecting Rod

Release Date November 18, 2022

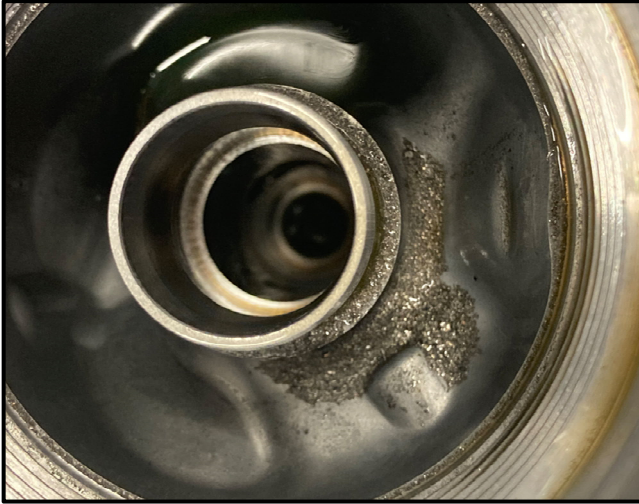
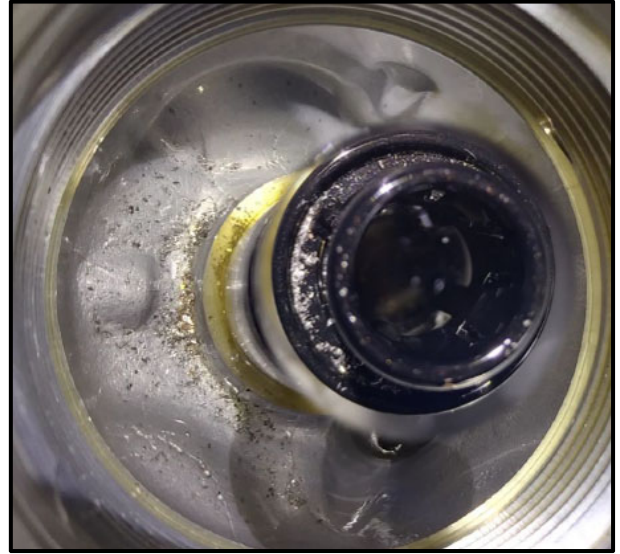
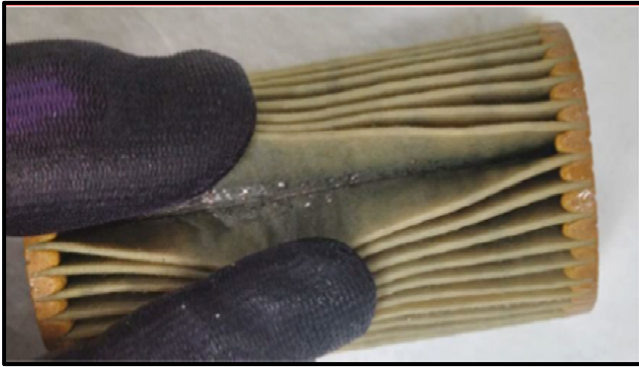
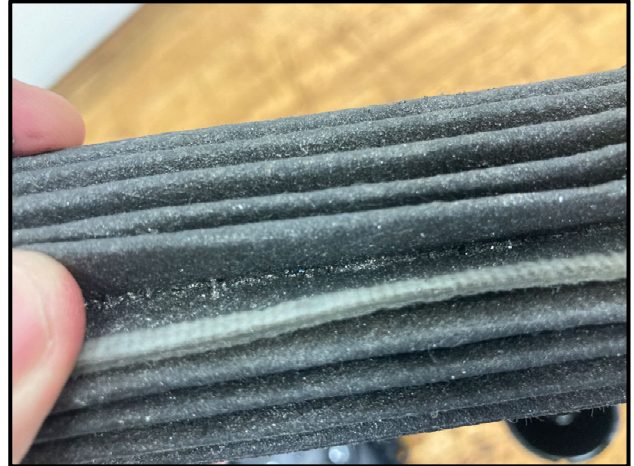
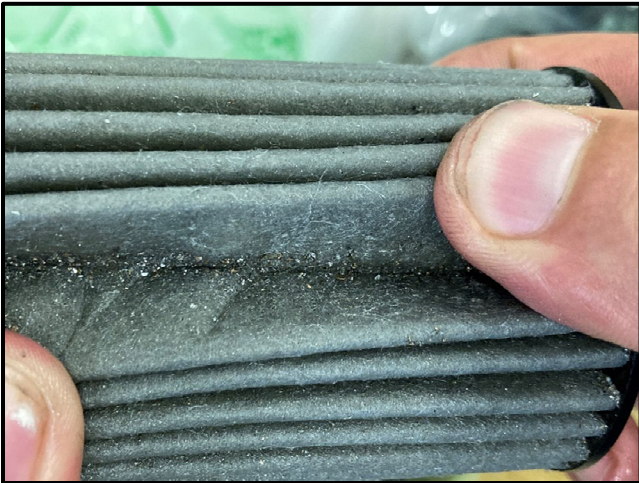
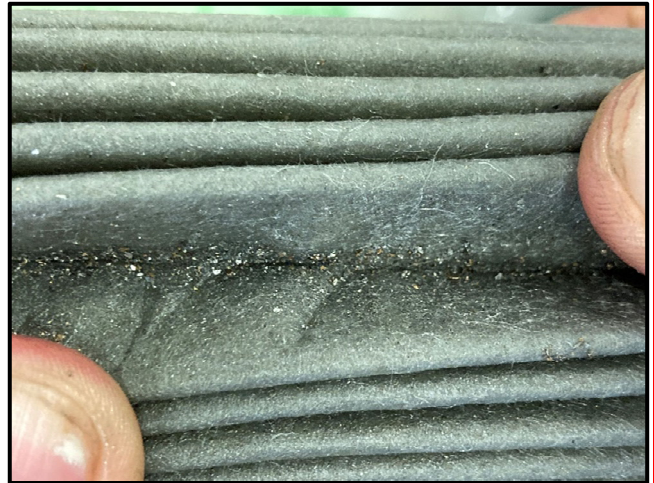
Examples of NOT OK Oil Filters and Oil Filter Housing

Deviations in the mechanical production process of the connecting rods may have caused an increased particle occurrence in the engine oil circuit, which may lead to extensive wear and play and result in damage to the connecting rod bearings. A connecting rod bearing with continuously rising bearing play leads to excessive engine noise.

- The engine requires replacement.
 - Take clear photos of oil filter and housing.
 - Proceed to Section C
