# Safety Recall Code: 13i5

**Engine Connecting Rod**

January 25, 2023

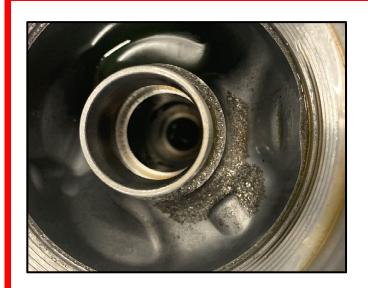
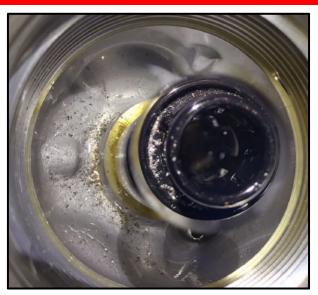
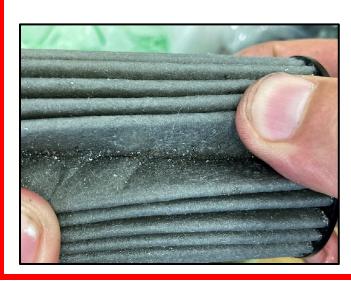
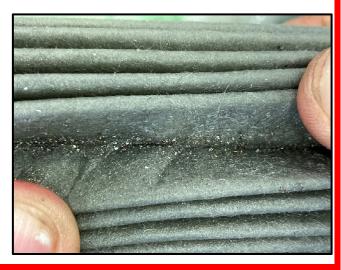
# **Examples of NOT OK Oil Filters and Oil Filter Housing**

- o The engine requires replacement.
  - Take clear photos of oil filter and housing.
  - Proceed to Section C

- Take clear photos of the filter and filter housing showing excessive metal particles.
- Create a TAC WEB Ticket and upload the photos to the TAC case.
- Select "13i4 / 13i5 Review" as the Concern Type.
- The consultant will review the photos and provide direction.

- If consultant advises that the engine DOES NOT require replacement:
  - Replace oil filter and seal again.
  - o Torque housing to 25 Nm.
  - Proceed to Section D.
- If consultant advises that the engine DOES require replacement:
  - Replace complete engine according to the ELSA Repair Manual: Repair manual > Engine > 4-Cylinder Direct Injection 2.0L 4V TFSI Engine (EA 888evo4) > 10 Engine Assembly > Engine, Removing and Installing
  - Adhere to all warnings outlined in the repair manual.
  - Reference ELSA Repair Manual for special tools.
  - Proceed to Section D
