# Safety Recall

## Code: 13i5

**Subject** Engine Connecting Rod

**Release Date** November 29, 2022

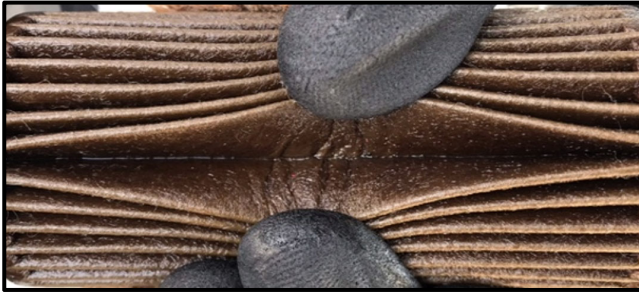
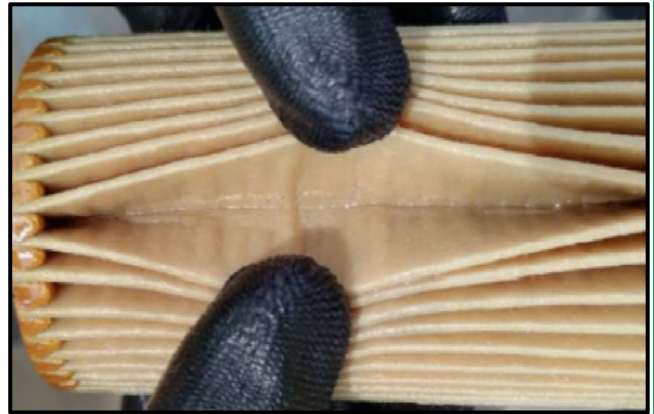
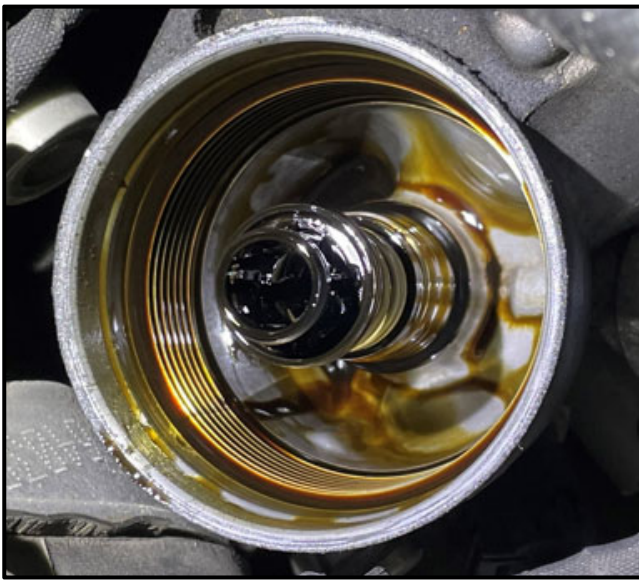
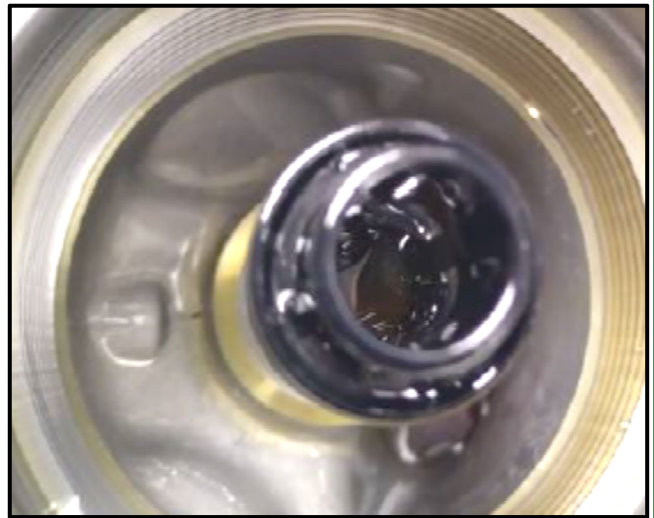
## Examples of OK Oil Filters and Oil Filter Housing

- Turn engine off.
- Remove oil filter.
- See examples of OK and NOT OK oil filter and housing on the following pages.
- If no excessive metal particles are found:

- Engine does not require replacement.
  - **Replace oil filter and seal again.**
  - Torque housing to 25 Nm.
  - Proceed to Section D.
- If excessive metal particles are found:
